PROJECT TITLE: Jefferson County MRC Operations and Projects

TASK NUMBER: 4-Eelgrass and shellfish voluntary no anchor zones

Year one final report

## Jefferson County Marine Resources Committee 2022 Voluntary Eelgrass and Shellfish Protection No-Anchor Zones Summary Report

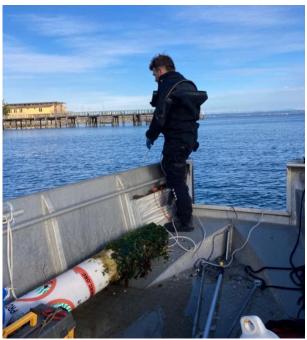
Due to scheduling conflicts and weather conditions, the volunteer dive team was unable to swap the summer spar buoys with winter floats as they normally do in the fall. On December 31, an MRC member, Frank, retrieved an eelgrass protection no-anchor zone buoy that had broken loose from the Port Townsend waterfront, likely due to stormy winter conditions.

Retrieved eelgrass protection buoy covered in marine growth.

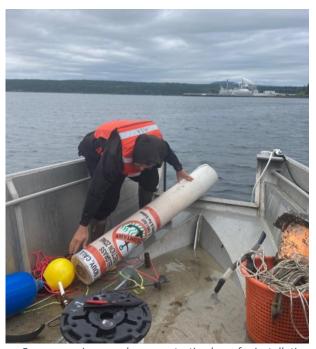
Bryan prepping an eelgrass protection buoy for installation.
Photo by Troy McKelvey.

On May 22, three MRC members (Gordon, Bryan, Troy) and a former Port of Port Townsend Commissioner and MRC representative, Steve, used the Port's boat to swap the four winter floats and relocated some of the missing buoys, installing a total of eight summer spar buoys. The same team went out again on June 12 to install three more spar buoys, bringing the total number of functioning no-anchor zone buoys to 11 of the 13 permitted.

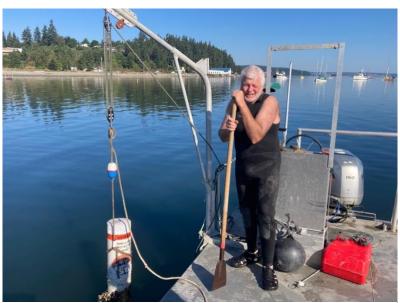
The team (Gordon, Bryan, Troy), with the help of the nearby aquaculture company (Hama Hama Oyster Co.) and donated use of their boat, did maintenance on the Port Hadlock buoys on July 31. All four buoys were nearly sunk, and one anchor was nearly broken off. The team replaced the anchor and cleaned the buoys, refitting them with new shackles and rope.

Gordon getting ready to scrape marine growth off one of the Port Hadlock buoys. Photo by Troy McKelvey.

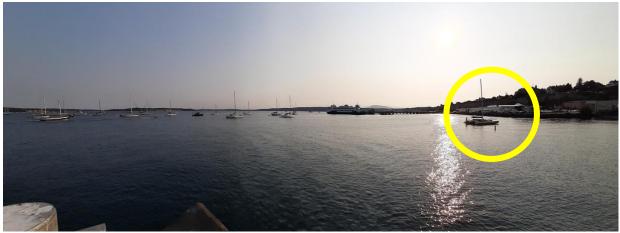
Six additional monitoring days by the MRC Coordinator, Bob Simmons (WSU Extension), and another MRC member, Gordon, bring the total to 21 monitoring days. Only one boat was observed anchoring within the boundaries of the buoys, during the Wooden Boat Festival which attracts hundreds of boats and thousands of visitors to Port Townsend Bay. This resulted in 95% boater compliance with the Port Townsend eelgrass protection no-anchor zone this year.

Vessel anchored within the eelgrass protection no-anchor zone (yellow circle) on September 9, during the Wooden Boat Festival. Photo by Monica Montgomery.
