PROJECT TITLE: Jefferson County MRC Operations and Projects

TASK NUMBER: 5-Eelgrass/Shellfish Protection No-Anchor Zones

PERIOD COVERED: October 1, 2022 – September 30, 2023

**Jefferson County Marine Resources Committee
2023 Voluntary Eelgrass and Shellfish Protection No-Anchor Zones
Project Summary Report**

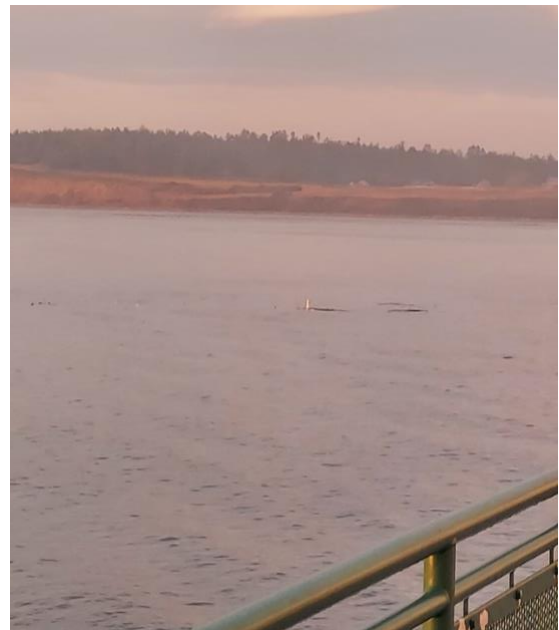
August 29 – MRC member, Nam Siu, reported possibly seeing a Port Townsend eelgrass protection buoy floating on the water as he was traveling on the ferry.

Figure 1. Photo of a possible floating eelgrass protection buoy from Port Townsend, sent from MRC member, Nam Siu, from the Port Townsend-Coupeville ferry on August 29.

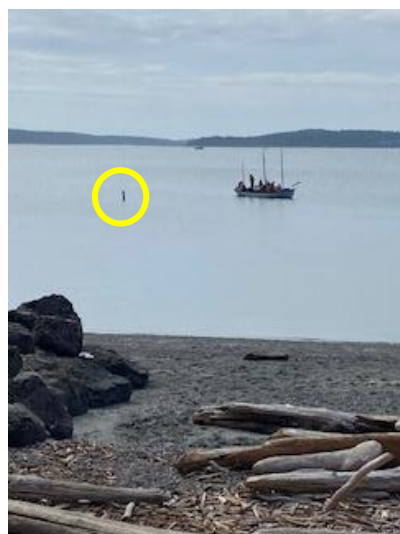
5/24/2023 at 10:25am

Figure 2. A sample of photos taken by MRC member, Frank, documenting vessel compliance with the Port Townsend No-Anchor Zone (buoys identified with yellow circles).

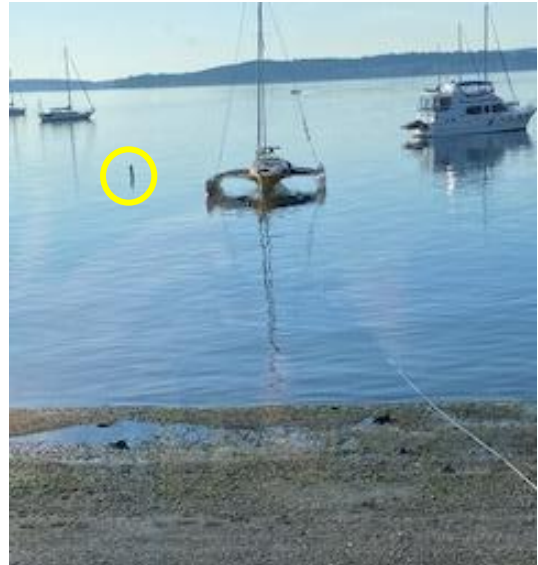
Two additional monitoring efforts were recorded by MRC members, Sarah, on 9/9/2023 and Neil and Brent on 9/10/2023 during the Wooden Boat Festival, bringing the total to 28 monitoring days. On 9/9/2023, Sarah noted a yellow catamaran anchored within the no-anchor zone near Better Living Through Coffee. Upon closer observation, Frank reported that the boat was instead anchored high up the shore, seeming to not disturb the nearshore vegetation (see Figure 3). See monitoring photos taken by Brent on 9/10/2023 in Figures 4-6 and vessel count data sheets attached at the end of this report. No boats were observed to be anchored within the boundaries of the buoys, even during the Wooden Boat Festival which attracts hundreds of boats and thousands of visitors to Port Townsend Bay. This resulted in 100% boater compliance with the Port Townsend eelgrass protection no-anchor zone this year.

Figure 3. Catamaran appearing to be anchored within the Port Townsend No-Anchor Zone (buoy circled in yellow), but with its anchor placed high up on the shore.

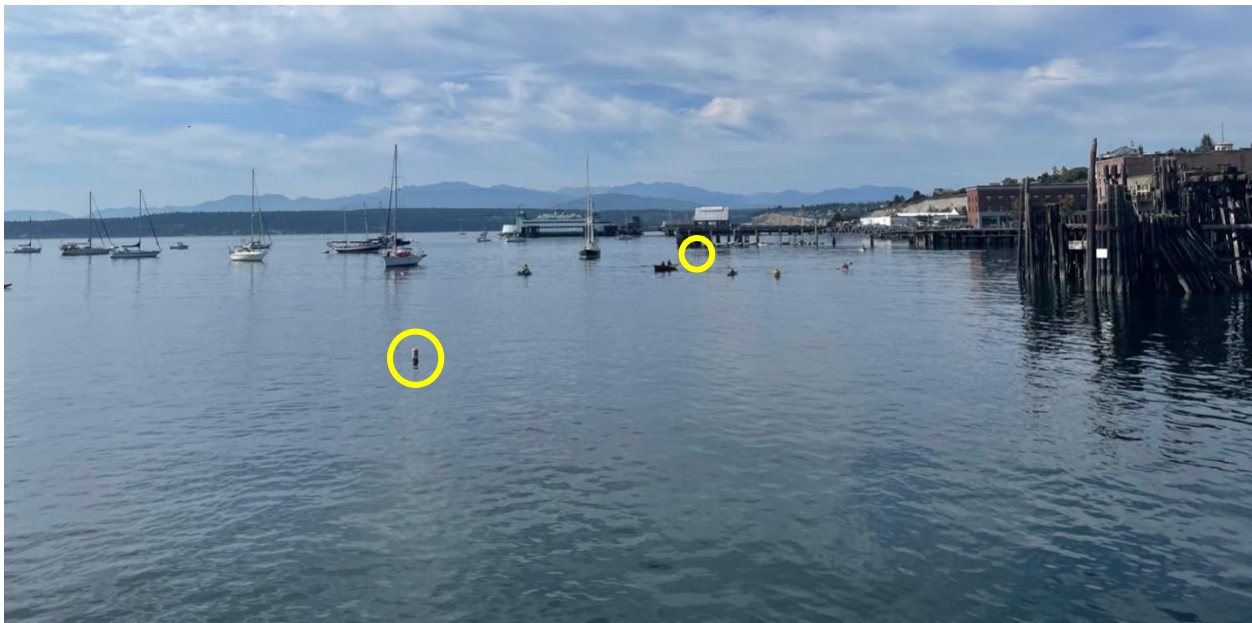
Figure 4. Photo of anchored vessels in compliance with the eelgrass protection no-anchor zone (buoys circled in yellow) during the Wooden Boat Festival (9/10/2023), by Brent Vadopalas.

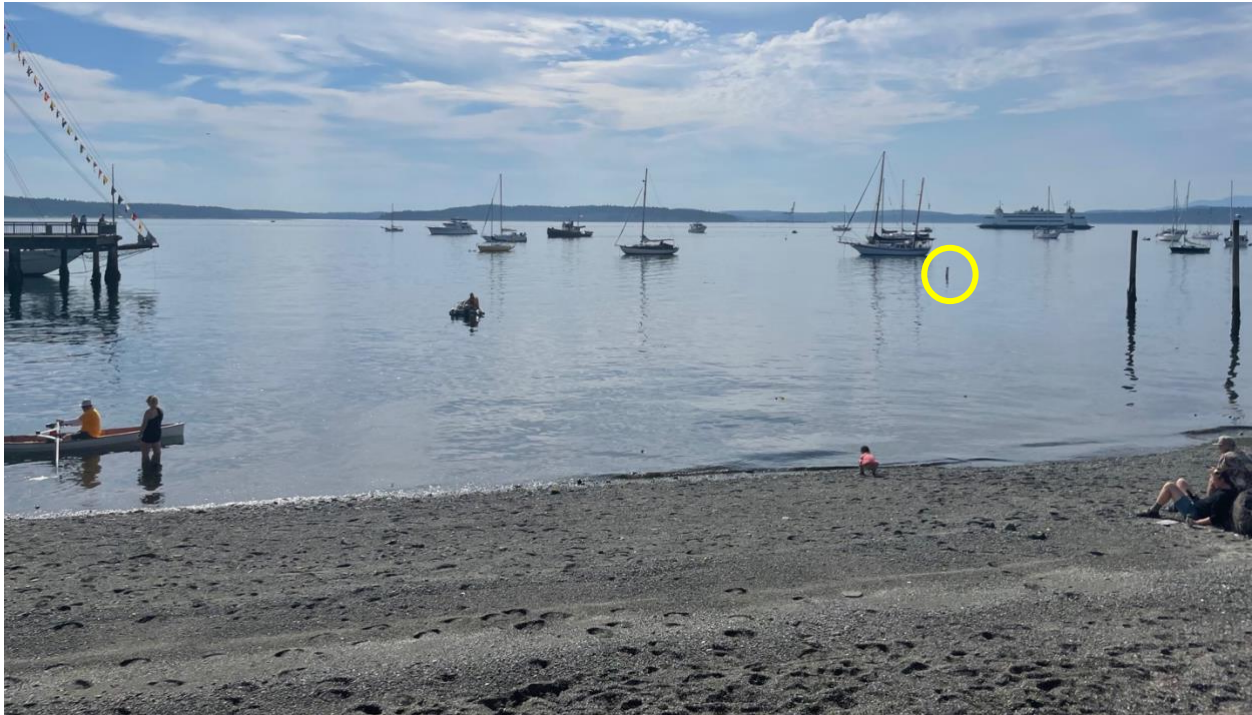
Figure 5. Photo of anchored vessels in compliance with the eelgrass protection no-anchor zone (buoy circled in yellow) during the Wooden Boat Festival (9/10/2023), by Brent Vadopalas.

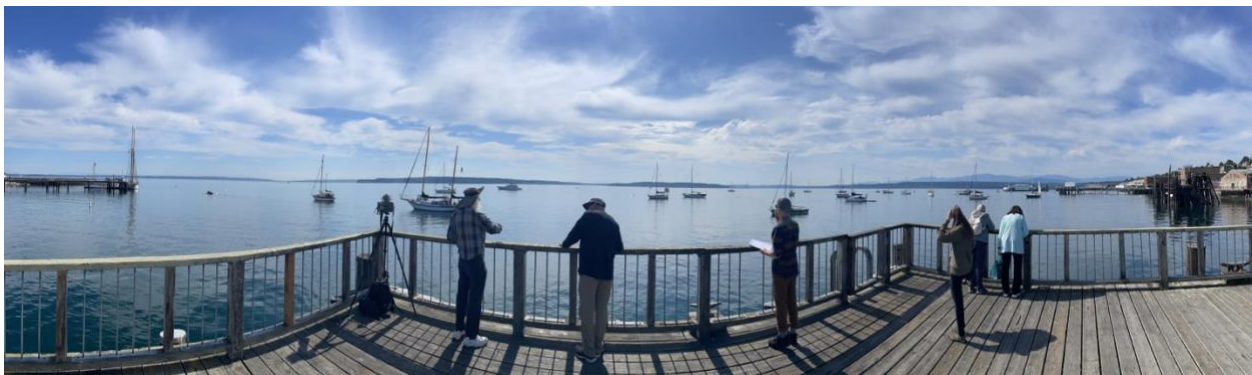
Figure 6. Photo of Neil (third from left) monitoring no-anchor zone vessel compliance during the Wooden Boat Festival (9/10/2023), by Brent Vadopalas.
