PROJECT TITLE: Island County Marine Resources Committee Operations and Projects

TASK NUMBER: 4.1 and 4.2 – Hoypus Point and Possession Point Feasibility study, including summary of priorities to select one site for preliminary design, and preliminary design of the selected site

Hoypus Point and Possession Point Restoration

Feasibility Report

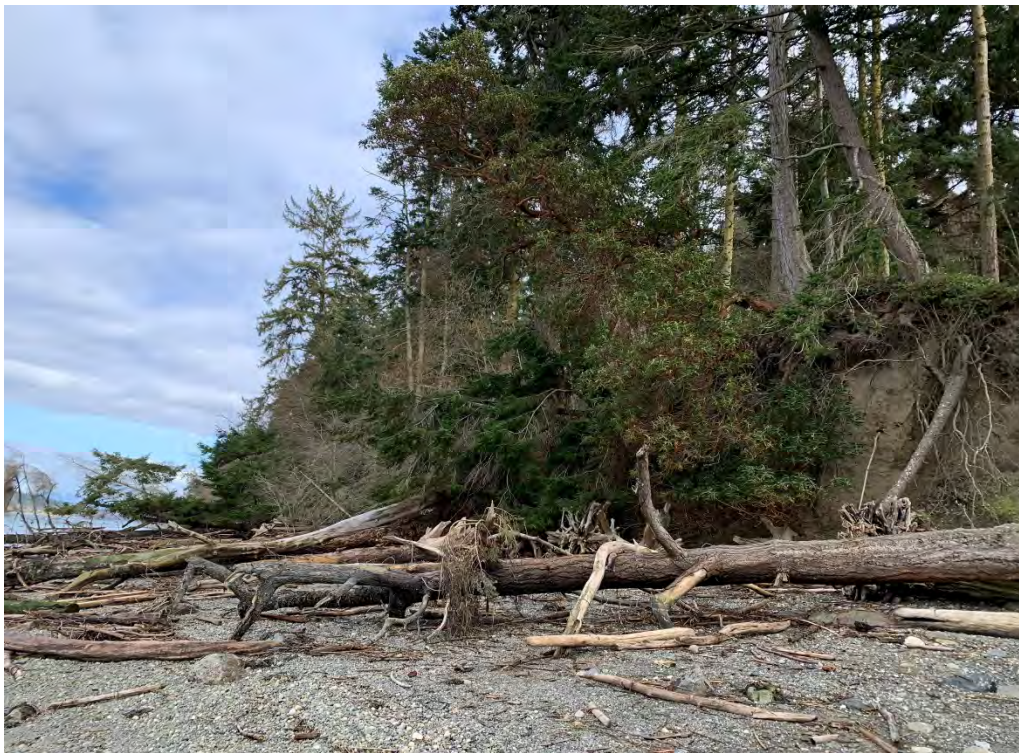
Figure A-2. Accumulation of large woody debris, west of Hoypus Point.

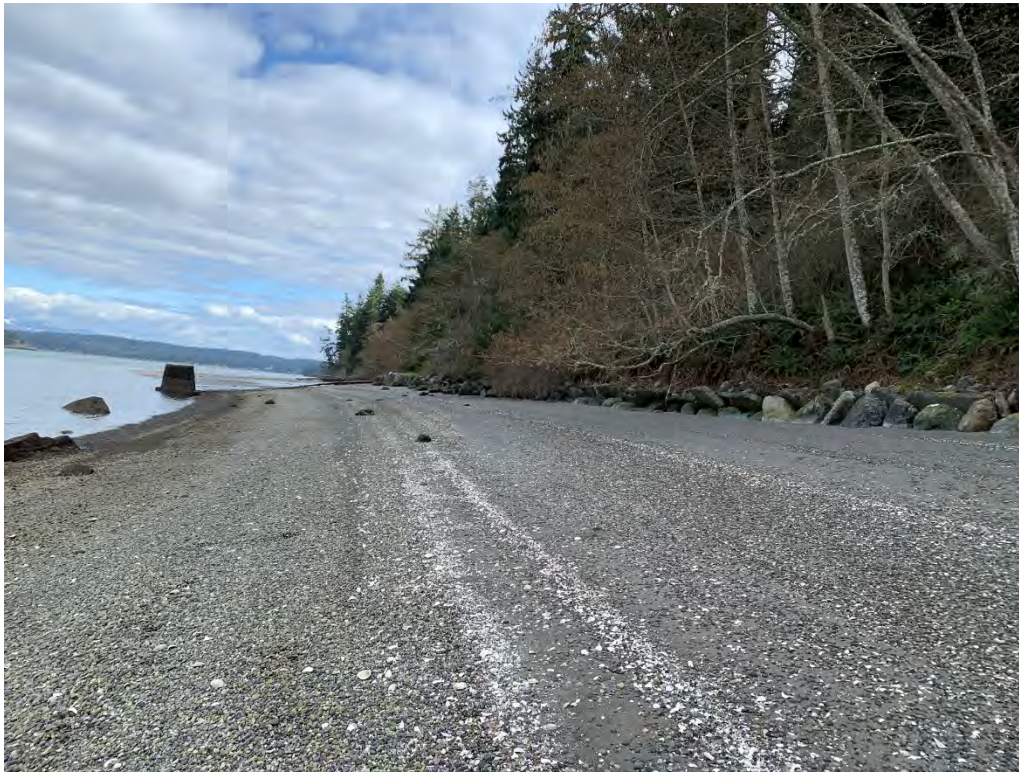
Figure A-3. Looking east from the start of armoring, abutment is visible on left.

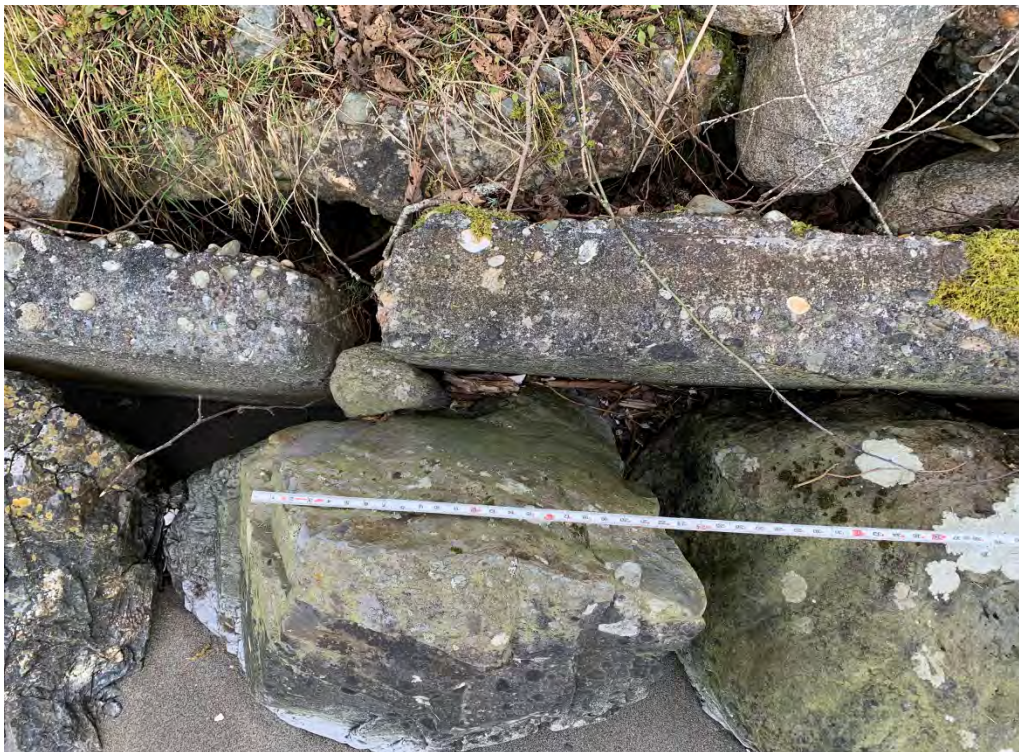
Figure A-4. Example of armoring along the shoreline.

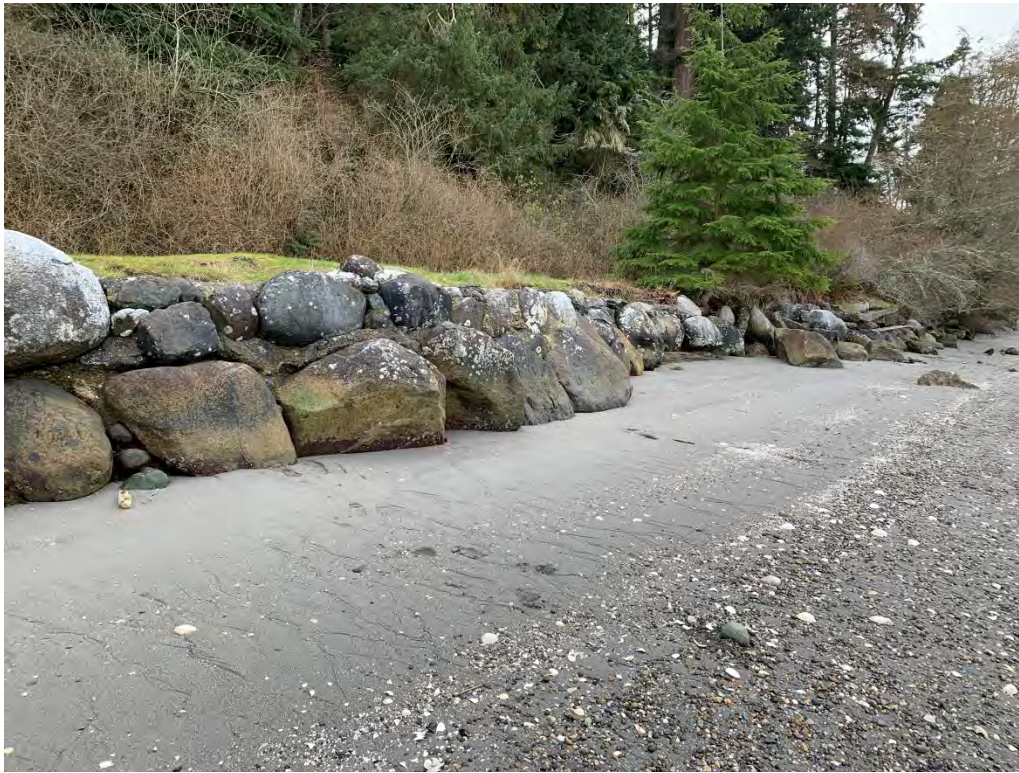
Figure A-5. Looking west towards the large flat area and along armoring.

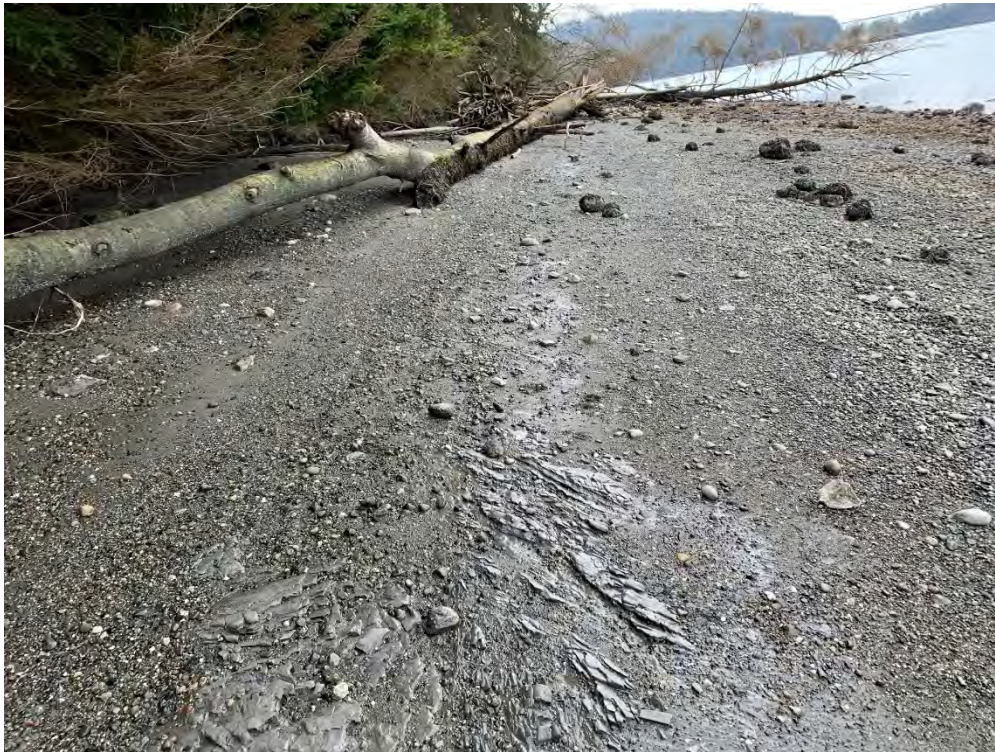
The shoreline and beach immediately southwest of the project site is mapped as Vashon Stade silt and clay deposits which have thin to thick bedded clay, silt, and silty sand. This unit is a consolidated material that has a very low permeability and can result in surface water and groundwater flow being perched on top of these sediments. The presence of clay layers and perched groundwater can result in erosion of mixed sand and gravel from the beach surface. This was observed to the southwest of the Project Area at Hoypus Point, but not within the Project Area (Figure A7).

Figure A-7. Clay sediments on the beach between Hoypus Point and Cornet Bay.

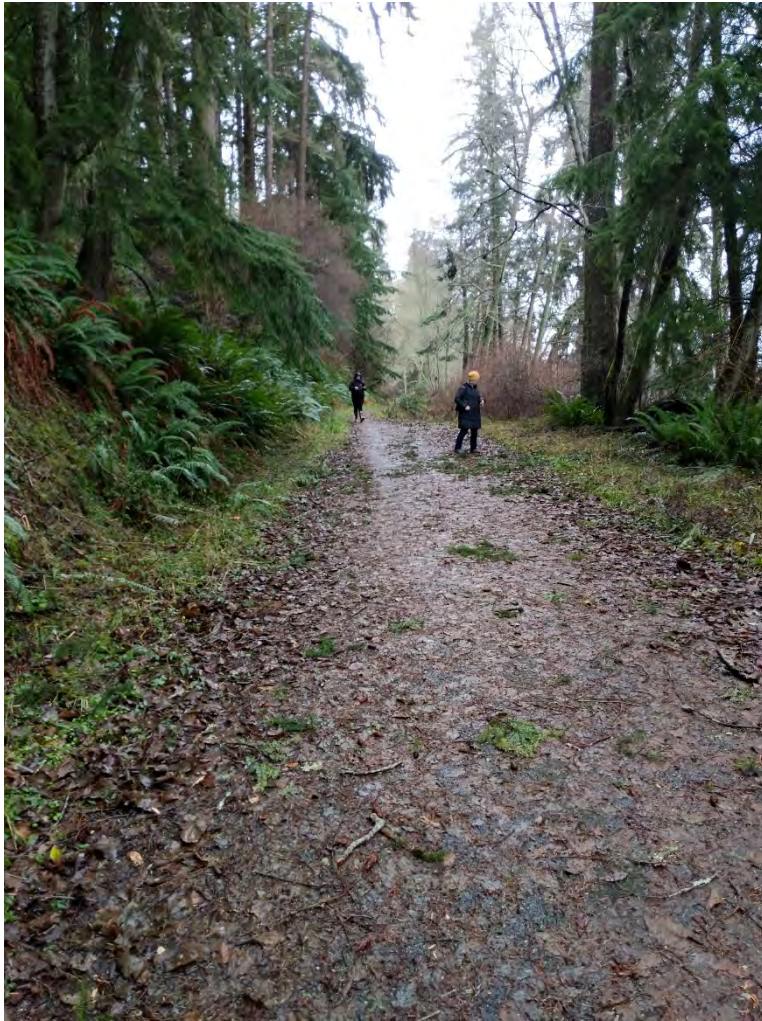
Figure A-8. The road/trail, person farthest back is alongside the slump on the trail.

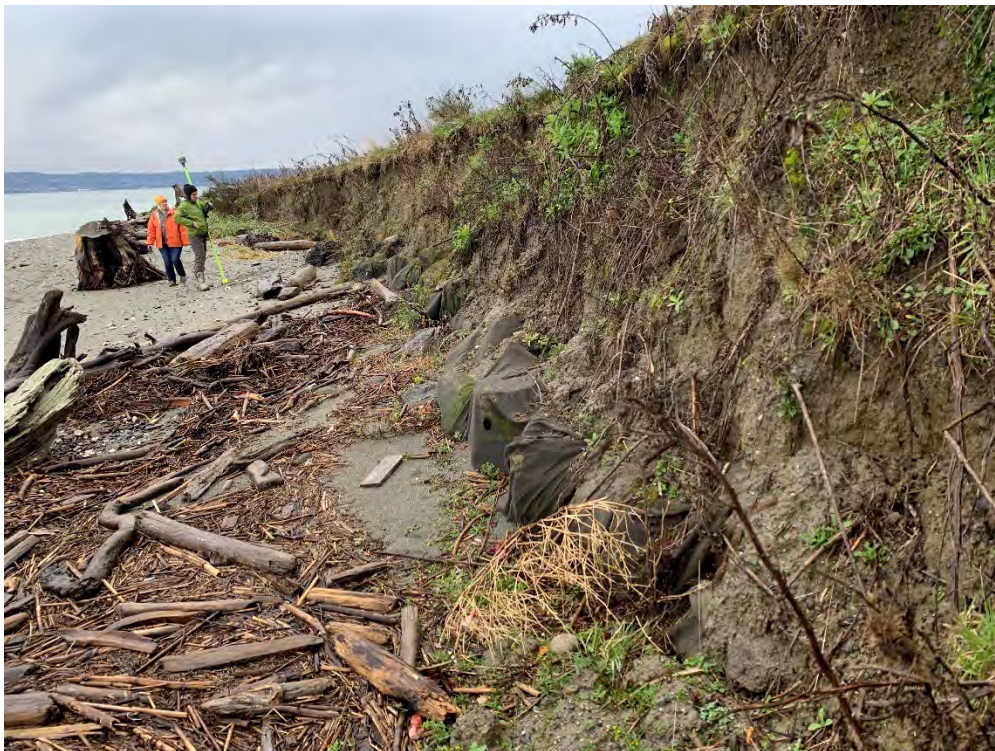
Figure A-9. Looking south at erosion and exposed geotextiles.

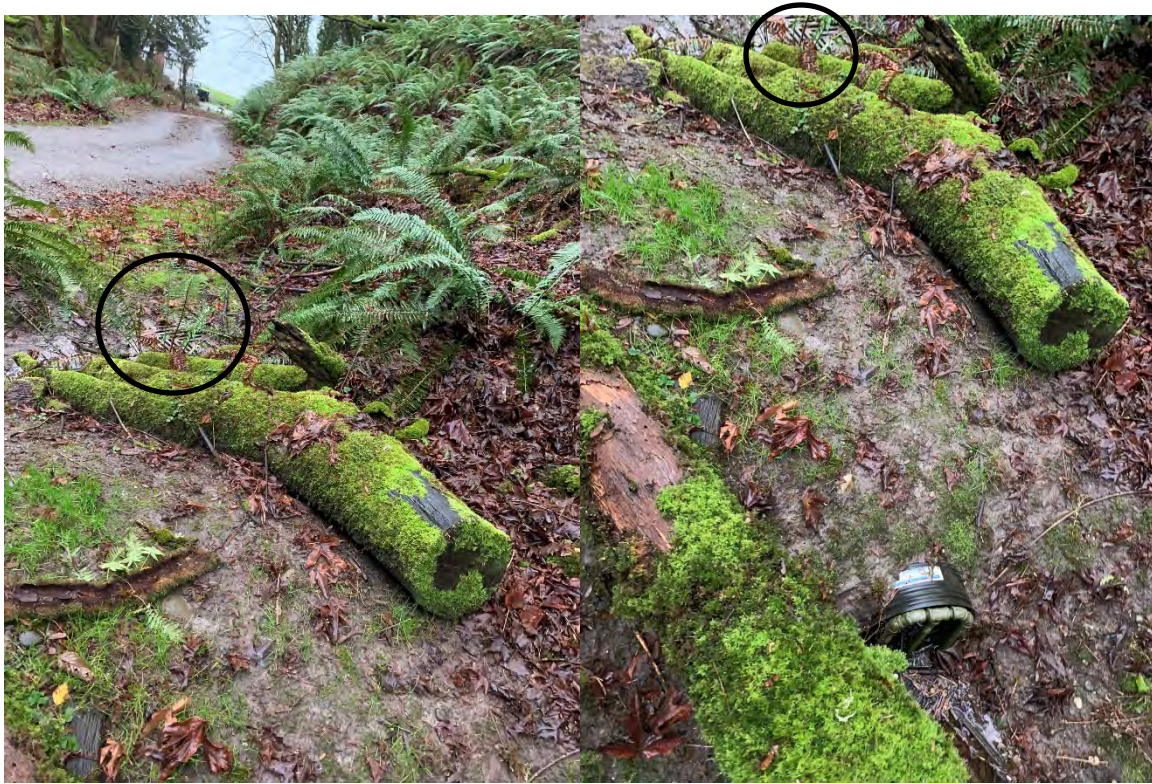
Figure A-14. Photo of southern upland drainage, the circle indicates the position of the same stormwater grate.

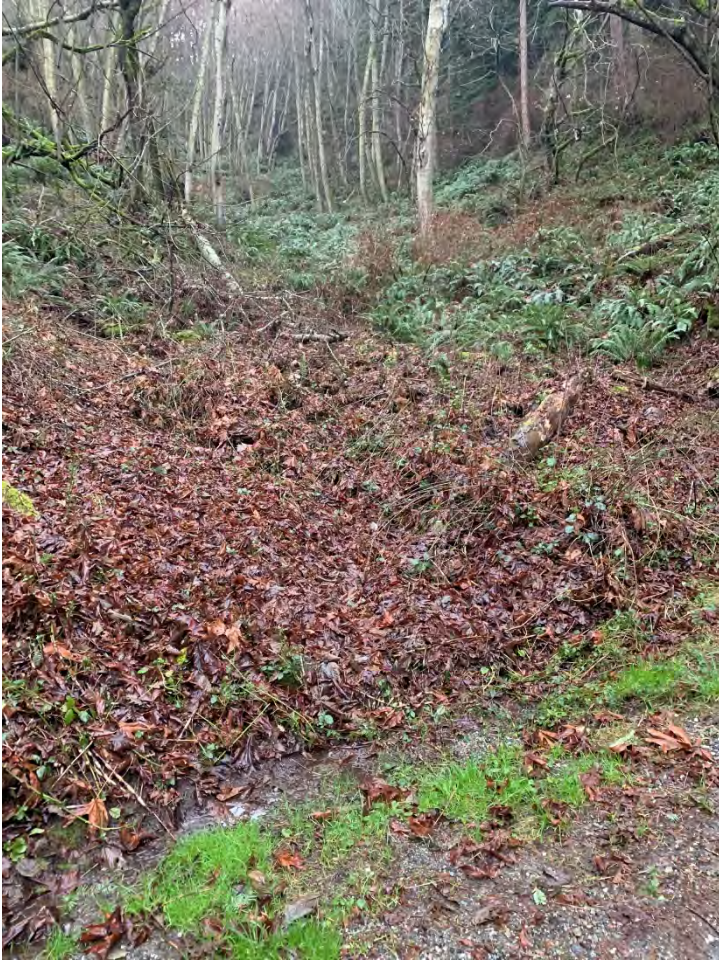
Figure A-15. Photo of northern upland drainage, looking upstream. Water is flowing in a ditch west side of the access road.
