# Jefferson County Nearshore Restoration Feasibility Report

Prepared for:  
Jefferson County Marine Resources Committee

Prepared by:  
Coastal Geologic Services Inc.  
Jim Johannessen, LEG, MS and  
Jonathan Waggoner, BS

June 29, 2007

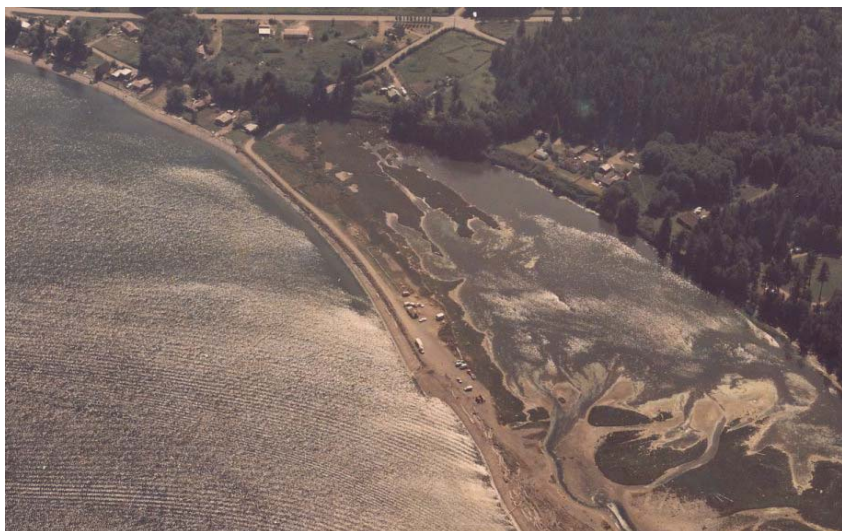
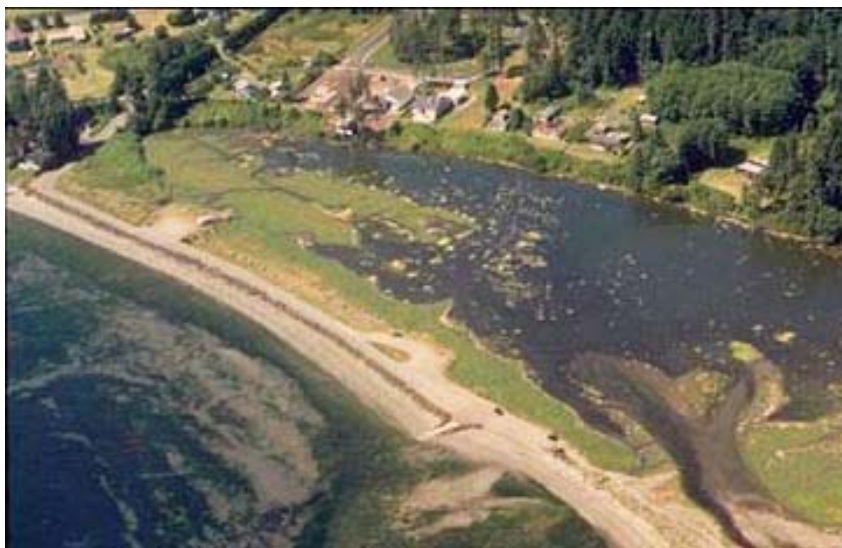
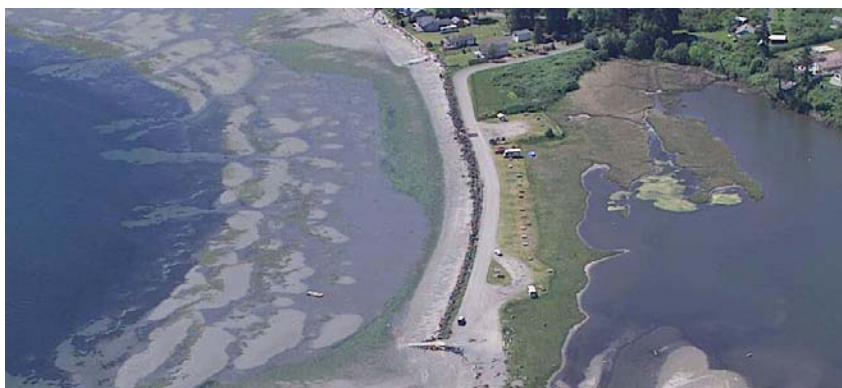
The park road and portions of the camping sites were constructed atop intertidal habitat (Figure 9). During the site visit the upper intertidal sediments appeared to be of the type utilized as spawning substrate for forage fish such as sand lance and surf smelt, which typically spawn in the upper intertidal areas (Pentilla 1978). Sand lance spawning was mapped at this site by WDFW. Since the upper intertidal was covered by rock from the rock revetment waterward of the road, this beach likely no longer provides valuable habitat services.

**Figure 9.** Oak Bay West oblique aerial photographs from 1977 (top), 1994 (middle), and 2001 (bottom).

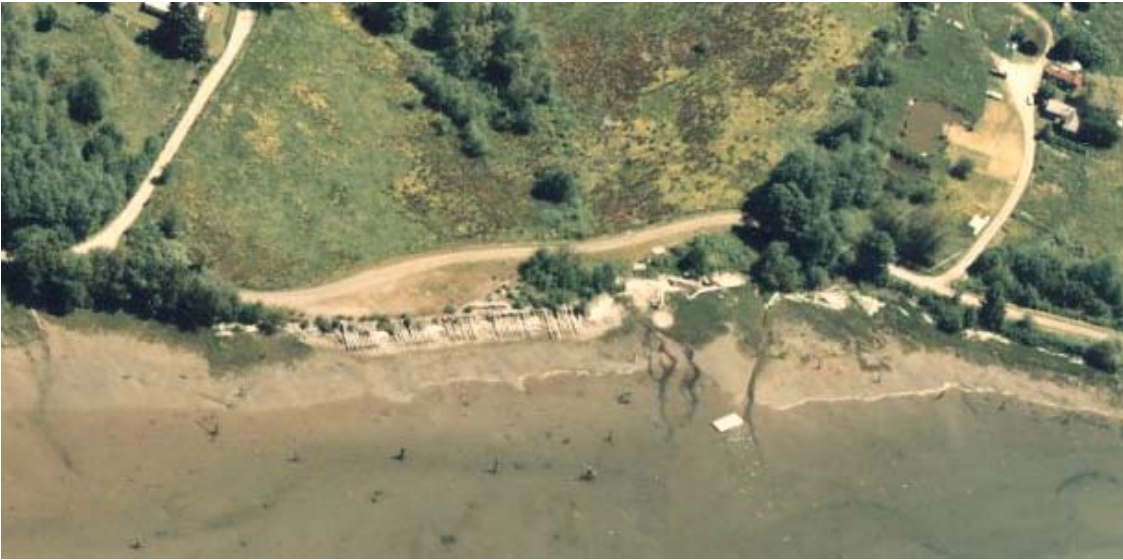
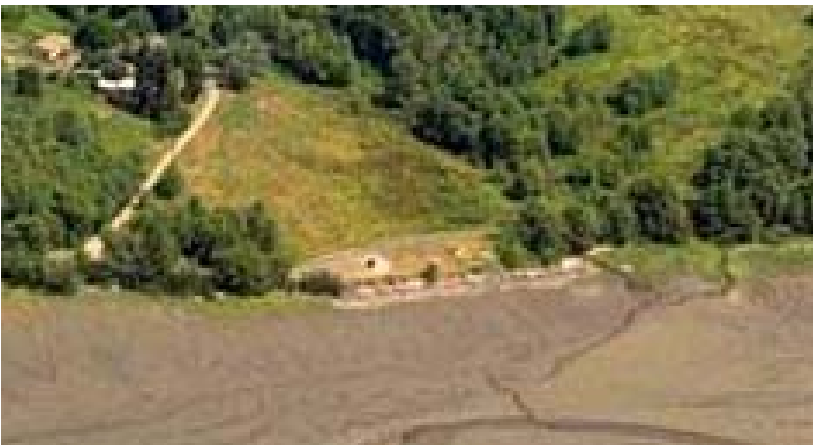
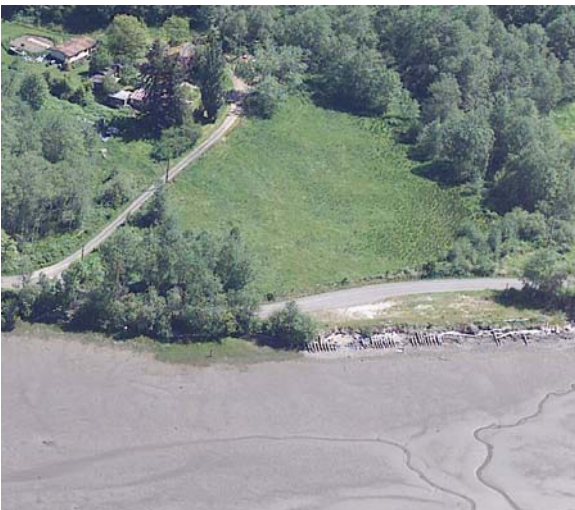
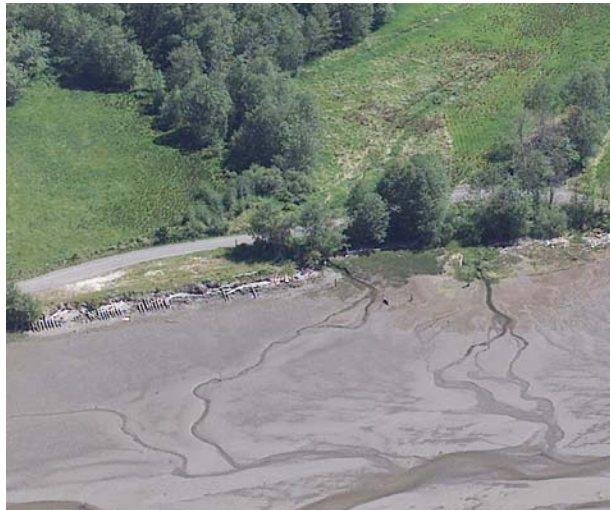
**Location** – The site is located in northeastern Tarboo Bay on the waterward side of Dabob Post Office Rd, approximately 250 ft south of the intersection with Broshear Rd. (Figure 1). This was the location of a log rolling operation, now abandoned in place with remnant rocks and logs on the intertidal. The logs have largely rotted away, but 25 upright logs remained at the time of the site visit (Figure 11).

**Figure 11.** Tarboo Bay oblique aerial photographs from 1977 (top), 1994 (middle), and 2001 (bottom).

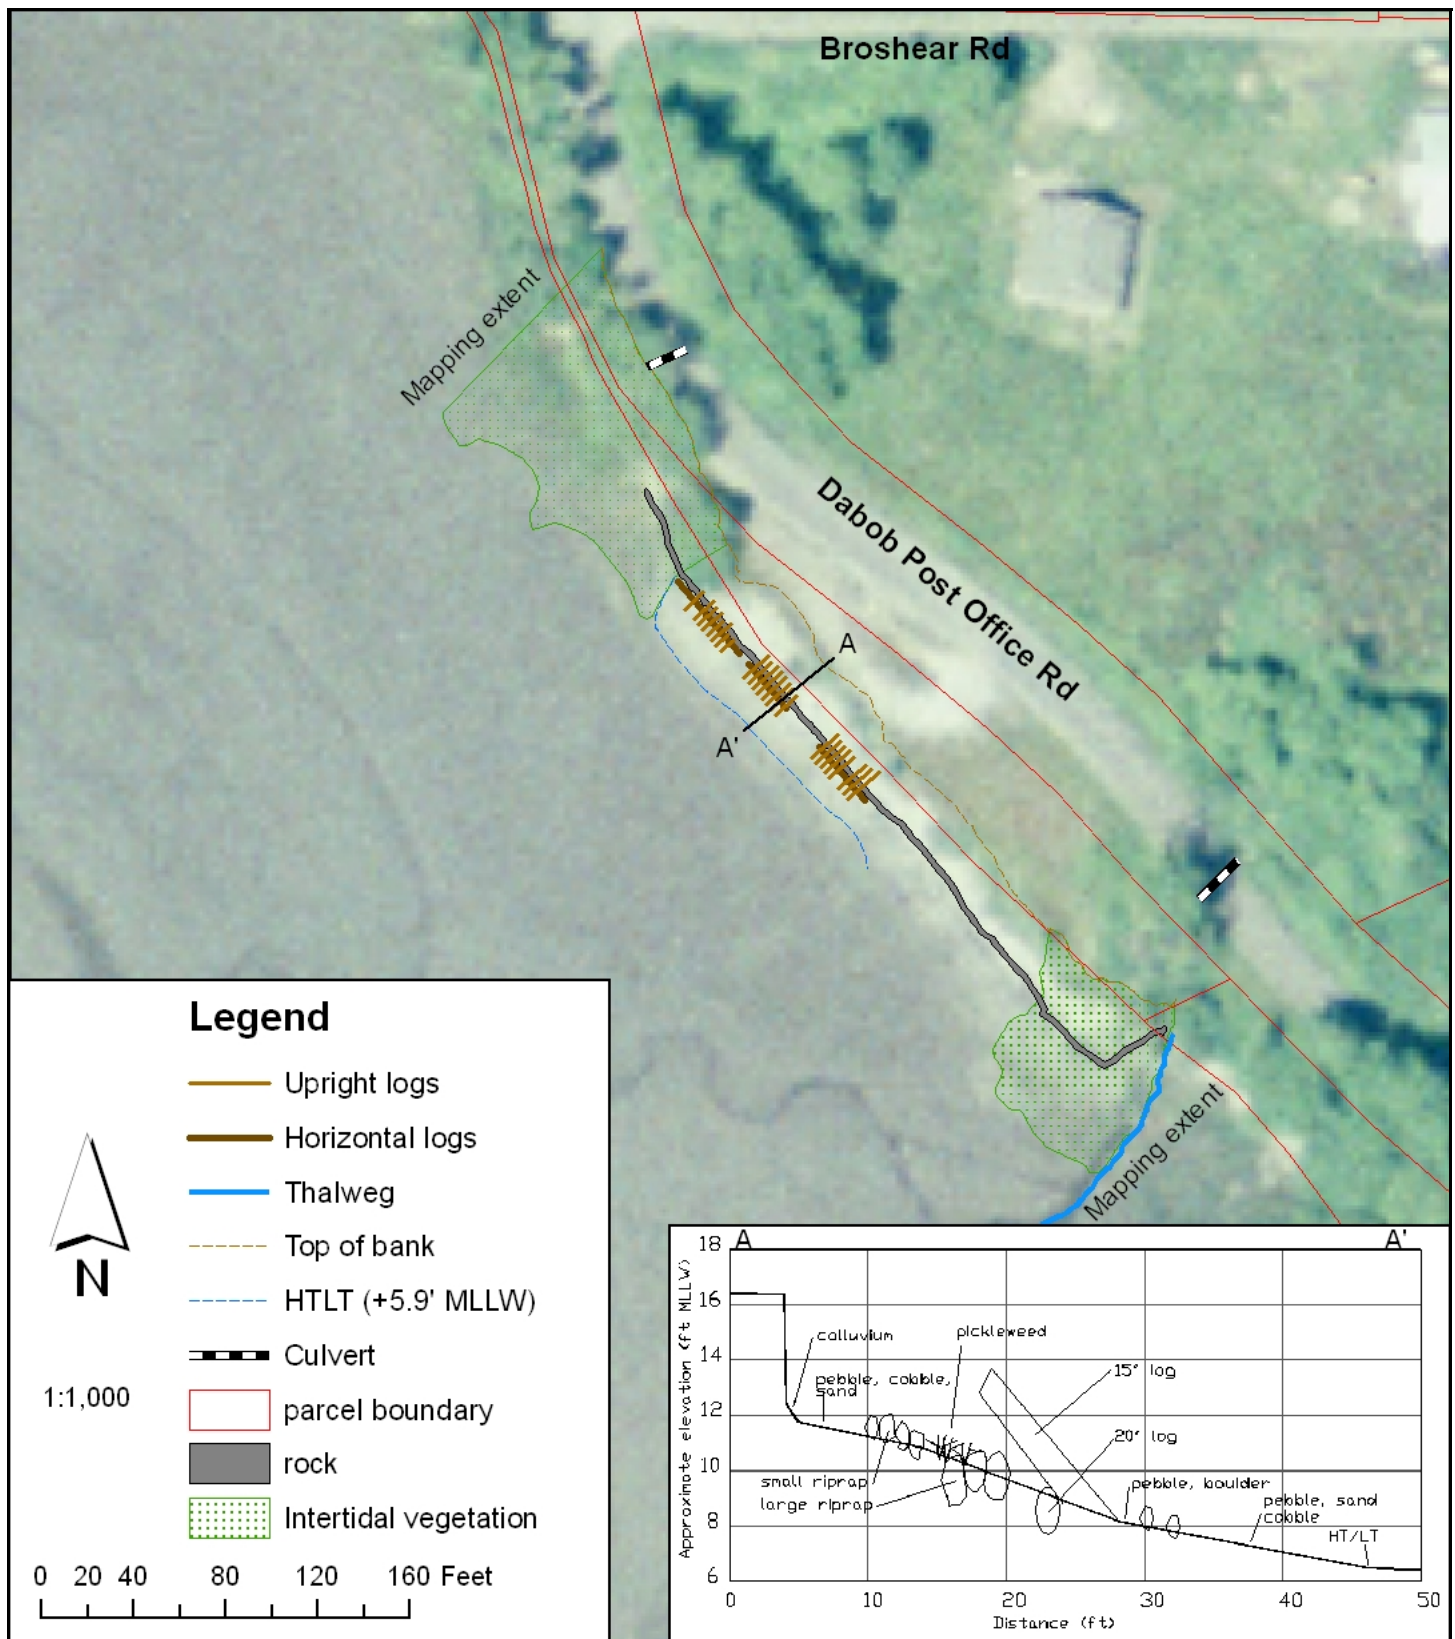
Figure 13. Tarboo Bay existing conditions

**Mapping** – Shoreline features at the site were mapped using DGPS. These features were all digitized and imported in a GIS for analysis (Figure 13). The line of rock was mapped as extending 350 ft alongshore, covering approximately 1,050 ft<sup>2</sup> of intertidal habitat. More habitat was covered by the smaller rip rap landward of the line of rock, but was not measured during the site visit. The remaining logs were in the central and northern portion of the site and cov a substantial amount of beach area.

A typical cross section was drawn from measurements made on site (Figure 13). Above and below the area of rock and logs the beach slope was found to be approximately 10:1 (H:V). Where the rock and logs were located the slope was approximately 6:1 (H:V).
