# Whatcom County Nearshore Habitat Restoration Prioritization

Prepared for: Whatcom County Marine Resources Committee

Coastal Geologic Services Inc.

June 27, 2007

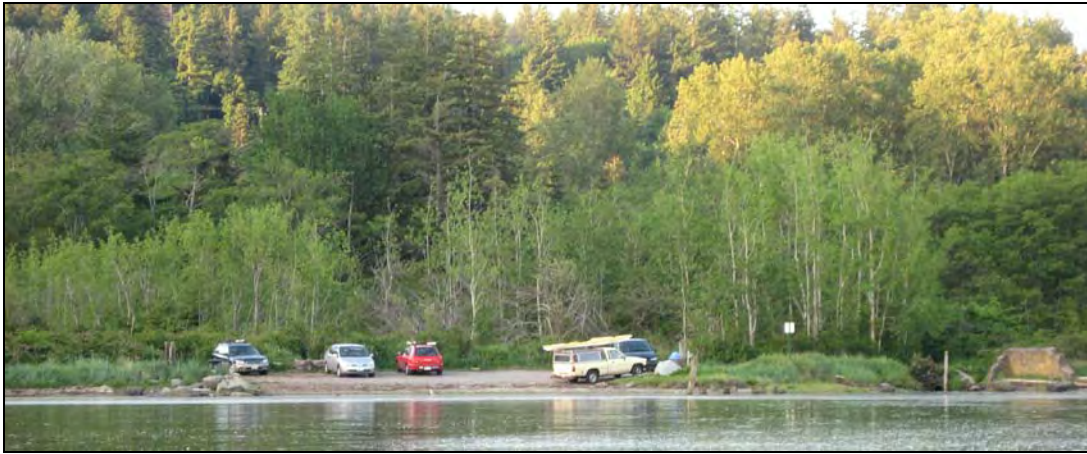
**Figure 7.** Restore backshore currently occupied by parking lot (CGS field photo).

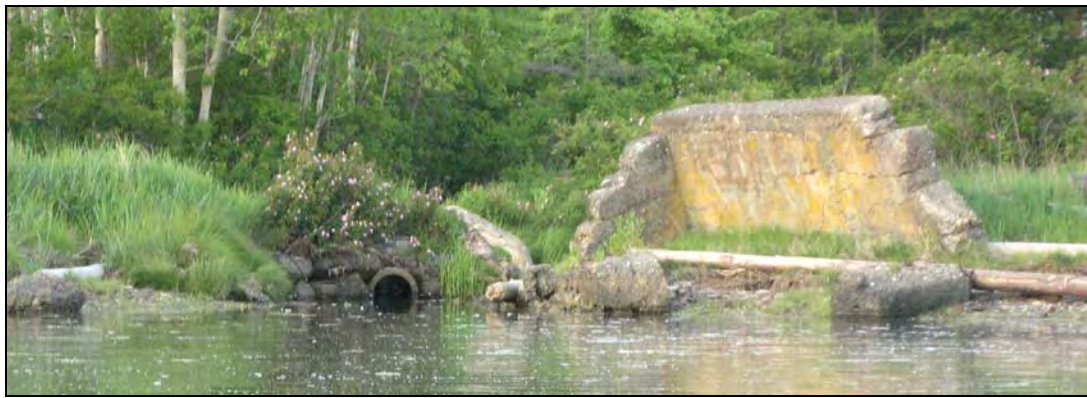
**Figure 8.** Remove relict concrete structure from backshore and enhance connectivity between backshore marsh/wetland and marine environment (CGS field photo).

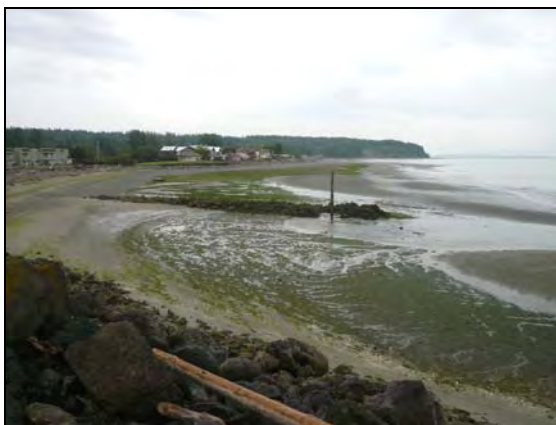
**Figure 12.** Looking east at armored culvert extending across shore (CGS field photo).

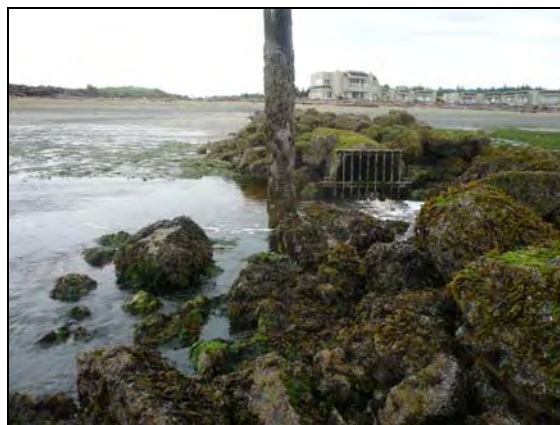
**Figure 13.** Culvert out-flow with considerable flow (CGS field photo).

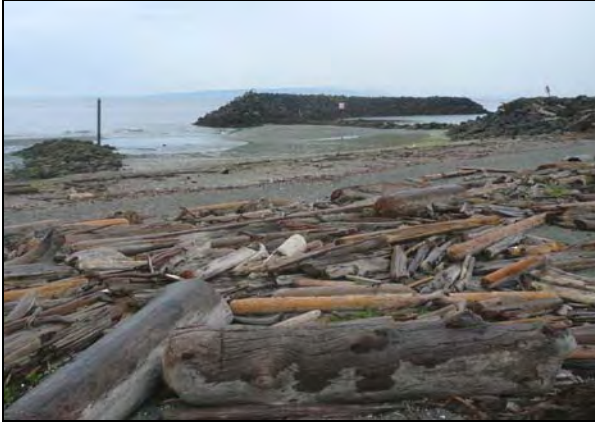
**Figure 14.** Culvert/stream buried beneath backshore east of Pt Roberts marina (CGS field photo).

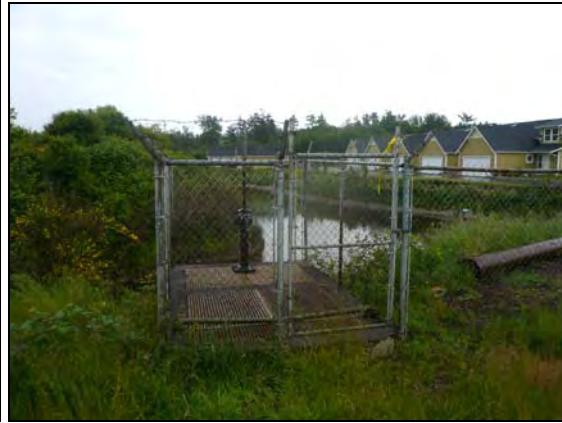
**Figure 15.** Tide gate and pond drained from Pt Roberts wetlands (CGS field photo).

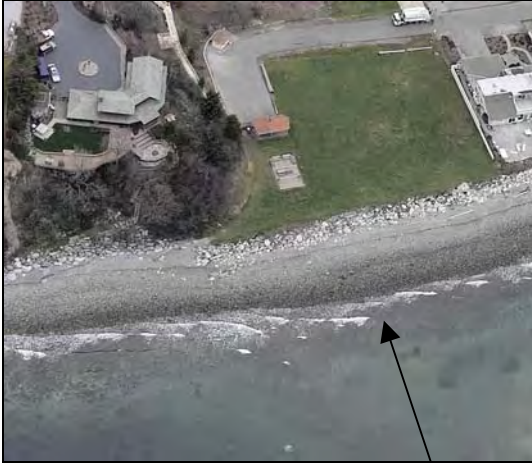
The rockery bulkhead extended well waterward of the adjacent bulkhead to the west and infringed on the upper intertidal beach (Figures 16 and 17). The site could be enhanced by removal of the rock and recreating a wider beach and backshore area. The site was filled to a higher elevation, likely during development of the marina, as shell fragments were observed in the eroding bank. An upper beach and backshore area would be created between retained (adjacent) bulkheads, resembling the upper part of a pocket beach. A small portion of the removed rock would likely be required for construction of return walls (running landward at the ends of adjacent bulkheads, designed to minimize end effects). These return walls would generally run landward along the property lines. The upper beach should also be nourished to aid in the reformation of lost forage fish spawning habitat area covered by riprap. Additional restoration recommendations for this site include enhancing the marine riparian area.

**Figure 16.** Air photo of Sunset Beach site, note toppled and infringing riprap at west end of site (Pictometry International Corp 2004)

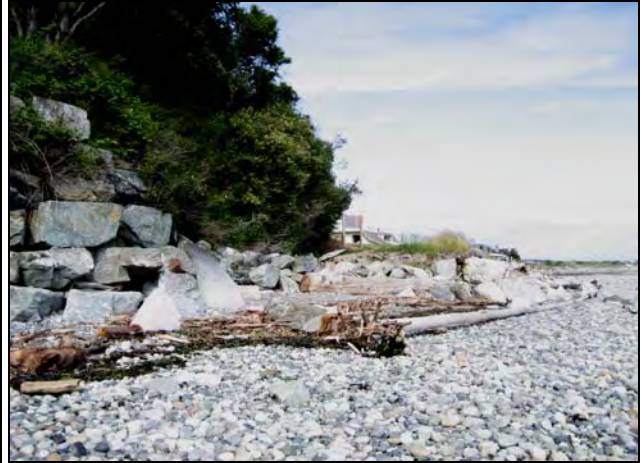
**Figure 17.** Infringing riprap at Sunset Beach (CGS field photo).

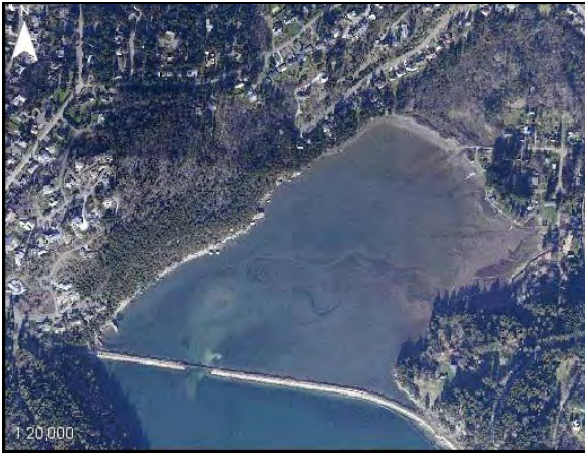
The causeway currently covers 153,040 sq ft of subtidal and intertidal area. The beach was historically composed of coarser material and apparently eelgrass beds were found throughout the inner shore of the Bay (Pers. Comm. T. Wahl 2007). Currently inner Chuckanut Bay beaches are comprised of relatively fine sediment (sands and silt) and patches of eelgrass are only found in the waterward end of the Bay. It is likely that if sedimentation rates continue at the current accelerated rate the Bay will experience further habitat degradation in the form of water quality issues, exceeded temperature thresholds for salmonids, and the progressive loss of intertidal area. It is likely that the tidal prism has already been substantially reduced in volume due to the accelerated sedimentation occurring within these shores. This process will likely be slowed by sea level rise, however, the native substrate of the beaches and the natural tidal hydrodynamics will not be recovered without restoration actions.

**Figure 19.** Aerial view of Chuckanut Bay causeway (Pictometry International Corp 2004).

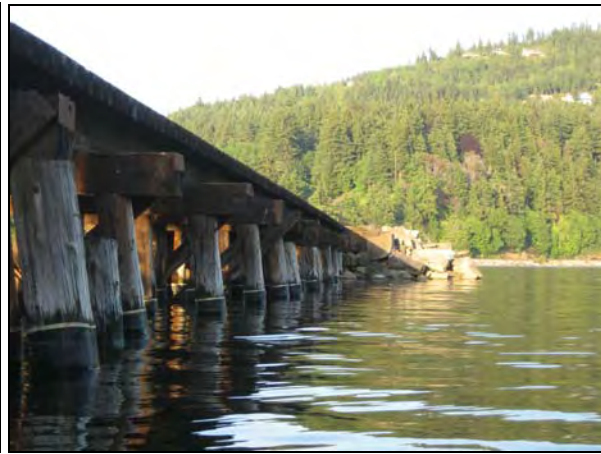
The causeway created additional shoreline along the revetment and the open shaded area beneath the causeway opening is the only access to the bay (Figure 20). The shading and additional riprap shoreline, provides an abrupt transition from shallow to deep water, likely increasing migrating juvenile salmonids' vulnerability to predation. The causeway opening was also constructed of heavily creosoted pilings, which likely adversely impacts water quality.

**Figure 20.** Chuckanut Bay causeway opening, creosote pilings (CGS field photo).

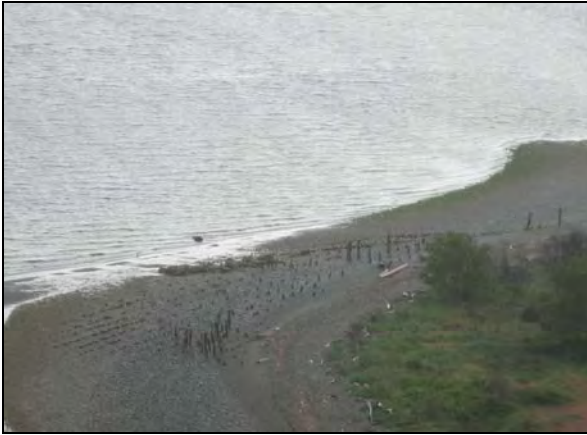
Removal of these relict items would restore intertidal habitat structure and ameliorate adverse impacts to water quality caused from the further decay and erosion of the slag and car parts. The field of over 100 relict piles would recover lost intertidal substrate, and enhance alongshore sediment transport that appears diminished due to wave attenuation caused by the piles and slag deposit. Juvenile salmonid migration pathways would likely also be enhanced as a result of the restoration. The cumulative targeted response of these actions was awarded 18 out of 45 points for these reasons.

**Figure 21.** Lily Point piling field (CGS field photo).

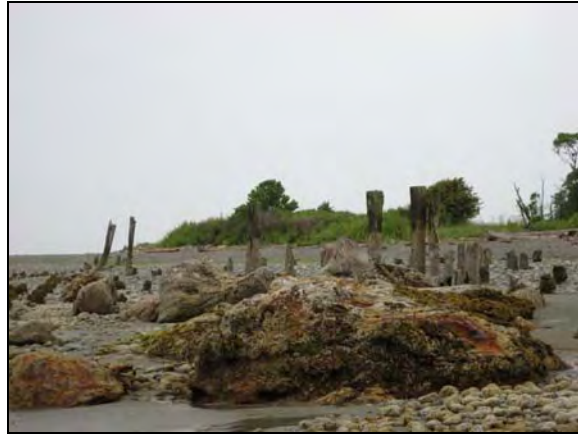
**Figure 22.** Slag deposits in lower beachface left from old cannery (CGS field photo).

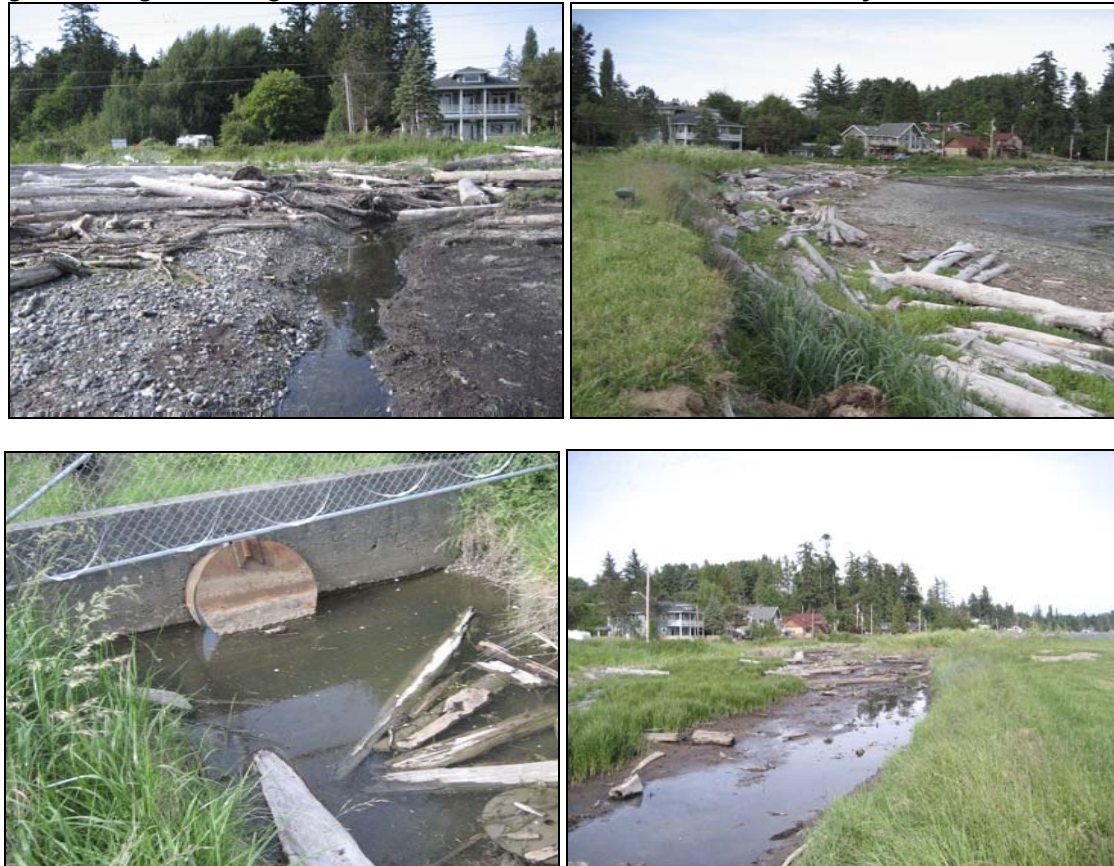
**Birch Bay, Roger's Slough and Roger's Slough Side Channel and Confluence with Birch Bay**

Restoration Recommendation: Enhance tidal flushing and enlarge culverts.

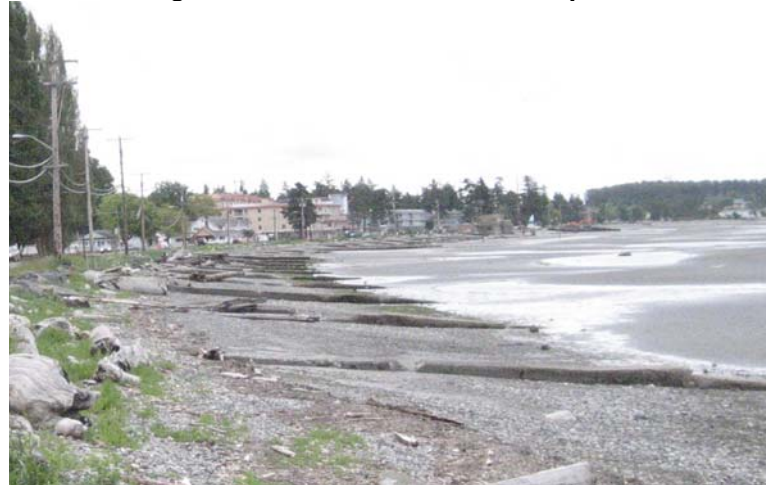
### Birch Bay, Groins and Scalloped Foreshore Resulting from Sediment Accretion at Up-Drift End of Net Shore-Drift Impediments

Restoration Recommendation: Remove groins. Perform upper beach nourishment.
