# ***Skagit County Creosote Inventory and Removal Project: Phase III***

**Skagit County Marine Resources Committee**

**Final Report – January 2009**

PROJECT TITLE: Treated Wood Inventory and Removal

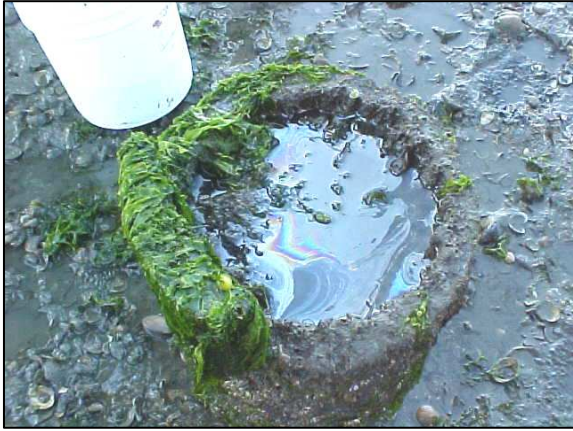
Figure 1. Creosote compounds leaching from an old piling in South Fidalgo Bay. Photo by Paul Dinnel.

Creosote compounds and other wood preservatives continually drip or leach from treated wood used in marine and aquatic situations (Figs. 1 and 2). Treated wood is often eroded into smaller particles due to the abrasive action of boat traffic, storms and contact with shorelines when pilings break off. Some creosote-related compounds can accumulate in marine sediments (Westin Solutions 2006) where they can cause direct toxicity or they may be mobilized into higher trophic levels via the food chain. Bioassays of sediments collected around creosote pilings in Fidalgo Bay, WA found that sediments were toxic to amphipods (*Rhepoxynius abronius*) and sand dollar (*Dendraster excentricus*) embryos within 0.5 meters of the pilings and that PAH compounds could be chemically detected in the sediments for at least two meters from the pilings (Stefansson 2008). Creosote compounds can also leach into the surface microlayer where they can adversely affect floating fish eggs, invertebrate larvae and plankton. Forage fish feeding on these organisms may then accumulate some compounds from the microlayer and pass them to higher trophic levels (marine fish, sea birds, marine mammals, and humans). Contaminants found in the surface microlayer eventually are deposited on shorelines (the bath tub ring effect), which are rich in marine life, including surf smelt and sand lance eggs, molluscan shellfish, juvenile fish, and crustaceans of many species. Indeed, the conclusions of a recently completed risk evaluation for NOAA (Stratus Consulting 2005) concluded that

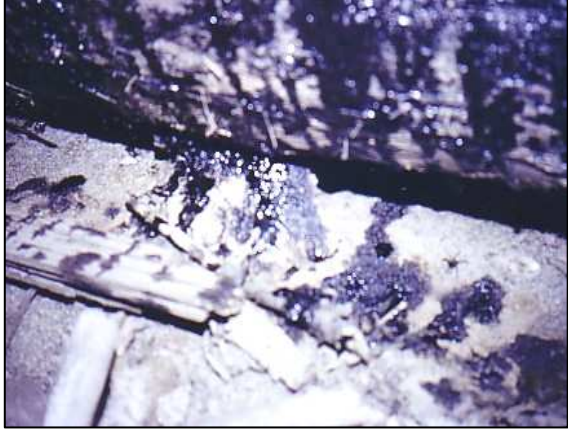
Figure 2. Creosote compounds leaking from a beached log (source: <http://www.pscap.net/id19.htm>).

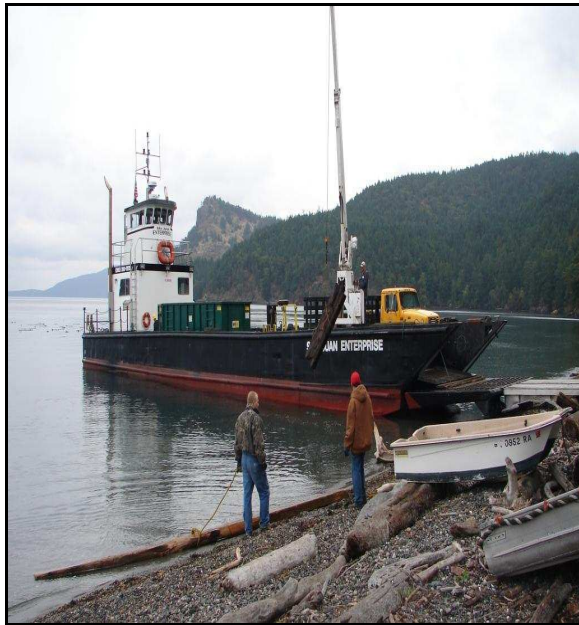
Figure 3. The vessel and crew used to remove treated wood from Cypress Island in 2008. Photo by Nathan Rice.

Treated wood removal from Cypress Island in 2008 was carried out by WDNR, which contracted the vessel *San Juan Enterprise* and its crew to perform the removal operation with assistance from Washington Conservation Corps workers. The vessel was a large landing craft with a drop-down bow ramp and a hydraulic crane (Figs. 3 and 4). The treated wood pieces were lifted from the beach using the crane and deposited in a large trash bin on the deck. These bins were then unloaded at the Port of Anacortes and sent to the hazardous waste landfill site located at Roosevelt, WA.

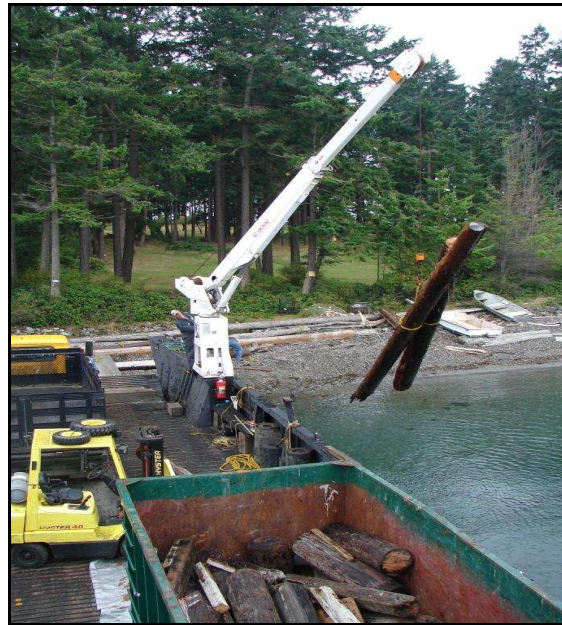
Figure 4. Loading treated wood into a disposal bin on board the recovery vessel. Photo by Nathan Rice.

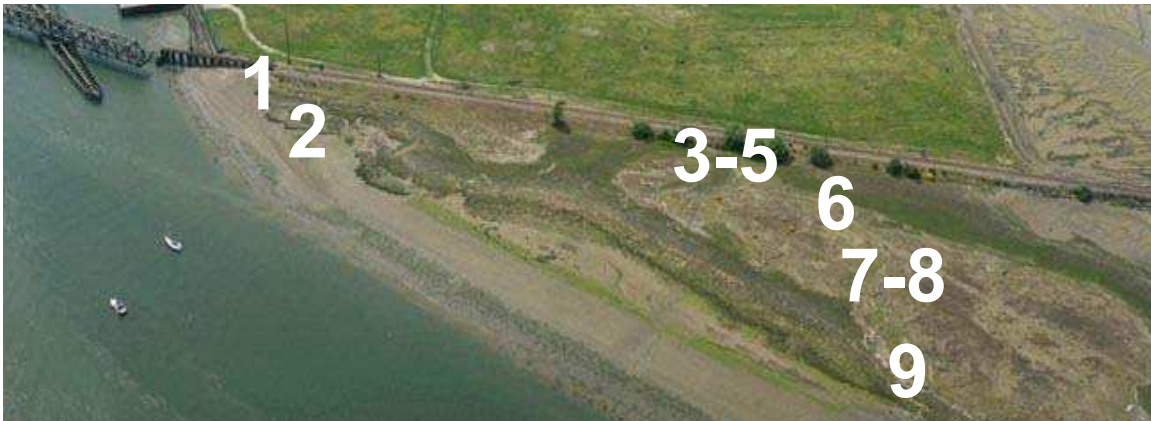
Shoreline Aerial Photo #SKA0349

1. Treated beam, 24" x 6" x 4"
2. Creosote timber 84" x 8" x 6"
3. Creosote beam 78" x 13" x 13"
4. Creosote beam 41" x 5" x 3"
5. Creosote log 15" x 13" dia.
6. Creosote log 240" x 10" dia.
7. Creosote beam 96" x 8" x 4"
8. Creosote beam 48" x 12" x 4"
9. Treated beam 40" x 8" x 2"

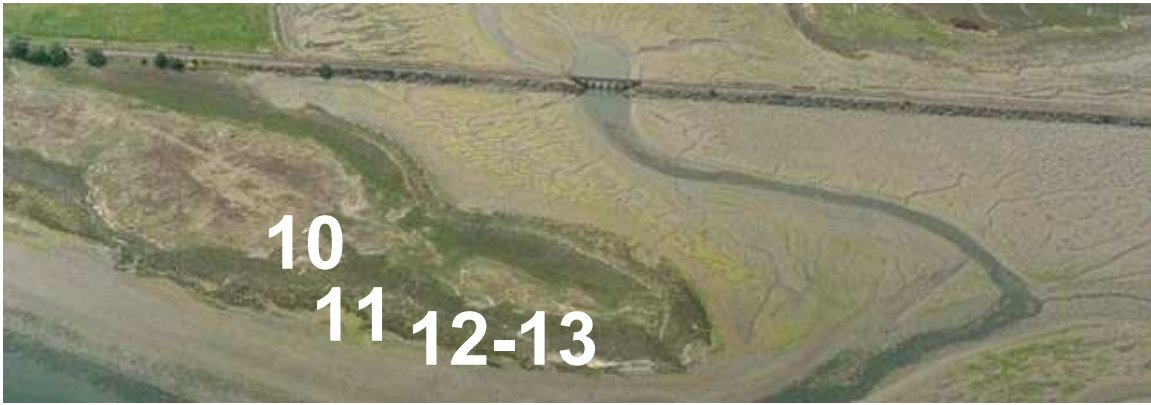
Shoreline Aerial Photo #SKA0350

1. Creosote log, 60" x 14" dia.
2. Creosote log, 25" x 12" dia.
3. Creosote log, 46" x 12" dia.
4. Creosote beam, 90" x 8" x 4"
5. Creosote log, 44" x 7" dia.
6. Creosote log, 102" x 12" dia.
7. Creosote log, 63" x 16" dia.
8. Creosote log, 48" x 12" dia.
9. Creosote beam, 40" x 6" x 8"
10. Treated beam, 42" x 3" x 2"
11. Creosote log, 14" x 18" dia.
12. Treated beam, 64" x 6" x 2"
13. Treated beam, 28" x 8" x 3"

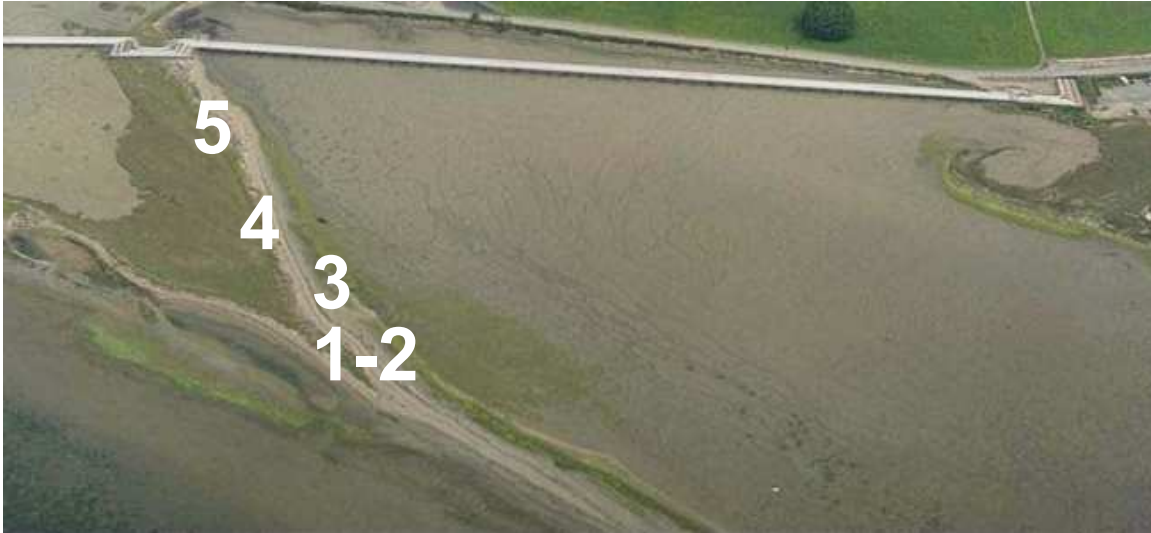
Shoreline Aerial Photo #SKA0371

1. Creosote beam, 180" x 16" x 16"
2. Creosote beam, 78" x 6" x 6"
3. Creosote beam, 42" x 8" x 8"
4. Creosote beam, 48" x 6" x 6"
5. Creosote beam, 324" x 4" x 4"

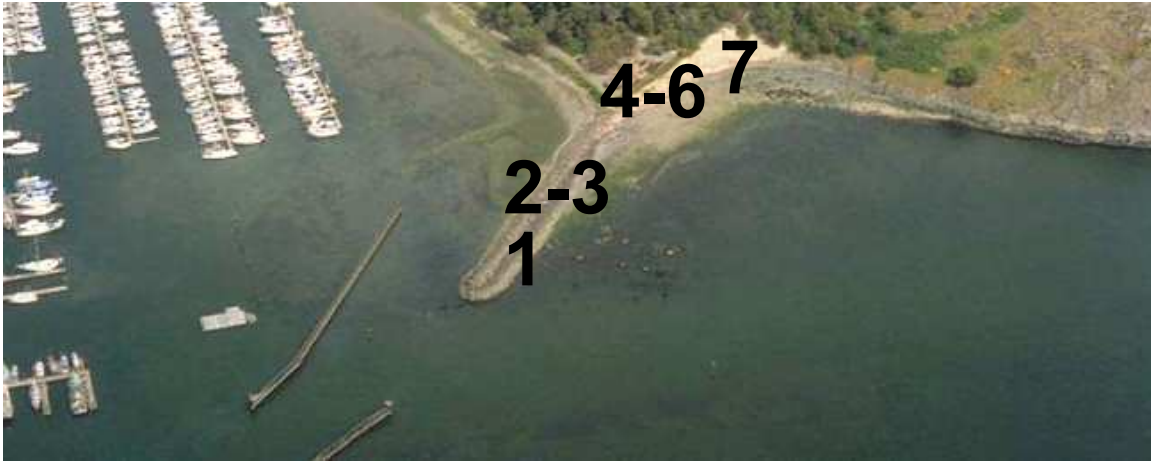
Shoreline Aerial Photo #SKA0402

1. Creosote beam, 48" x 3" x 1"
2. Creosote timber, 72" x 6" x 5"
3. Creosote log, 25" x 14" dia.
4. Creosote log, 24" x 10" dia.
5. Creosote log, split, 65" x 1"
6. Treated beam, 108" x 6" x 4"
7. Creosote beam, 31" x 5" x 4"

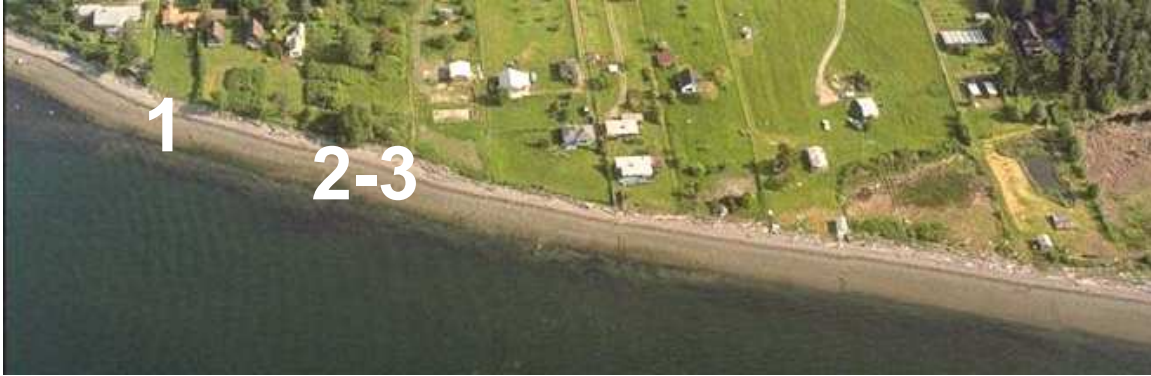
Shoreline Aerial Photo #SKA0047, south shore, west of ferry dock

1. Creosote log, 62" x 15" dia.
2. Treated timber, 41" x 6" x 2"
3. Creosote beam, 162" x 8" x 4"

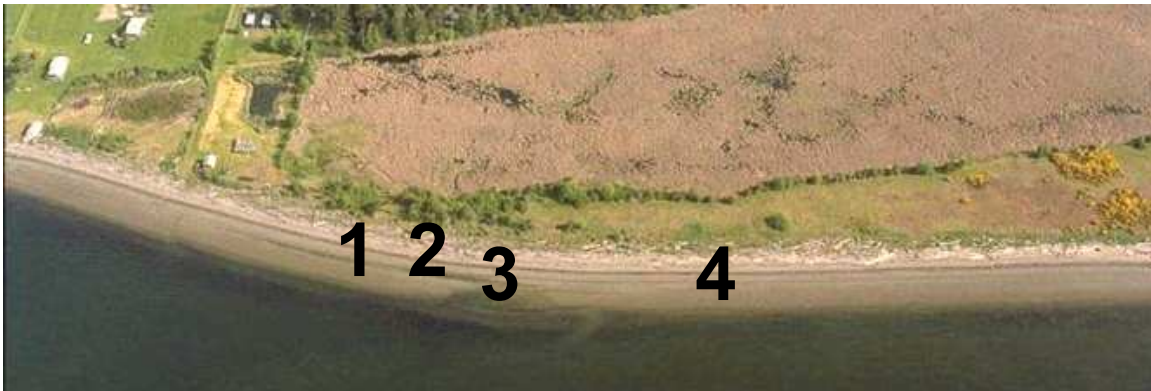
Shoreline Aerial Photo #SKA0048, south shore, west of ferry dock

1. Creosote beam, 94" x 12" x 12"
2. Creosote beam, 122" x 12" x 4"
3. Creosote piling, 48" x 10" dia.
4. Creosote beam, 30" x 12" x 6"

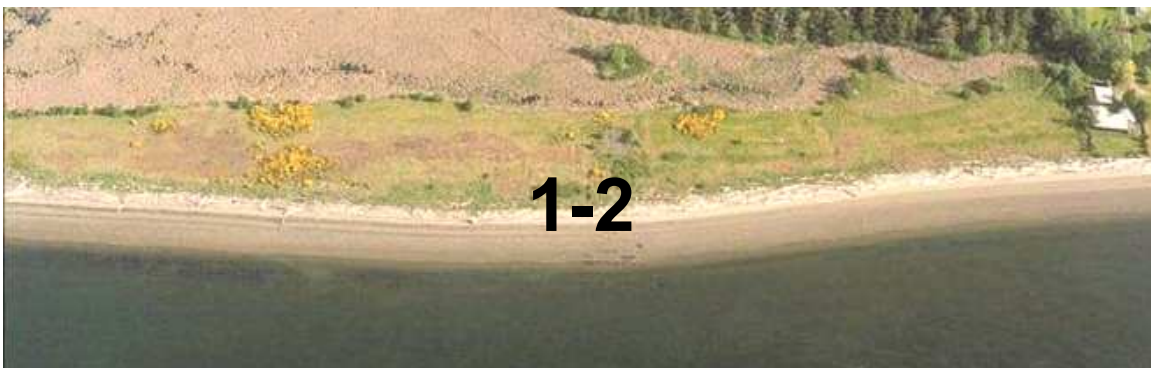
Shoreline Aerial Photo #SKA0049, south shore, west of ferry dock

1. Creosote beam, 30" x 6" x 4"
2. Creosote beam, 192" x 8" x 6"

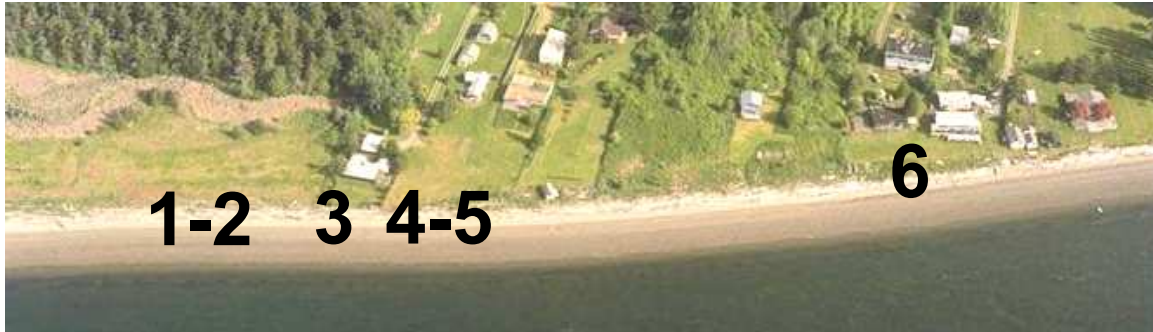
Shoreline Aerial Photo #SKA0050, south shore, west of ferry dock

1. Treated beam, 67" x 8" x 4"
2. Creosote log, 145" x 12" dia.
3. Creosote log, 33" x 11" dia.
4. Creosote log, 52" x 14" dia.
5. Creosote log, 79" x 9" dia.
6. Creosote log, 101" x 12" dia.

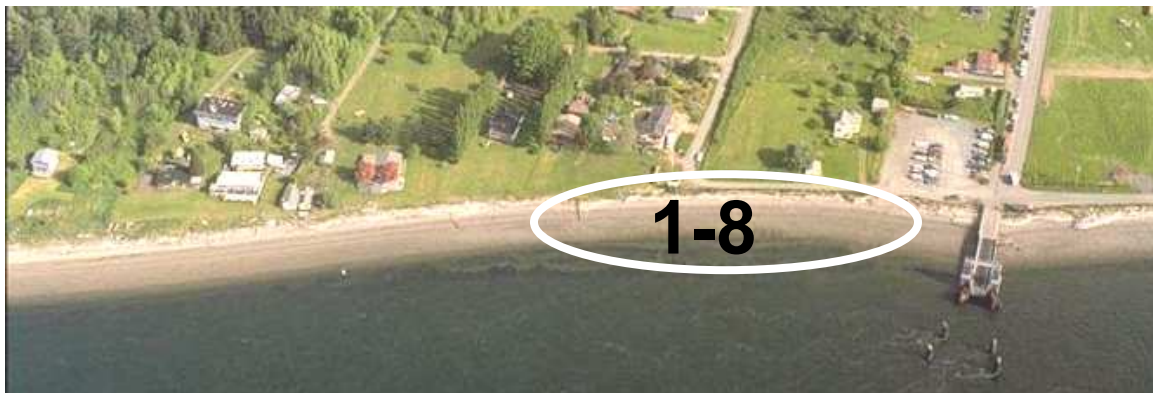
Shoreline Aerial Photo #SKA0050, south shore, west of ferry dock

1. Treated beam, 50" x 8" x 2"
2. Creosote beam, 348" x 18" x 12"
3. Creosote log, 30" x 9" dia.
4. Creosote log, 12" x 9" dia.
5. Creosote beam, 48" x 8" x 4"
6. Creosote beam, 60" x 9" x 2"
7. Creosote beam, 30" x 10" x 2"

8. Creosote beam, 80" x 8" x 4"

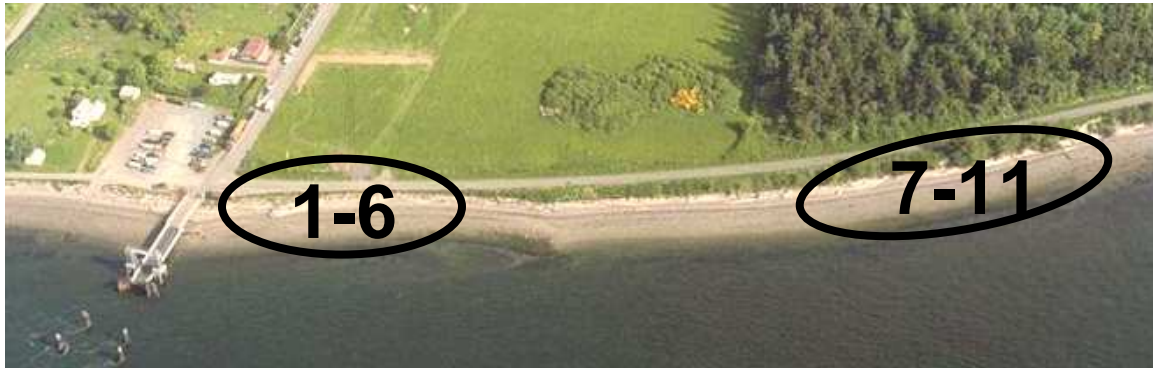
Shoreline Aerial Photo #SKA0052, south shore, east of ferry dock

1. Treated beam, 41" x 9" x 2"
2. Creosote beam, 66" x 8" x 4"
3. Various creosote pilings pieces, 12"-14" dia.
4. Creosote beam, 78" x 12" x 10"
5. Treated beam, 22" x 10" x 4"
6. Treated beam, 82" x 5" x 4"
7. Creosote beam, 17" x 12" x 12"
8. Creosote log, 12" x 12" dia.
9. Treated beam, 44" x 12" x 2"
10. Treated beam, 36" x 10" x 3"
11. Creosote beam, 18" x 4" x 4"

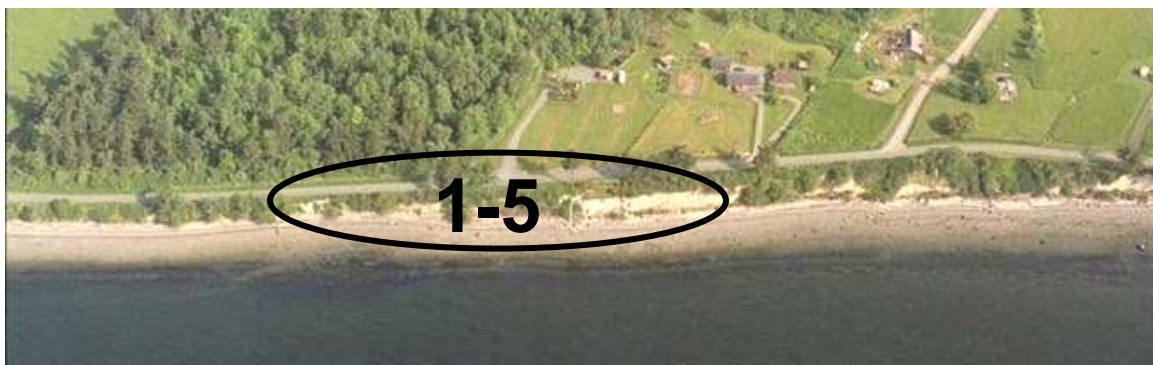
Shoreline Aerial Photo #SKA0053, south shore, east of ferry dock

1. Creosote log, 92" x 7" dia.
2. Creosote beam, 252" x 10" x 10"

3. Treated beam, 39" x 12" x 6"
4. Creosote log, 102" x 12" dia.
5. Treated beam, 51" x 12" x 12"

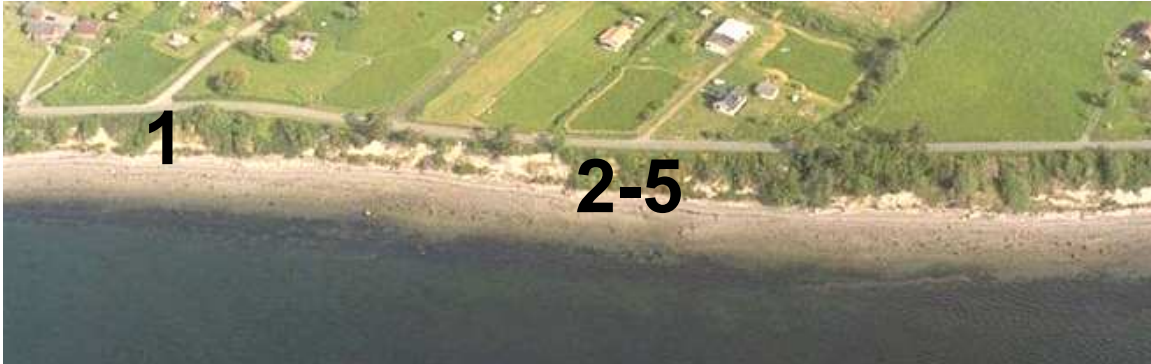
Shoreline Aerial Photo #SKA0054, south shore, east of ferry dock

1. Treated beam, 15" x 11" x 4"
2. Treated beam, 27" x 3" x 1"
3. Creosote beam, 16" x 12" x 12"
4. Creosote log, 264" x 12" dia.
5. Treated beam, 20" x 12" x 4"

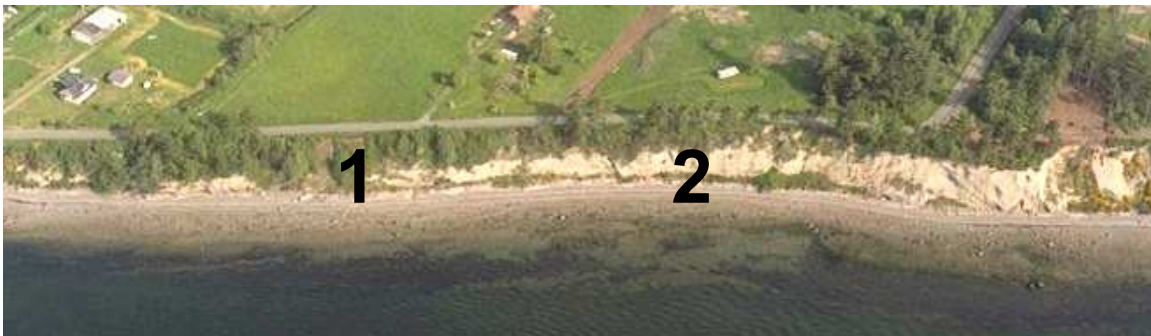
Shoreline Aerial Photo #SKA0055, south shore, east of ferry dock

1. Creosote timber, 80" x 5" x 1"
2. Creosote log, 276" x 15" dia.

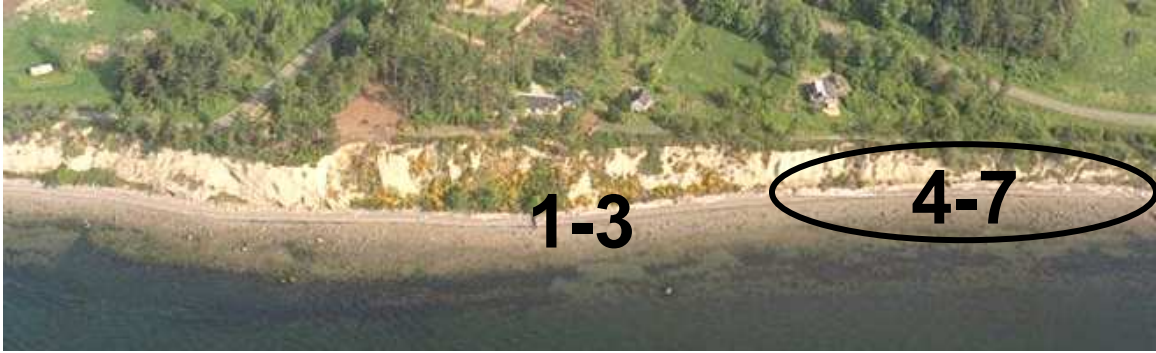
Shoreline Aerial Photo #SKA0056, south shore, east of ferry dock

1. Creosote beam, 48" x 14" x 14"
2. Creosote beam, 52" x 3" x 3"
3. Treated beam, 122" x 4" x 8"
4. Creosote beam, 158" x 12" x 4"
5. Creosote beam, 104" x 10" x 6"
6. Creosote log, 237" x 12" dia.
7. Treated beam, 134" x 6" x 2"

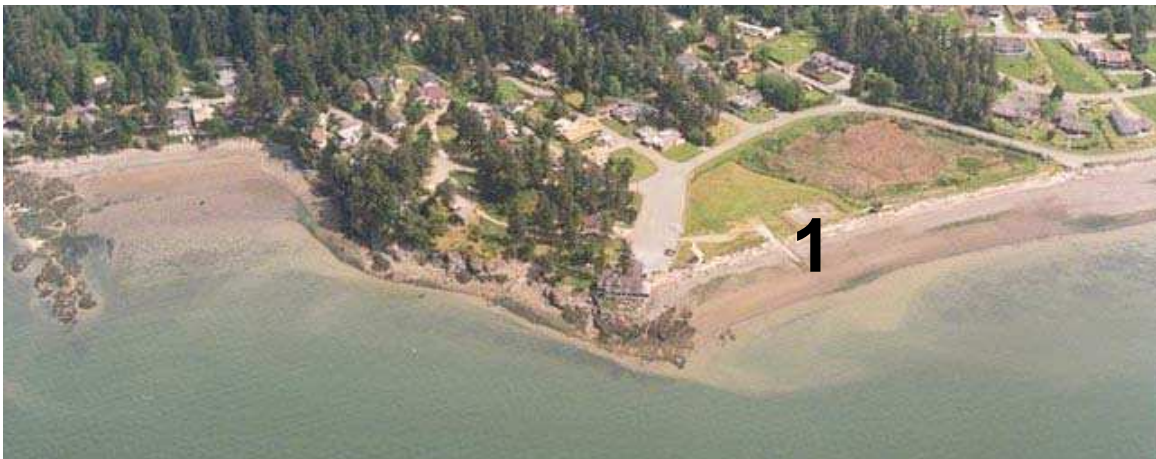
Shoreline Aerial Photo #SKA0550, Hope Island Inn

1. Treated beam, 36" x 6" x 2"

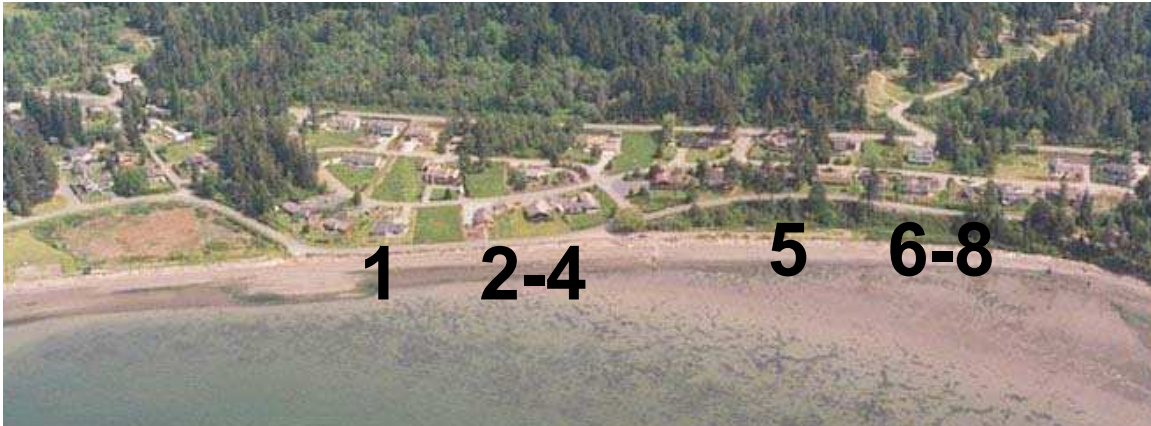
Shoreline Aerial Photo #SKA0551, south of Hope Island Inn  
Surveyed by Tom Richards and Kurt Buchanan

1. Creosote beam, 144" x 10" x 10"
2. Creosote log, 79" x 12" dia.
3. Creosote log, 16" x 12" dia.
4. Treated beam, 36" x 6" x 2"
5. Creosote log, 79" x 12" dia.
6. Treated beam, 79" x 6" x 2"
7. Creosote log, 216" x 10" dia.
8. 5 treated beams, each 96" x 6" x 6"

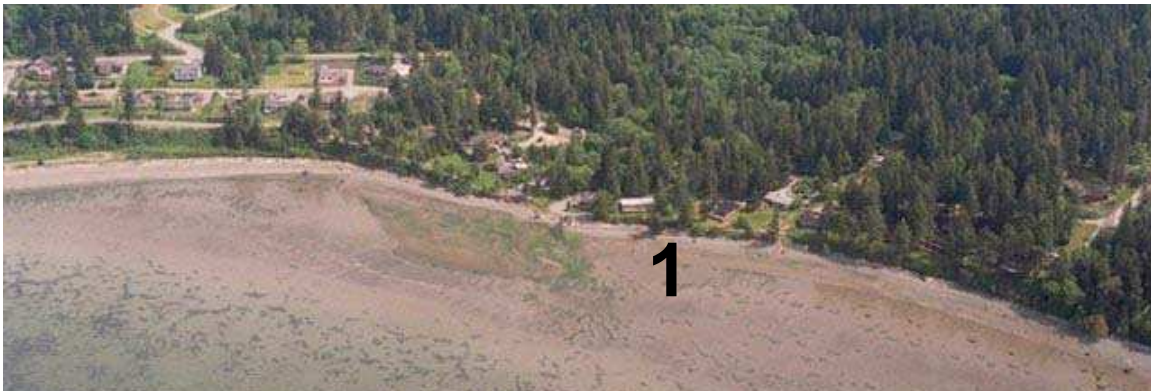
Shoreline Aerial Photo #SKA0552, south of Hope Island Inn  
Surveyed by Tom Richards and Kurt Buchanan

1. Patch of *Spartina*, ~1 meter diameter.

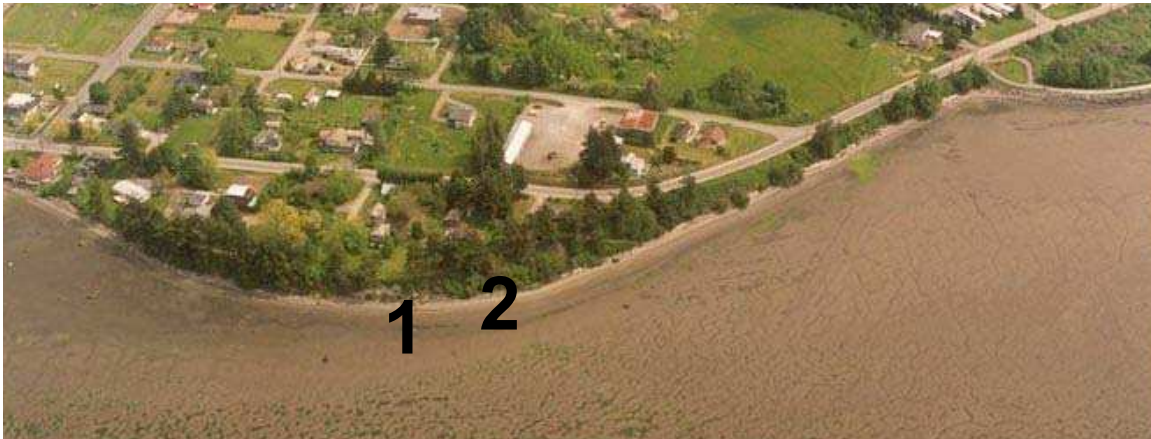
Shoreline Aerial Photo #SKA0319, North of dike trail

1. 2 creosote piles, each 48" x 10" dia.
2. Unknown number (estimate = 20) of creosote beams used as a bulkhead, each 156" x 10" x 5"

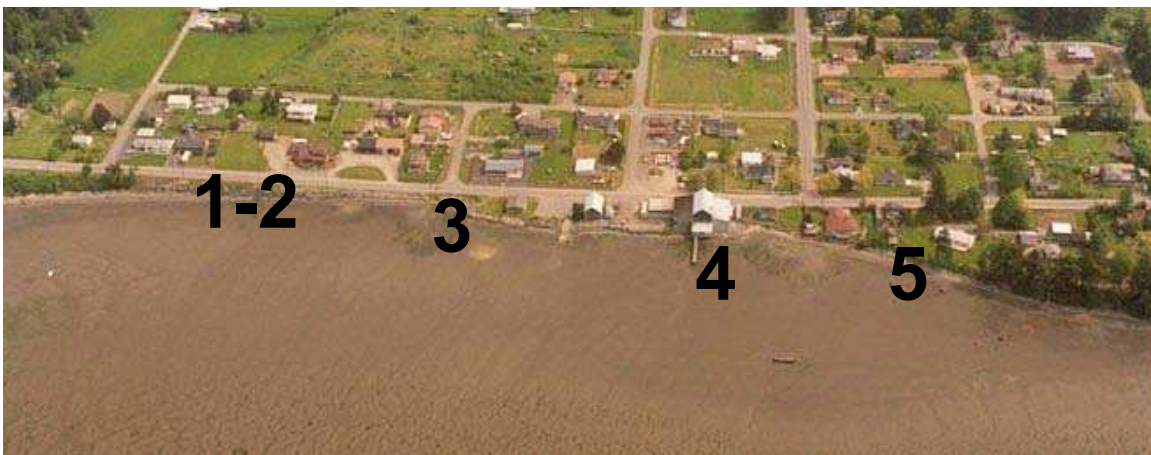
Shoreline Aerial Photo #SKA0318, at town of Bay View

1. Creosote log, 290" x 14" dia.
2. Creosote beam, 28" x 8" x 6"
3. Creosote log, 54" x 12" dia.
4. 20 creosote pilings in use as dock, each 180" x 16" dia.
5. Creosote piling, 36" x 9" dia. plus two small pieces of treated wood

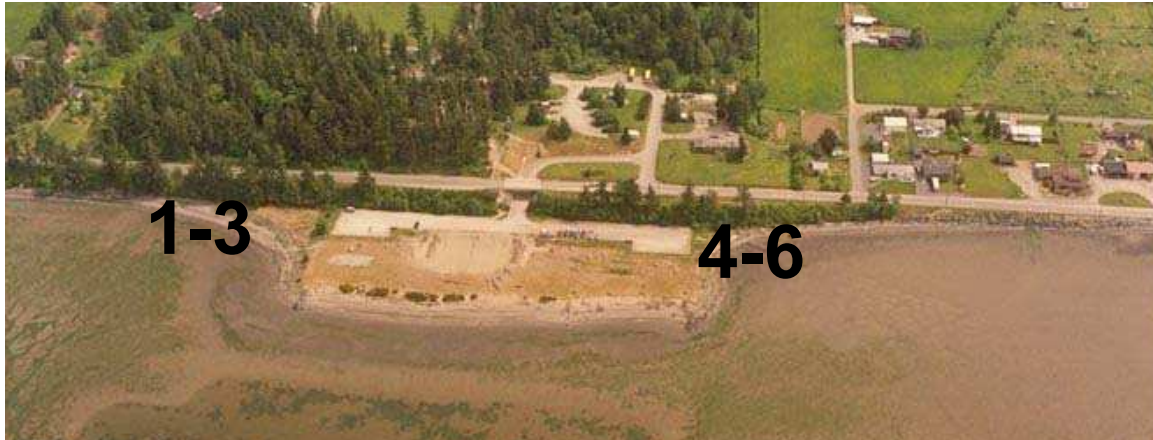
Shoreline Aerial Photo #SKA0317, at Bay View State Park

1. Creosote log, 204" x 14" dia.
2. Creosote log, 339" x 11" dia.
3. Creosote log, 351" x 11" dia.
4. Creosote log, 380" x 16" dia.
5. Creosote log, 84" x 9" dia.
6. Creosote beam, 108" x 11" x 11"

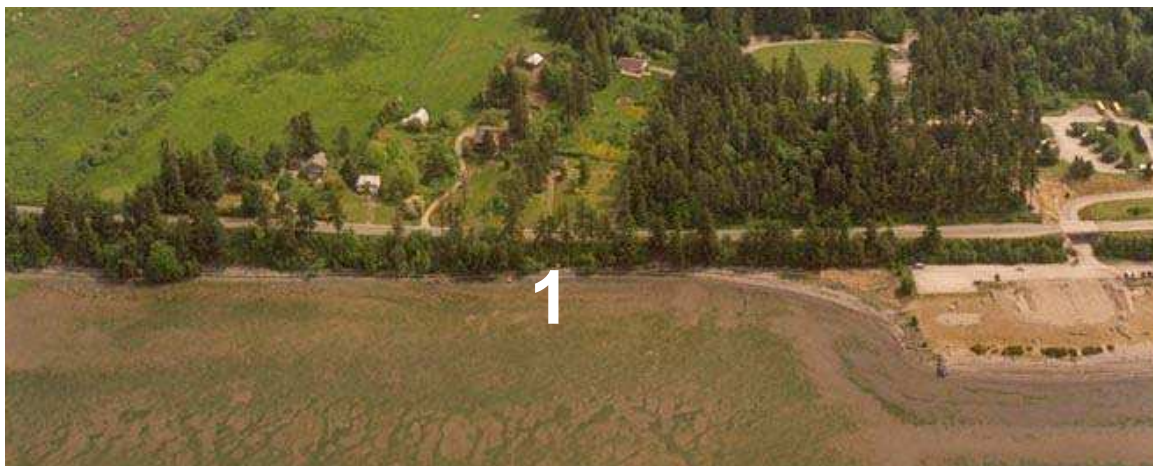
Shoreline Aerial Photo #SKA0316, north of Bay View State Park

1. Creosote log, 360" x 11" dia.

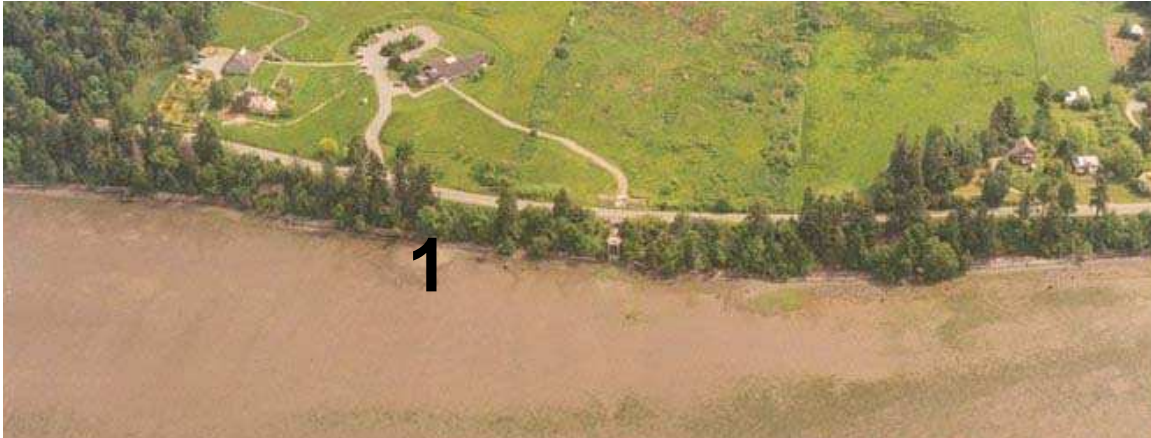
Shoreline Aerial Photo #SKA0316, at Padilla Bay Research Reserve Headquarters

1. Creosote beam, 40" x 8" x 6"

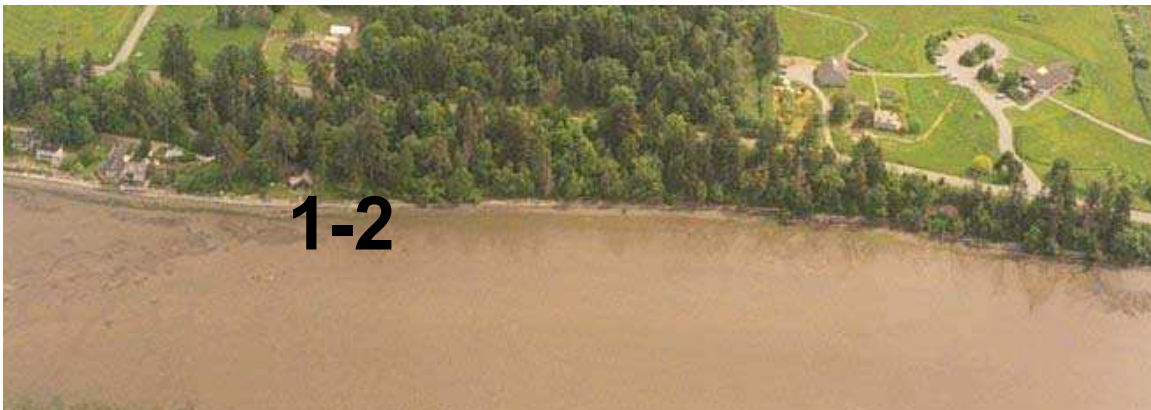
Shoreline Aerial Photo #SKA0314, north of Padilla Bay Research Reserve Headquarters

1. Creosote beam, 42" x 3" x 2"
2. Treated beam, 31" x 4" x 4"

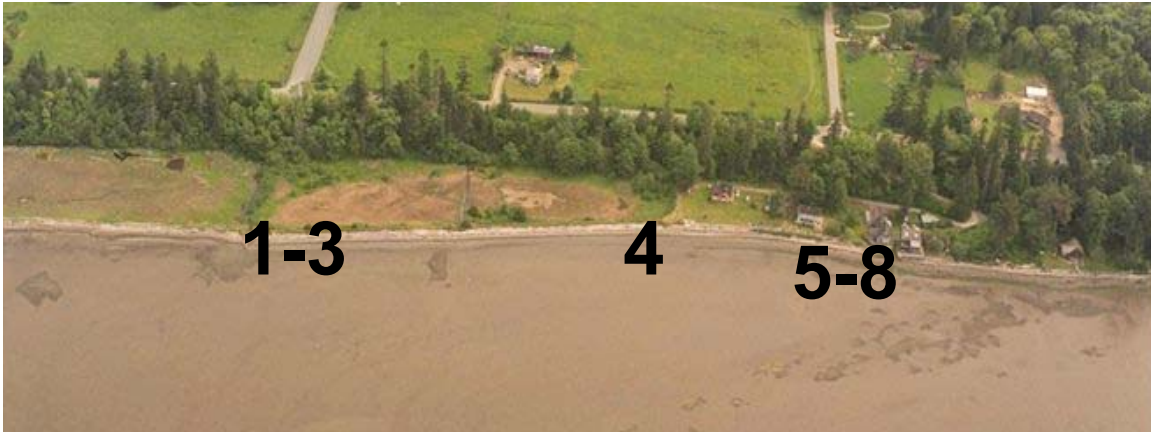
Shoreline Aerial Photo #SKA0313, south of Persons Road  
Surveyed by Jack Middleton and Tom Richards

1. Creosote piling, 238" x 13" dia.
2. Creosote log, 42" x 12" dia.
3. Creosote beam, 64" x 7" x 4"
4. Creosote log, 24" x 14" dia.
5. 3 railroad ties, each 72" x 8" x 6"
6. Creosote piling, 80" x 16" dia.
7. Creosote beam, 244" x 12" x 6"
8. Creosote beam, 72" x 12" x 5"

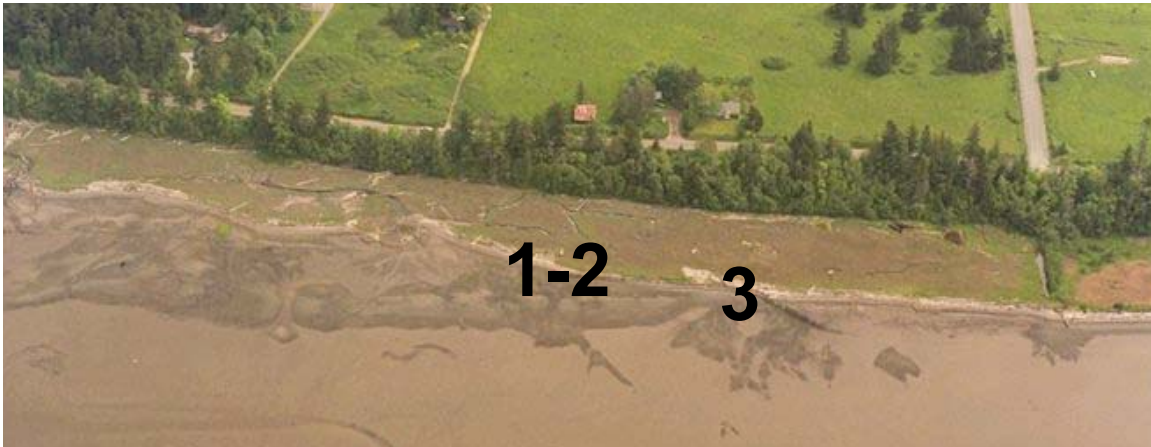
Shoreline Aerial Photo #SKA0312, north of Persons Road  
Surveyed by Jack Middleton and Tom Richards

1. Creosote beam, 43" x 4" x 4"
2. Creosote beam, 60" x 16" x 8"
3. Treated beam, 28" x 12" x 2"

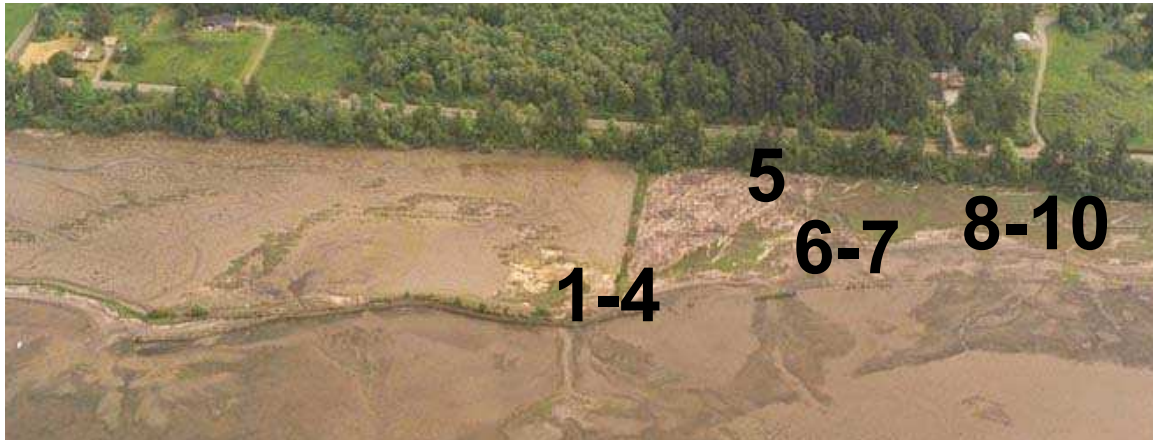
Shoreline Aerial Photo #SKA0311, north of Persons Road

1. Creosote log, 364" X 10" dia.
2. Creosote beam, 87" x 8" x 2"
3. Creosote beam, 96" x 12" x 3"
4. Treated beam, 147" x 4" x 4"
5. Creosote beam, 254" x 12" x 2"
6. Treated beam, 41" x 6" x 2"
7. Treated plywood box, 18" square plus misc. small treated wood debris
8. Creosote beam, 266" x 12" x 4"
9. Creosote log, 14" x 14" dia.
10. Creosote log, 124" x 10" dia.

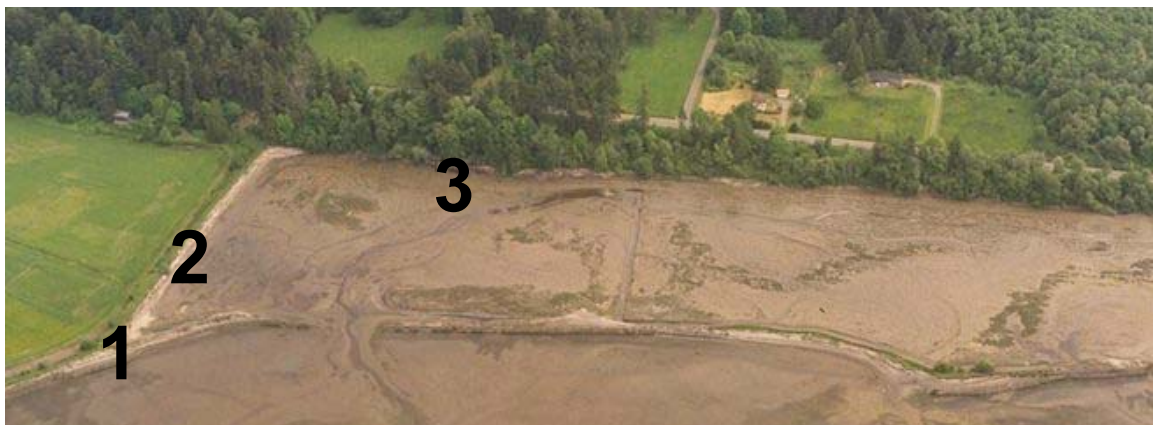
Shoreline Aerial Photo #SKA0310, north of Persons Road

1. Treated timber, 57" x 4" x 2"
2. Creosote railroad tie, 43" x 8" x 6"
3. Creosote beam, 72" x 15" x 5"

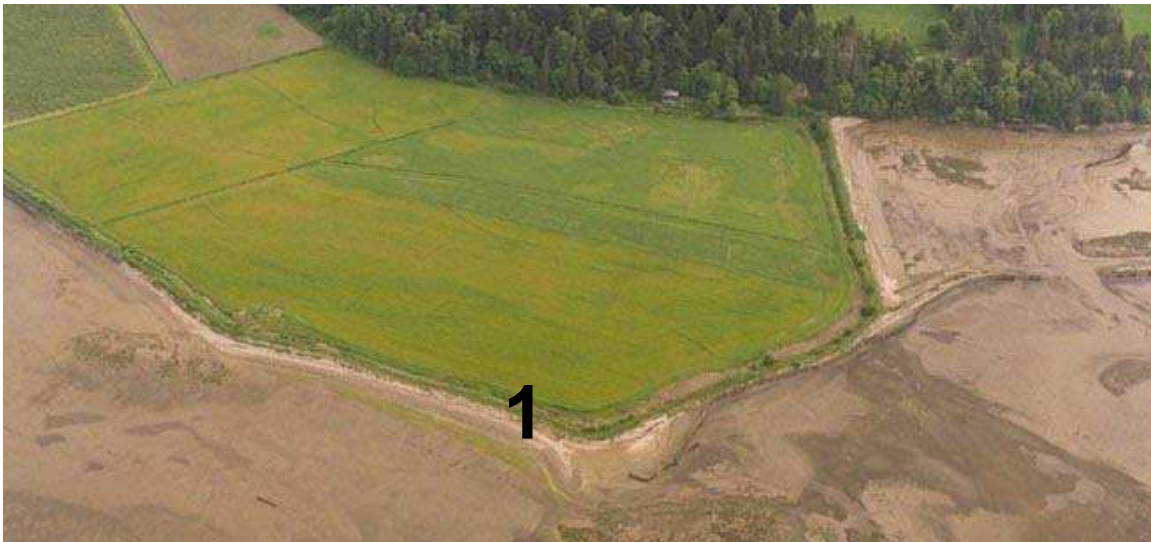
Shoreline Aerial Photo #SKA0309, north of Persons Road

1. Creosote log, 49" x 6" dia.

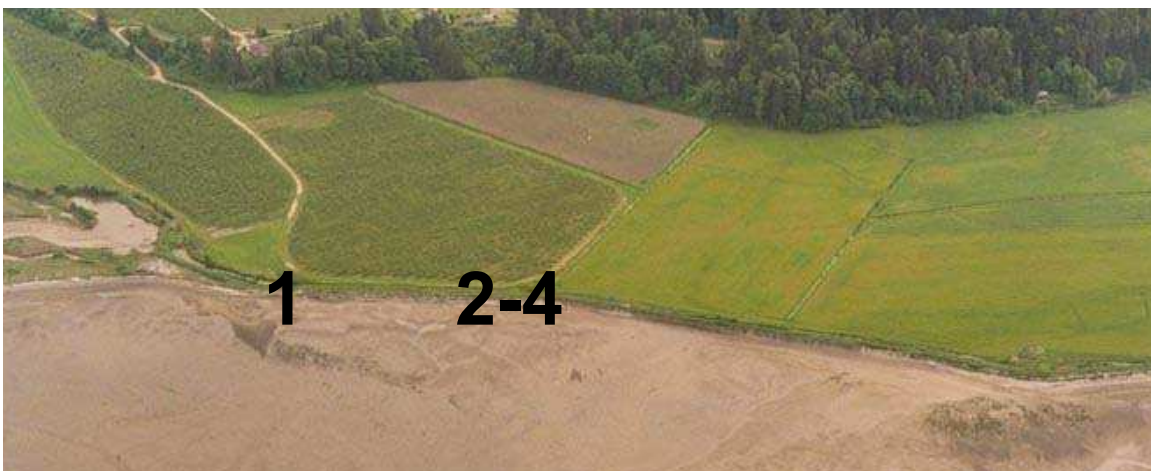
Shoreline Aerial Photo #SKA0308, south of Joe Leary Slough

1. Creosote log, 20" x 14" dia.
2. Creosote beam, 75" x 6" x 3"
3. Creosote beam, 24" x 12" x 3"

4. Creosote log, 686" x 17" dia.

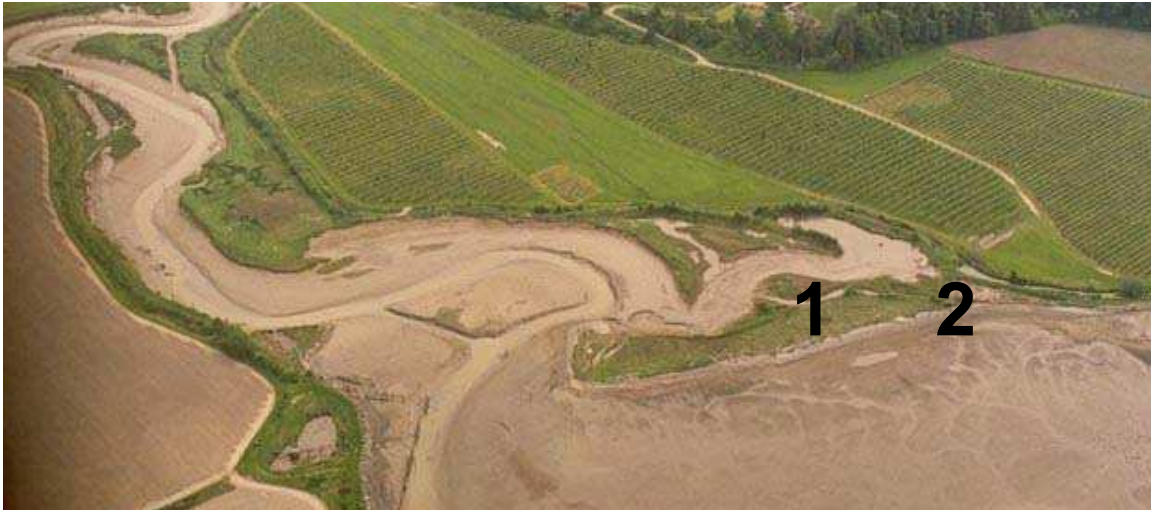
Shoreline Aerial Photo #SKA0307, at Joe Leary Slough  
Surveyed by Jack Middleton and Tom Richards

1. Creosote log, 66" x 14" dia.
2. Creosote log, 39" x 10" dia.
