PROJECT TITLE: Northwest Straits Project: Island County MRC Action and Administration

DELIVERABLE FOR TASK NO: 2.1 Habitat Restoration Feasibility Assessment

# **HABITAT RESTORATION FEASIBILITY ASSESSMENT**

## **Cornet Bay/Hoypus Point Improvement Project**

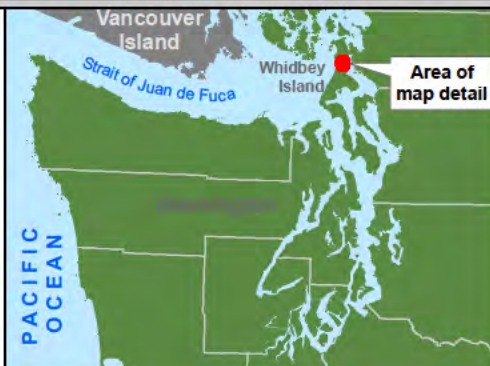
Figure 1. Project area and project site map for the Cornet Bay/Hoypus Point Improvement Project.

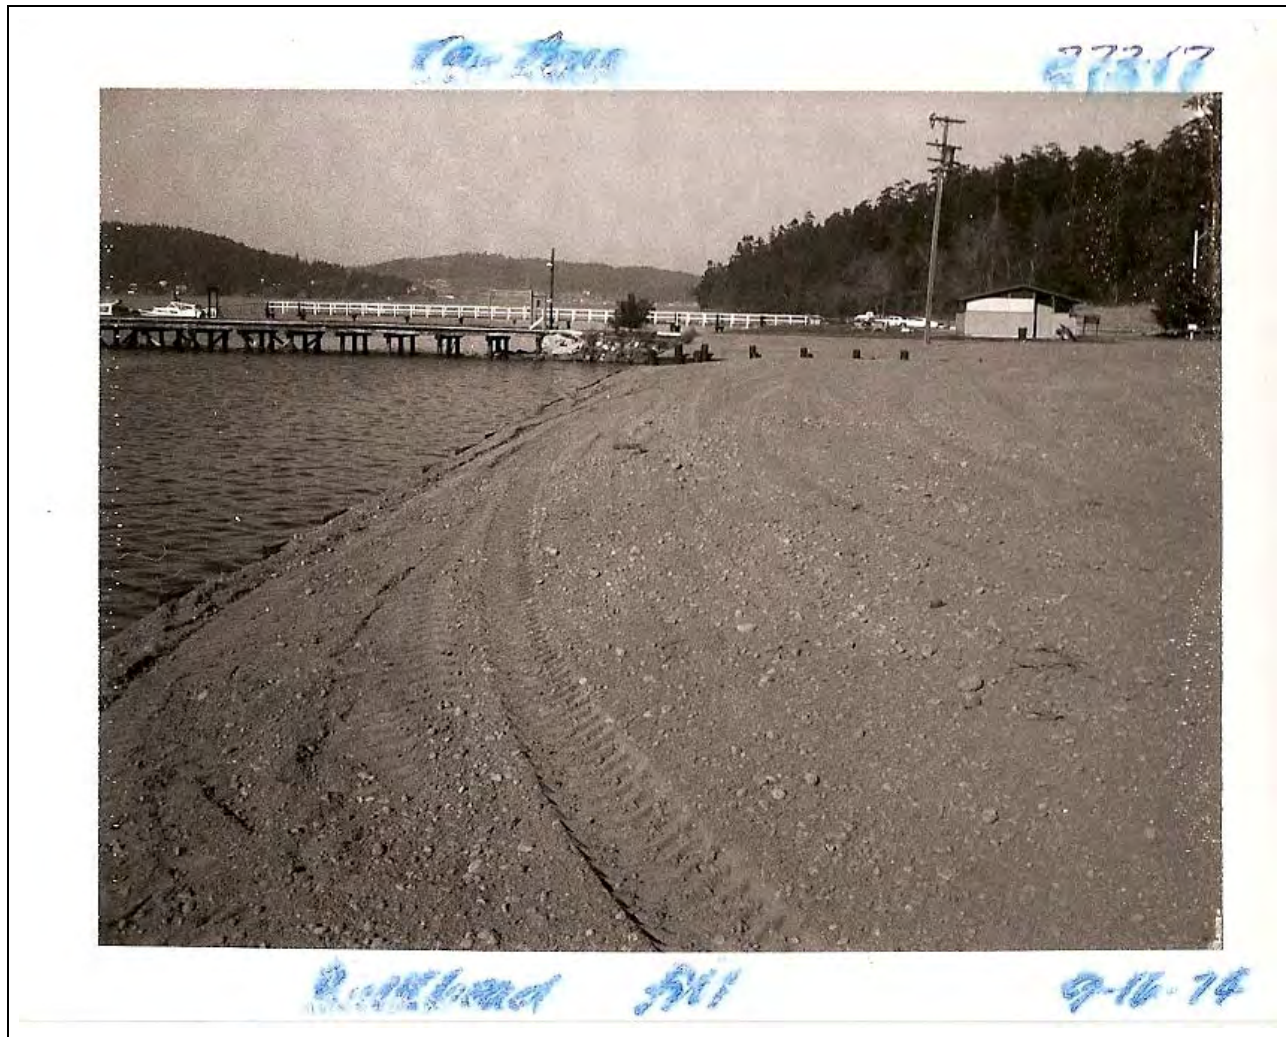
**Figure 3. Historical photograph of fill prior to the construction of the bulkhead. Looking to the northeast. September 16, 1974.**

- Filling and paving of the project site – Filling of the former backshore area occurred by the park entrance and in the vicinity of the park's marine facilities. The filling of the former backshore area required the construction of a bulkhead to protect the fill (see next item and Figure 3). In addition to filling the area, parking areas (over 3 acres total) were constructed on top of the fill. This further increased runoff flow rates over deforestation alone. Paving also forced stormwater through a single outlet next to (east of) the Public Access Boat Dock.
- Bulkhead construction – Aside from the chemical contamination, the creosote-timber bulkhead has increased the wave energy over pre-development conditions and fixed the shoreline in place.

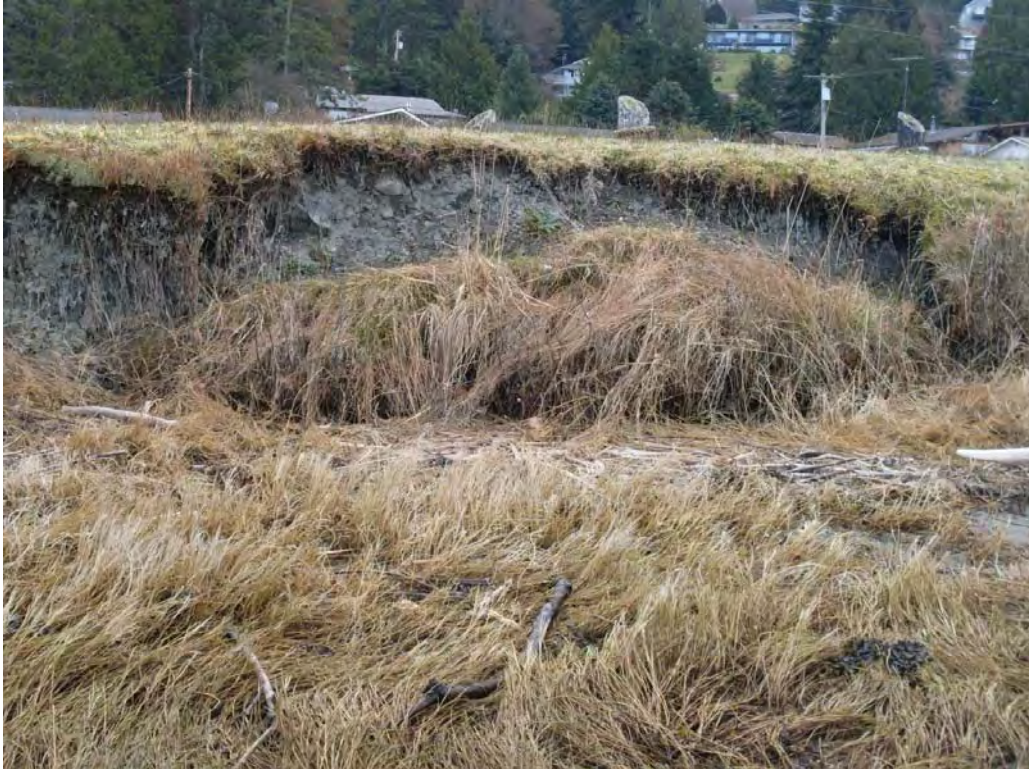
**Figure 4. Photograph of unprotected fill at the southeast end of the project area.**

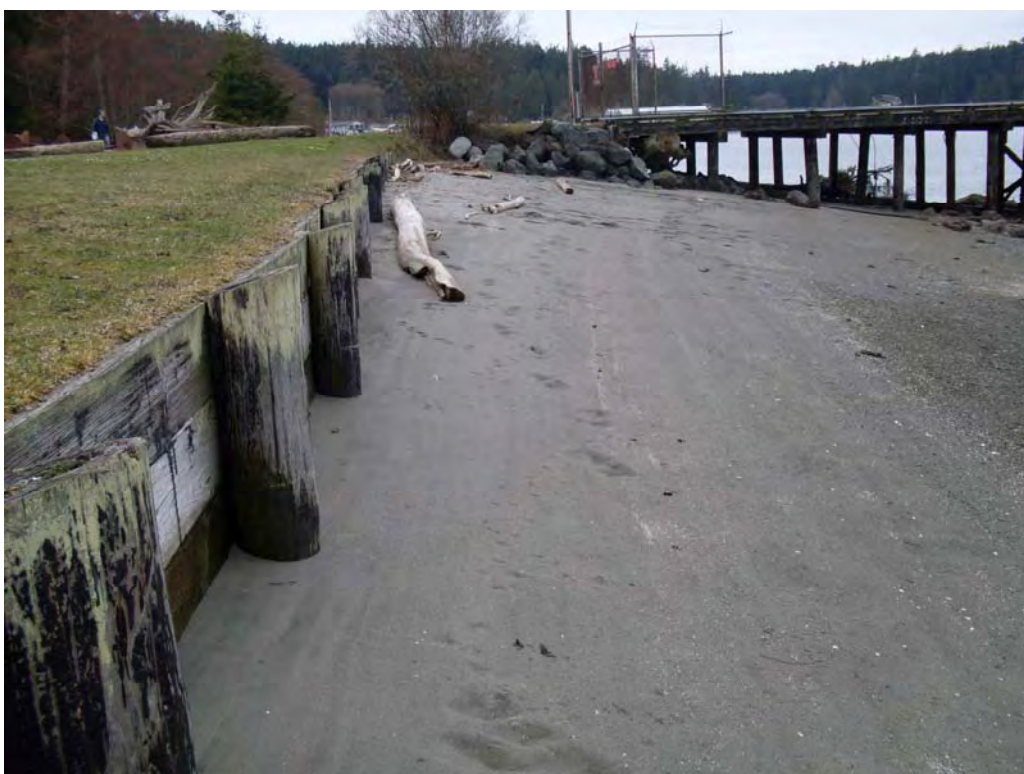
**Figure 5. Accumulation of sediment on the northeast side of the Marine Maintenance and Facilities Dock. Fill associated with the dock approach protrudes into the intertidal area. March 27, 2009.**

- Construction of the Marine Maintenance and Facilities Dock – The Marine Maintenance and Facilities Dock was constructed sometime after 1944. The dock is 300 feet long and 20 feet wide for a total overwater coverage of 6,300 square feet (not including removable floats). The dock has approximately 145 creosote-treated timber piles. The decking of the structure does not allow light penetration. Eelgrass beds are located adjacent to the Marine Maintenance and Facilities Dock, but the degree to which this structure has affected the eelgrass beds is unknown. The Marine Maintenance and Facilities Dock has a substantial amount of fill associated with the approach to the dock (Figure 5). The fill, and debris associated with it, extends down to approximately 3 to 5 feet above mean lower low water. As a result, this fill has impounded a large amount of sand on the northeast side of the filled area at elevations above extent of the fill. This is the single largest geomorphic impact to nearshore physical processes (i.e., impairment of longshore sediment transport) in the project area.

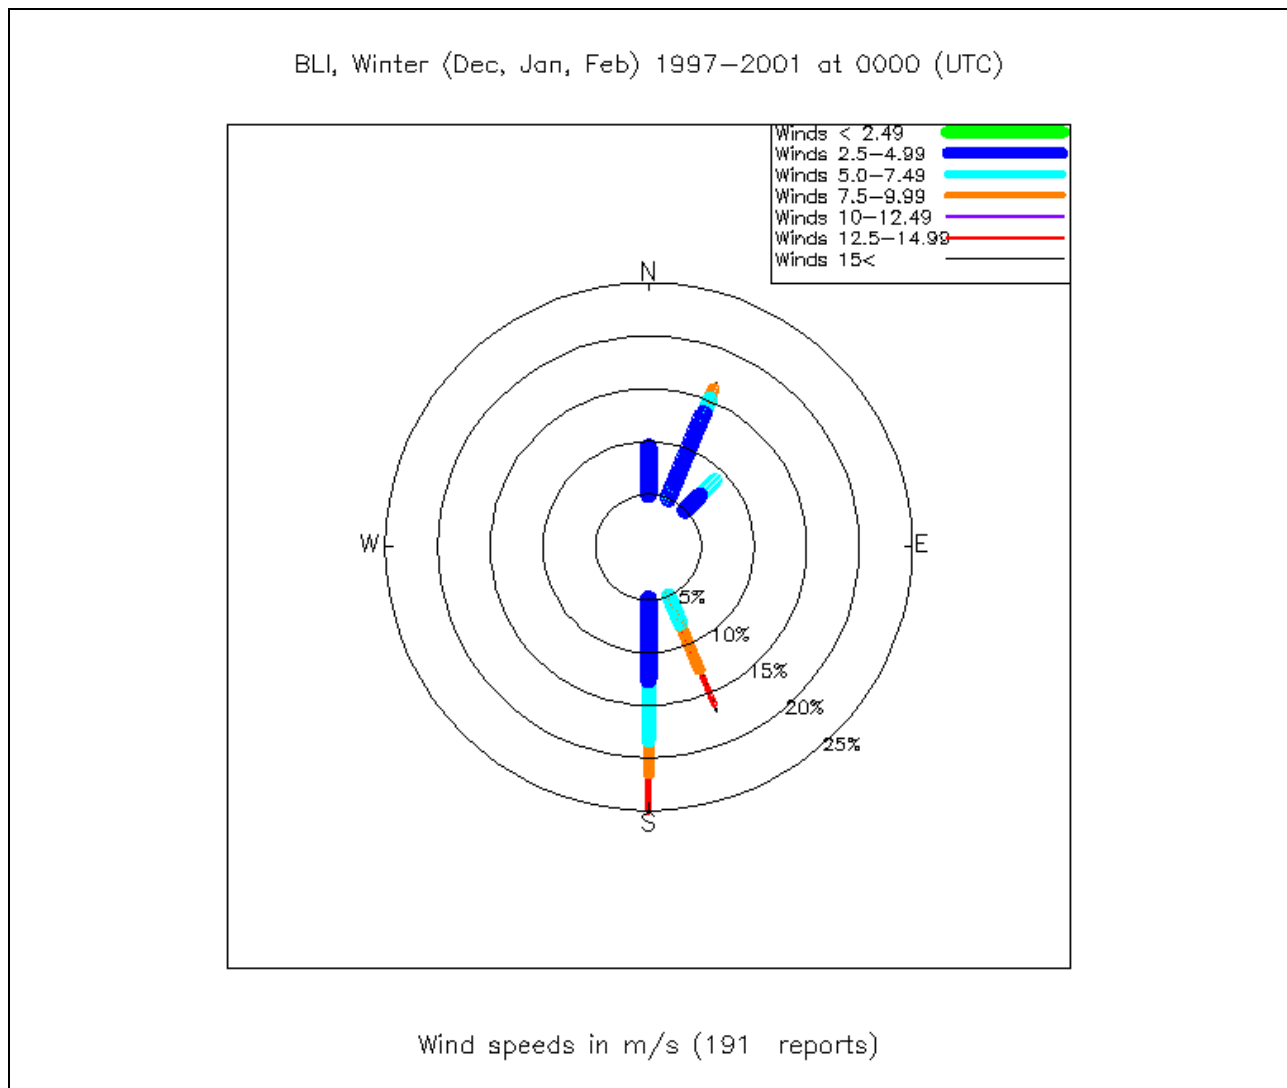
**Figure 6. Wind rose from Bellingham Airport during winter storms (Stewart 2009).**

Winds at Bellingham were generally light during the deployment, with the only significant winds (greater than 10 knots) coming from the south. The strongest wind observed was a southerly wind of 19 knots. No wind events above 10 knots occurred from the northeast during the deployment. Anecdotal evidence from local park staff indicates that the occurrence of rare northeasterly events that can produce significant waves in the project site. The largest of these in the last five years was reported to have produced waves approximately 2 feet in height, the same size as the largest wakes produced by the Victoria Clipper (Hart 2009). However, the Clipper rarely routes through Deception Pass and only during times of large waves.

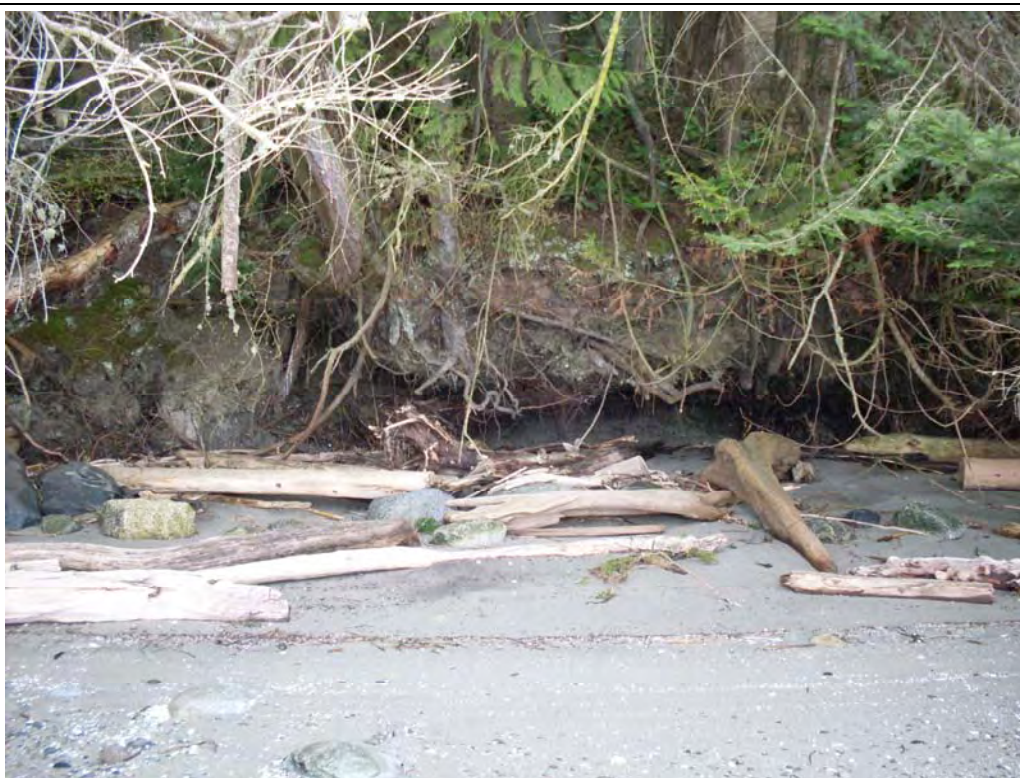
**Figure 8. Photograph of an eroding bank near Hoypus Point.**

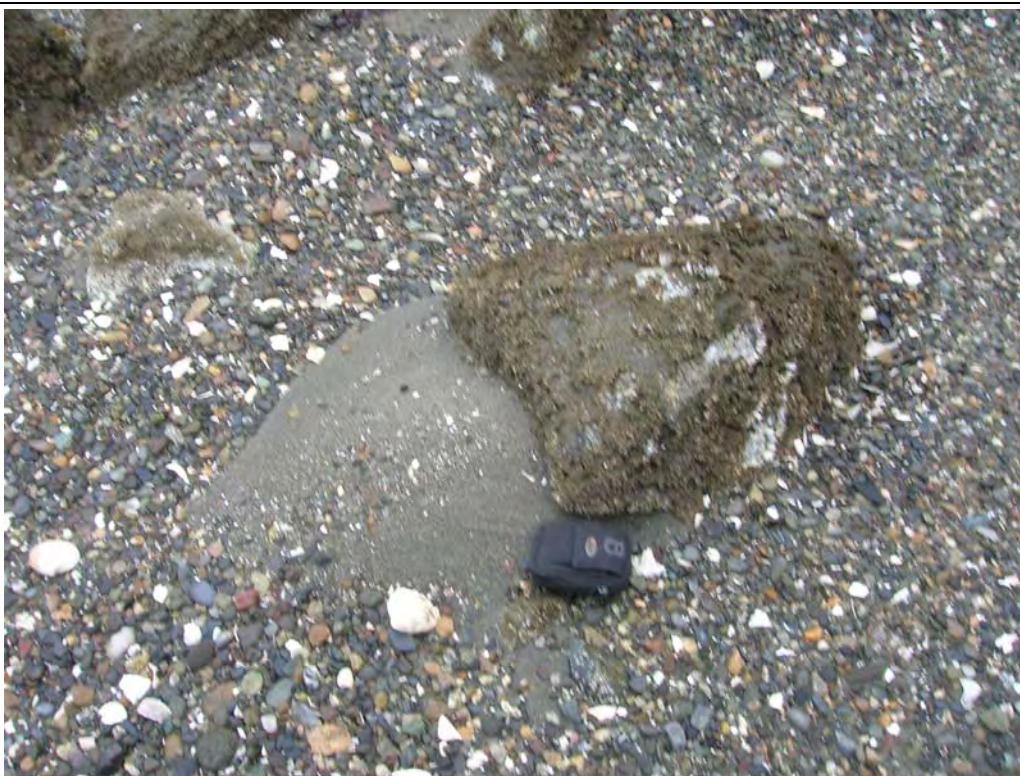
**Figure 9. Bedform in the lee of a large rock on the foreshore of Hoypus Point. Bedform indicates transport toward the west and the project site.**

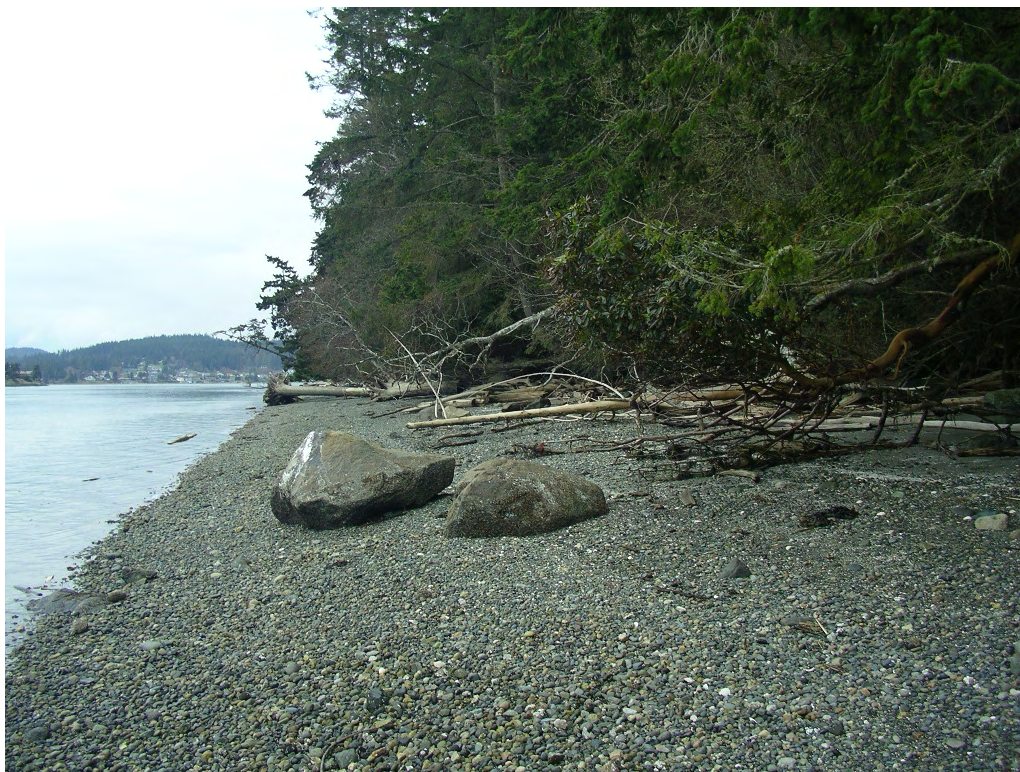
**Figure 12. Riparian vegetation along a representative section of the shoreline between Hoypus Point and the State Park boat launch.**

In this largely undeveloped nearshore section of the project area, the riparian vegetation community in many places reflects essentially unaltered, diverse, mixed and mature to old-growth coniferous forest with well-developed understory and shrub layers (Figure 12). These habitats occupy the top of the low bluffs found here, sometimes extend down to the shoreline, and extend beyond nearshore areas to the rest of the State Park. Downed wood (along with driftwood) and overhanging trees are extremely common along the shoreline in this area.

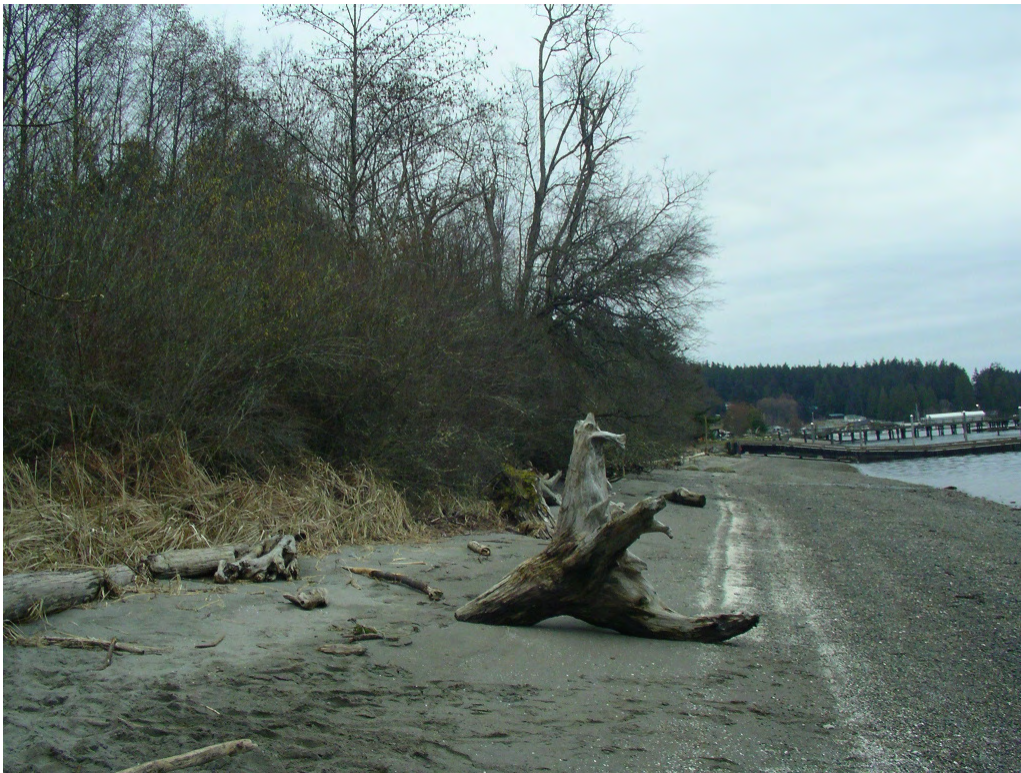
**Figure 13. Scrub-shrub areas immediately northeast of the State Park boat launch (looking southwest).**

Immediately northeast of the boat launch, the vegetation community has been altered and is now in a state of regeneration. This scrub-shrub area is located on a low shoreline bank and is dominated by young trees and shrub species (Figure 13). Dominant species observed here include red alder, Pacific crabapple, a variety of willow species (Hookers willow being the most common), snowberry, oceanspray, salal, Oregon grape, Nootka rose, salmonberry, and red elderberry. This area may serve an appropriate reference site for project plant community restoration target conditions. All planting prescriptions will need to consider specific species requirements and tolerance ranges in conjunction with on-site conditions to determine the most ecologically appropriate plant types for specific project areas.

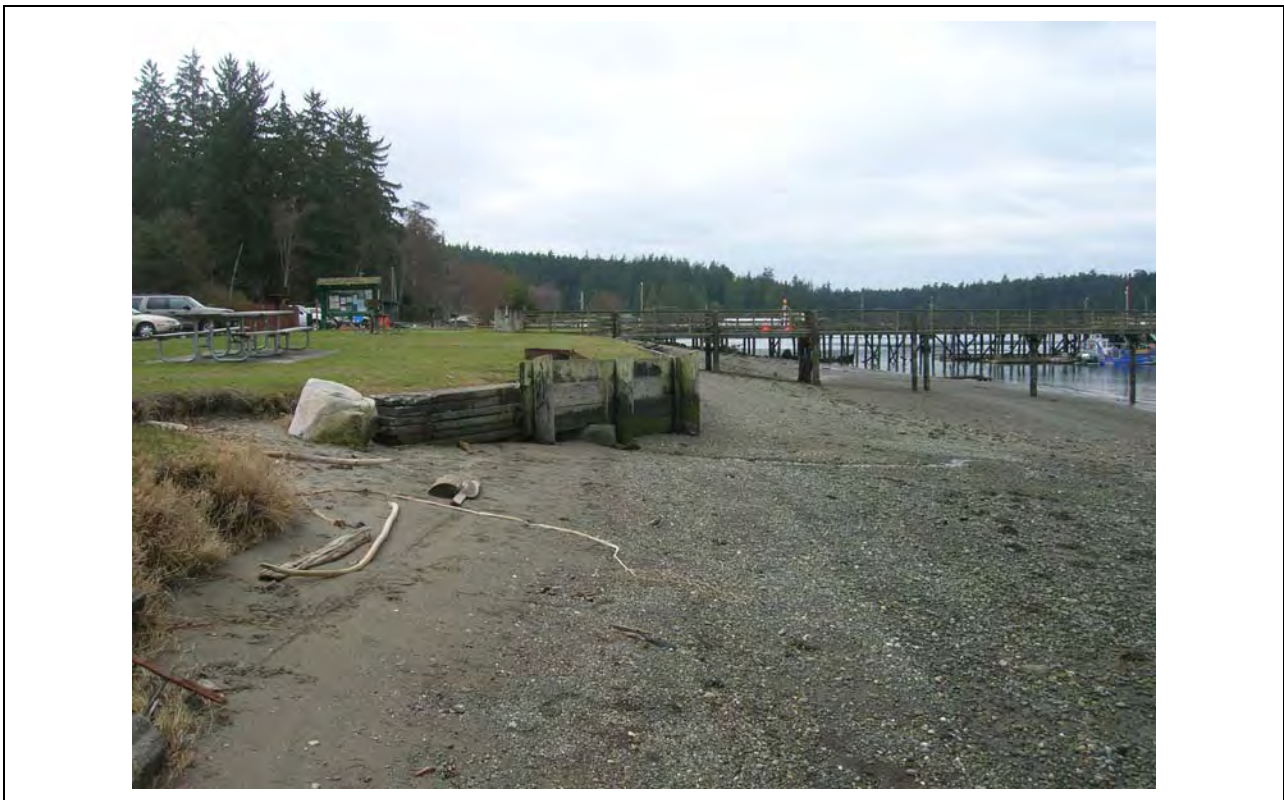
**Figure 14. Riparian vegetation conditions southwest of the State Park boat launch.**

In the southwest extent of the project area near the majority of park development and infrastructure, the historic native plant community has been largely replaced by State Park day use and maintenance facilities (Figure 14). The vegetation along the shoreline is dominated by lawn areas and weedy perennial and annual grass species, with intermittent patches of scrub-shrub habitats (species composition discussed above), and largely lacks the functions attributed to intact riparian communities discussed previously.

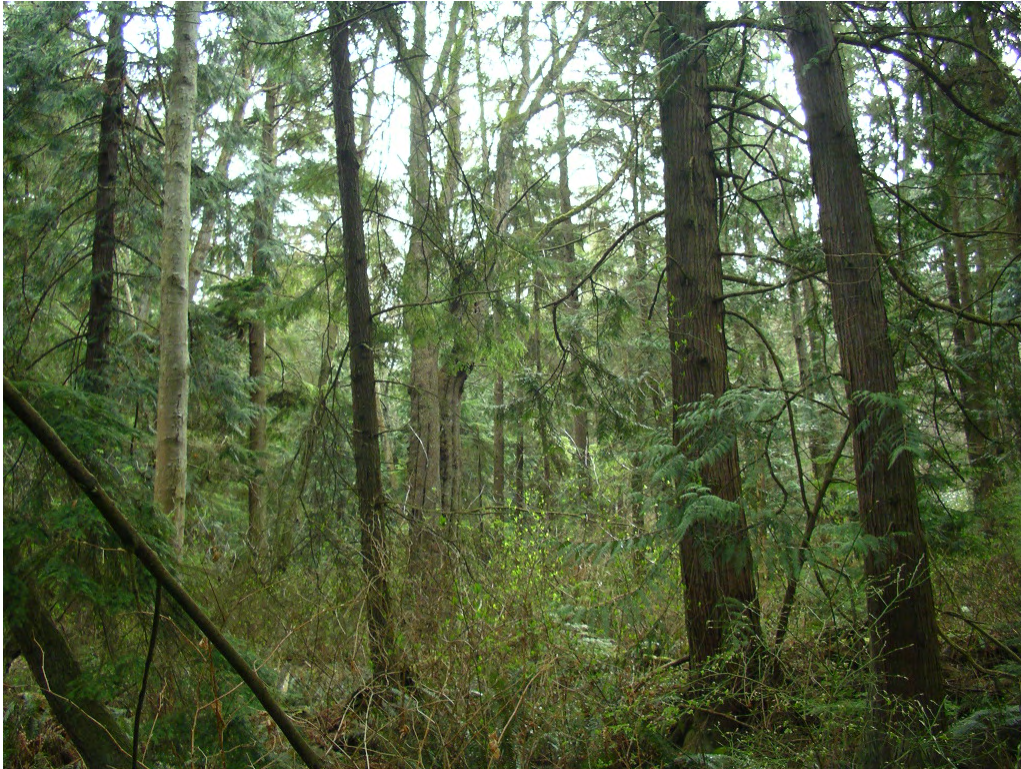
**Figure 15. Mature forested wetland area near southwest portion of project area (looking east).**

The understory of this habitat type is dominated by salmonberry, Pacific crabapple, gooseberry, red elderberry, sword fern (on hummocks), slough sedge, and skunk cabbage. Large stands of mature red alder and high densities of shrub species were observed in canopy gaps in the forested wetland at Cornet Bay. Forested wetland areas may occur as mosaics with patches of upland vegetation interspersed among wetland areas, especially in areas near the day use parking lot (see Appendix C).

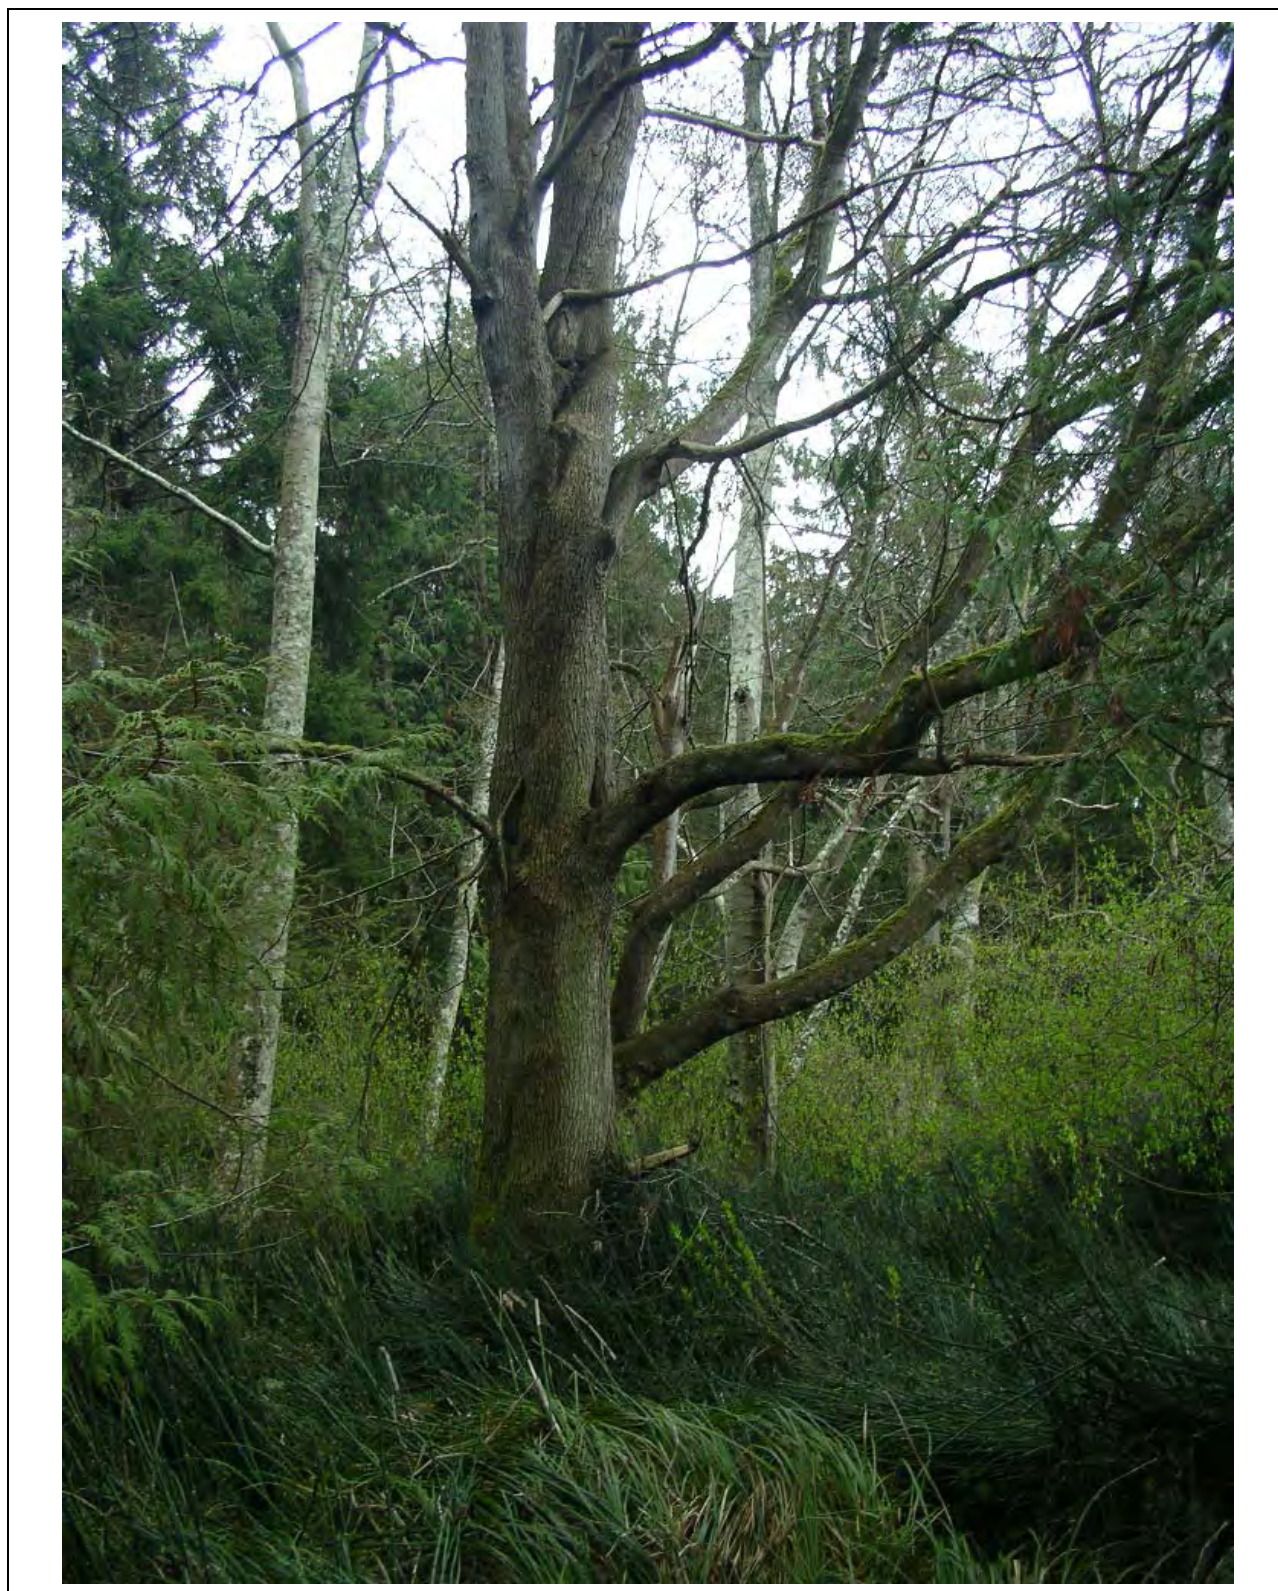
**Figure 16. Standing dead big leaf maple in the forested wetland area in southwestern portion of project area.**

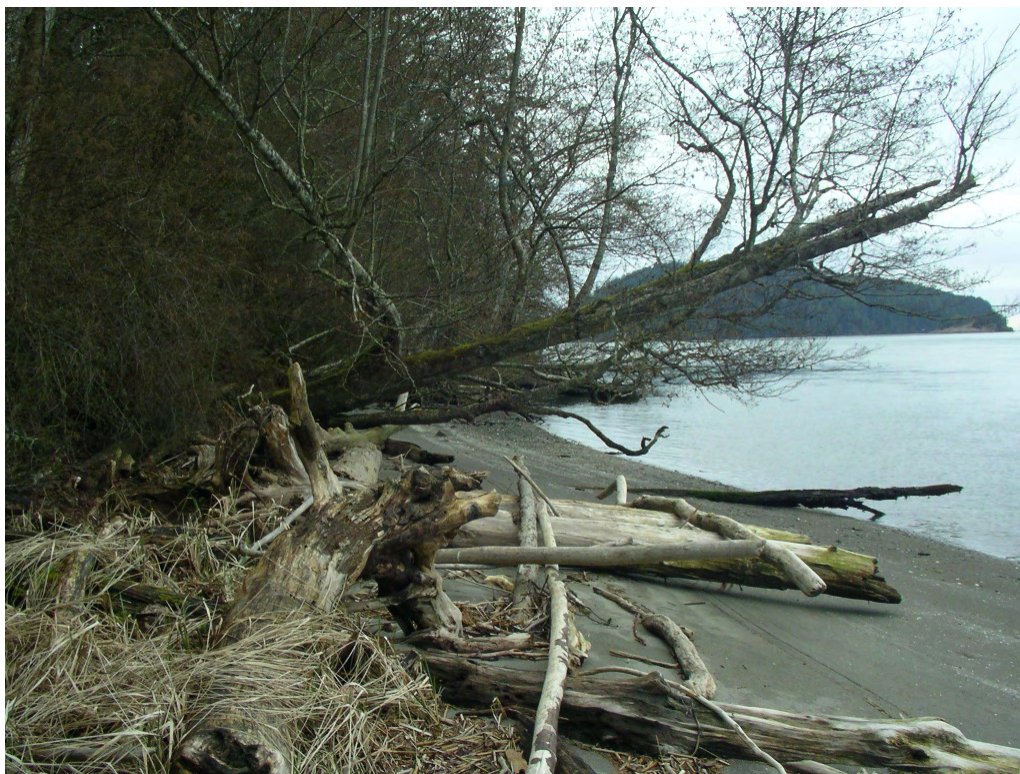
**Figure 17. Representative nearshore conditions along the segment of shoreline between Hoypus Point and the State Park boat launch (looking southwest).**

The foreshore sediment consists of well-sorted gravelly sand, consistent with close proximity to bluffs that are the source of sediment in this area. Beginning at the northernmost point of Hoypus Point, a number of isolated large boulders are present throughout the beach profile. Historical documents show that these are natural features of the landscape (Jordan 1891). These boulders are not present southwest of the boat launch. The low tide terrace is quite deep for much of this area (if it exists) and so was not observed on the site visits. Macroalgae are found sporadically across the intertidal gradient throughout this segment of shoreline.

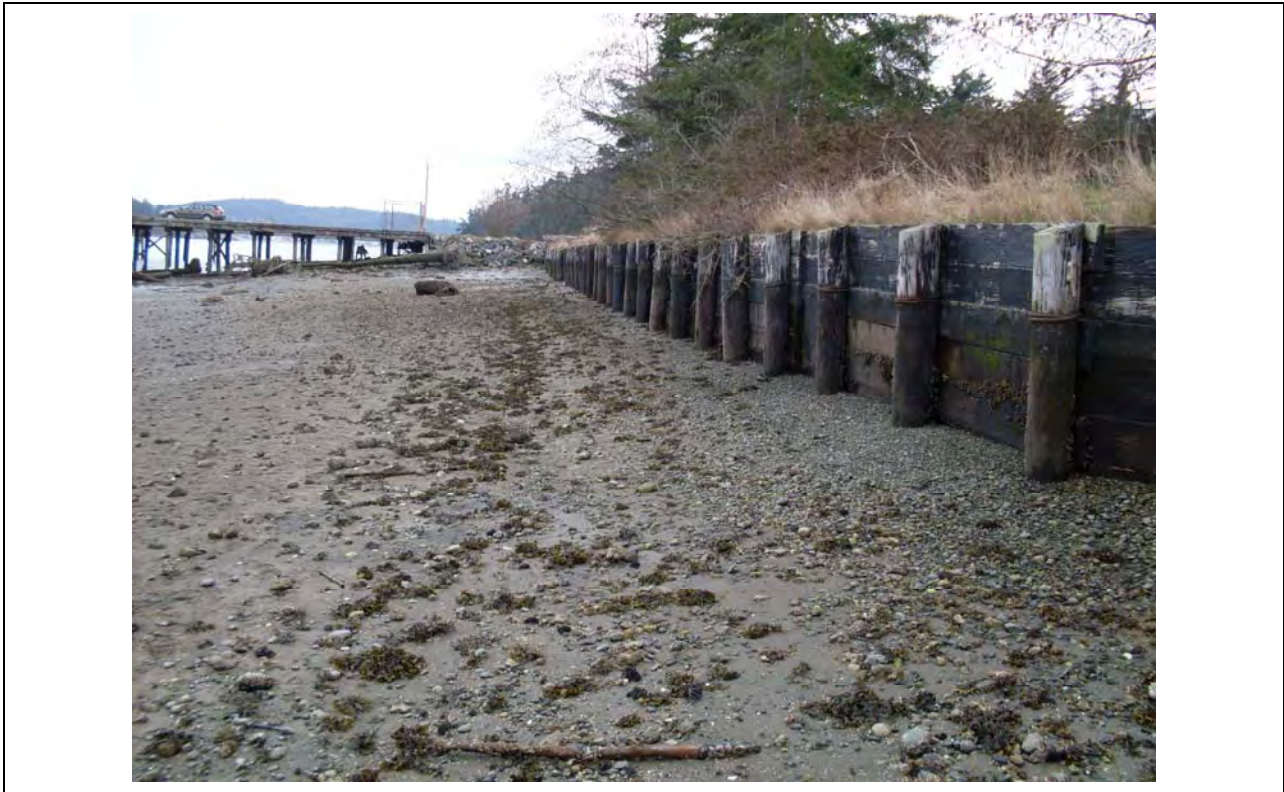
**Figure 18. Representative nearshore conditions along the armored segment of shoreline between the State Park boat launch and the private marina.**

Shoreline armoring throughout this area causes significant impacts to nearshore aquatic habitat, including coarsening and homogenizing of intertidal substrate and steepening of beach grades, which negatively affects forage fish spawning. In addition, shoreline armoring precludes the accumulation of LWD and development of backbeach habitats. Since nearshore conditions among various sections of the shoreline in this area exhibit differences with regard to degree of modification and substrate characteristics, they are described individually below.

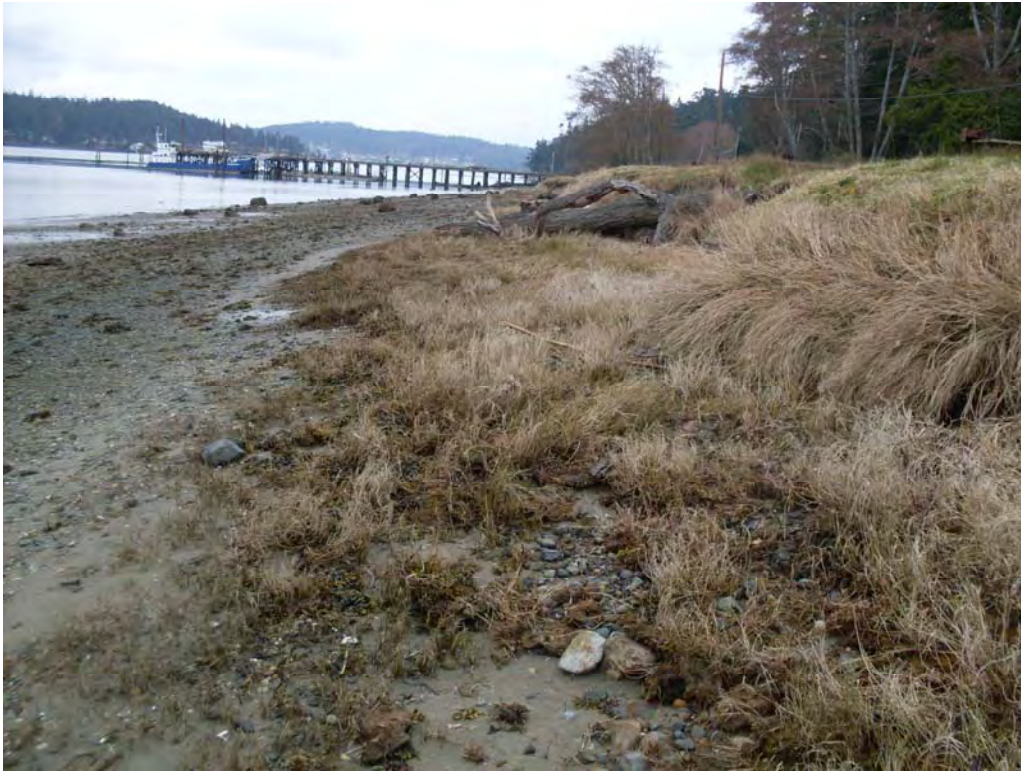
**Figure 19. Representative nearshore conditions along the unarmored segment of shoreline near the park boundary and the private marina.**

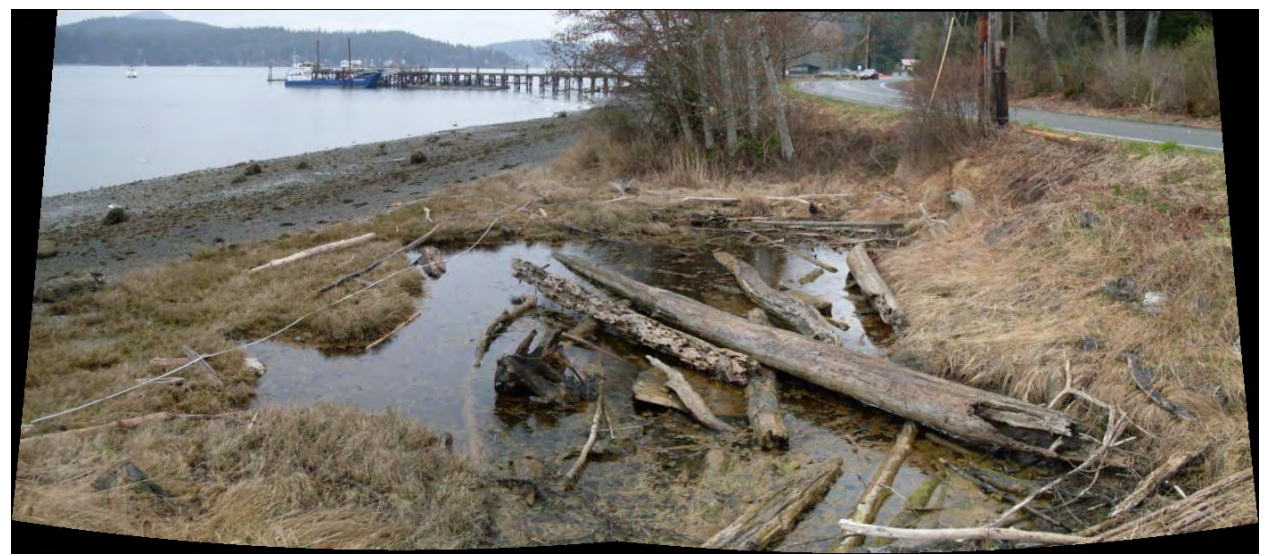
**Figure 20. Small lagoon feature (approximately 1,500 square feet) located approximately 300 feet northeast of the private marina; looking toward the northeast. Note scrub-shrub vegetation on the background.**

Similar to the other areas, riparian vegetation has been removed throughout this section, but some reestablishment has occurred in the area to the northeast of the lagoon feature. Although composed primarily of scrub-shrub vegetation (i.e., less than 20 feet in height), this area will likely continue to mature and provide increasingly greater benefits to the nearshore environment (Figure 20).

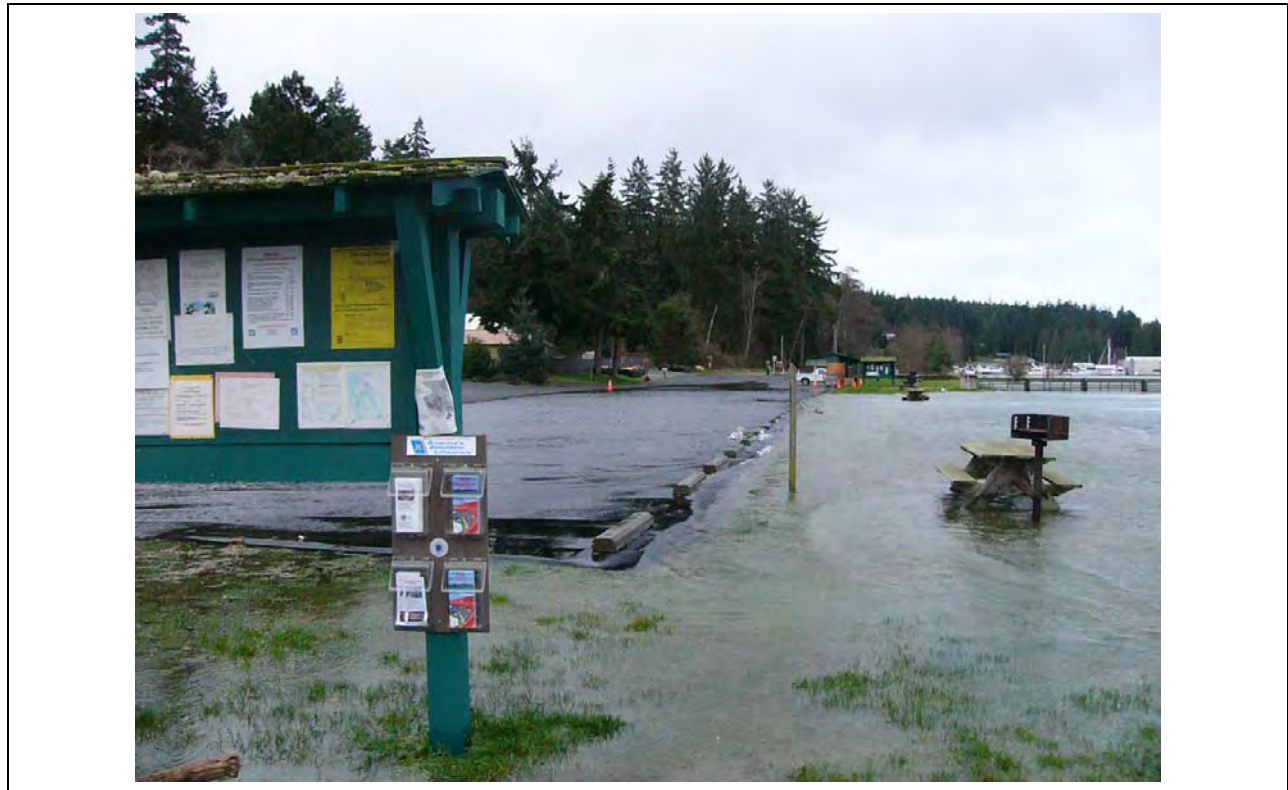
**Figure 21. Flooding during an extreme high water event at Deception Pass State Park, looking to the southwest.**

water levels. The largest wave event in the last five years postdicted using a Corps-approved wind-wave model from winds observed at Bellingham was found to be 1.7 feet, which is consistent with observations at the project site of waves approximately 2 feet in height (Hart 2009).

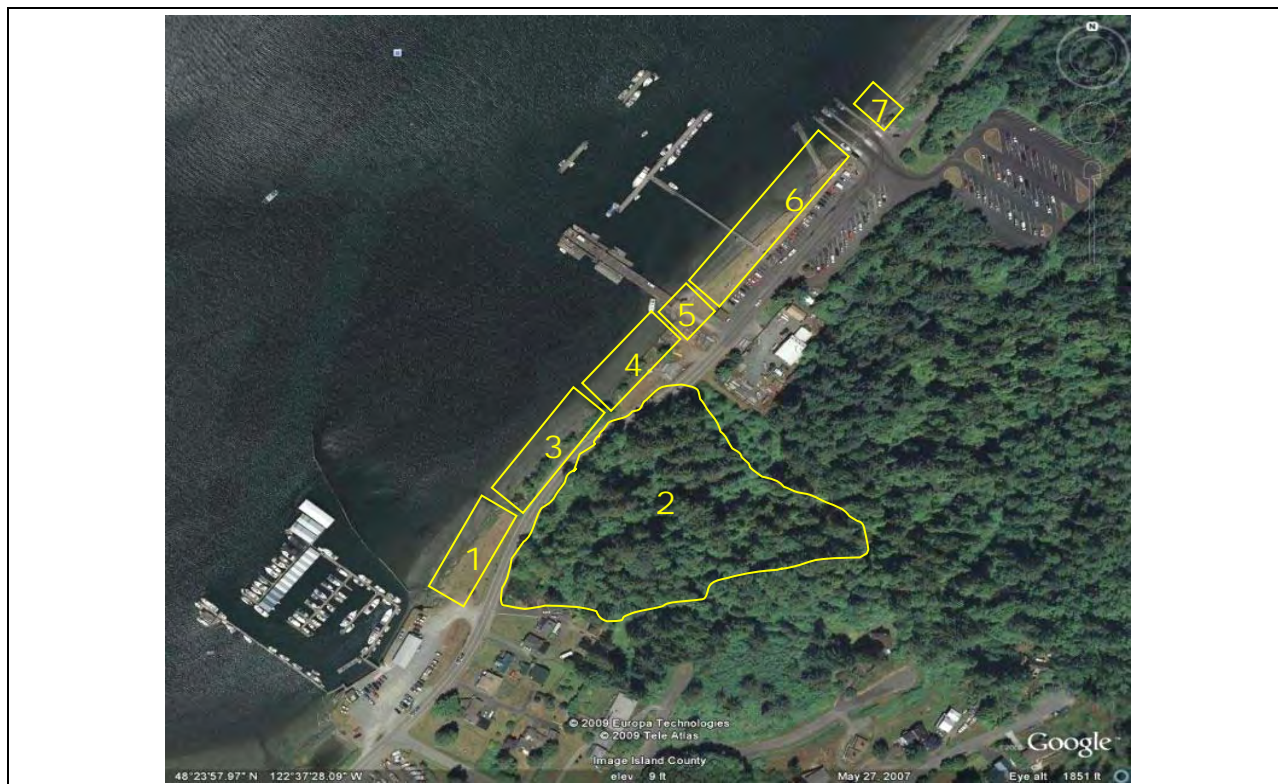
**Figure 22. Potential locations and extents of nearshore restoration target areas along Cornet Bay.**

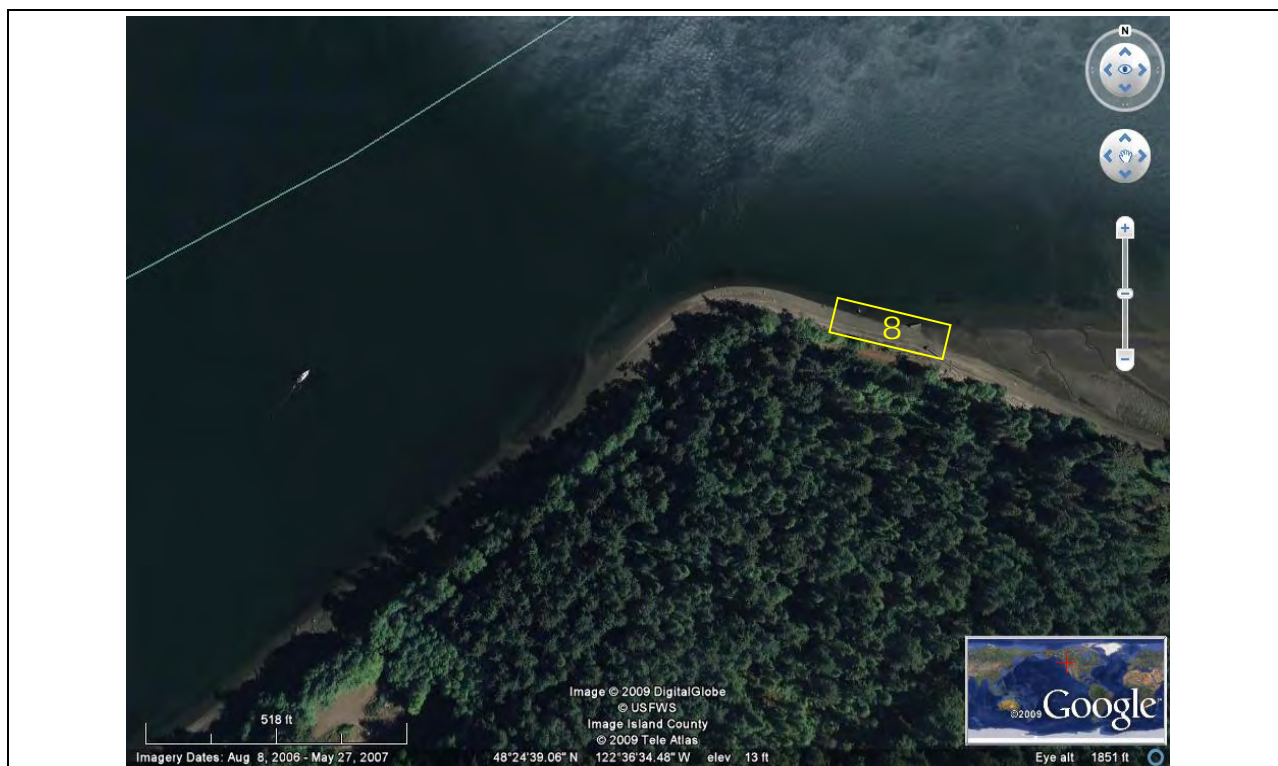
**Figure 23. Potential locations and extents of nearshore restoration target areas along Hoypus Point.**
