**Port Townsend Waterfront Eelgrass Survey
September 5 & 8, 2014**

Jefferson MRC

Port Townsend Waterfront Eelgrass Survey

September 5 & 8, 2014

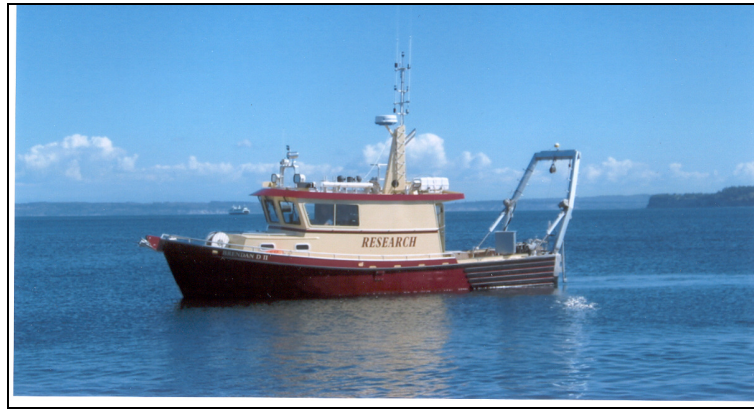
Figure 3. The *R/V Brendan D II*.Table 2. Equipment used onboard the *R/V Brendan D II* during the survey.

We conducted sampling aboard the 36-ft *R/V Brendan D II* (Fig. 3). We acquired position data using a sub-meter differential global positioning system (DGPS) with the antenna located at the tip of the A-frame used to deploy the camera towfish. Differential corrections were received from the United States Coast Guard public DGPS network using the WGS84 datum. A laptop computer running Hypack 2012 hydrographic survey software stored time, position and GPS quality data from the DGPS, depth data from one echosounder (Garmin), and user-supplied transect information onto its hard drive. Position data were stored in both latitude/longitude and State Plane coordinates (Washington South, US Survey Feet NAD83 HPGN). All data were updated at 1 s intervals. Table 3 lists all the equipment used during this survey.
