North Fidalgo Island Geomorphic Assessment & Drift Cell Restoration Prioritization

Prepared for:
Skagit County Marine Resources Committee

Prepared by:
Coastal Geologic Services, Inc.
Andrea MacLennan, MS and
Jim Johannessen, LEG, MS

April 24, 2008

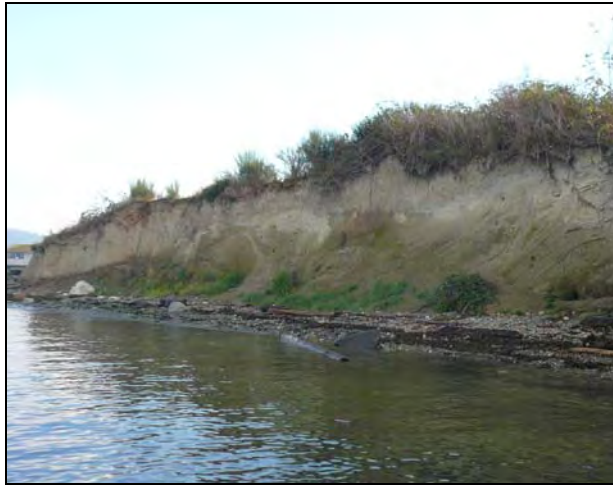
a) Feeder bluff

Figure 2. Photos of representative geomorphic shoretypes for the North Fidalgo study area. Photos a-e are CGS field photos, photo f Department of Ecology 2006 shoreline oblique.

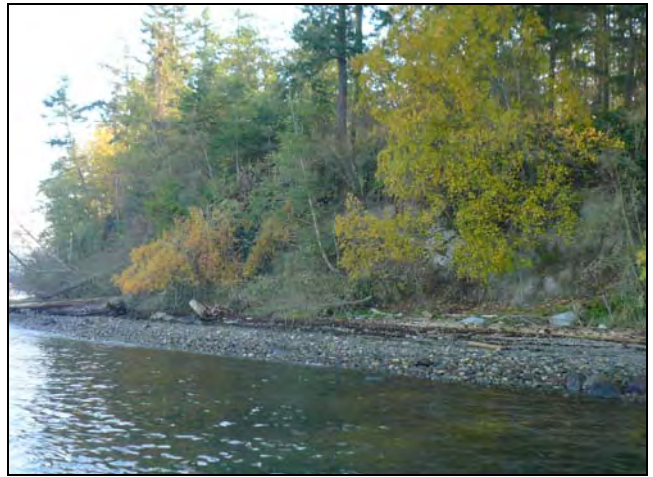
b) Transport zone

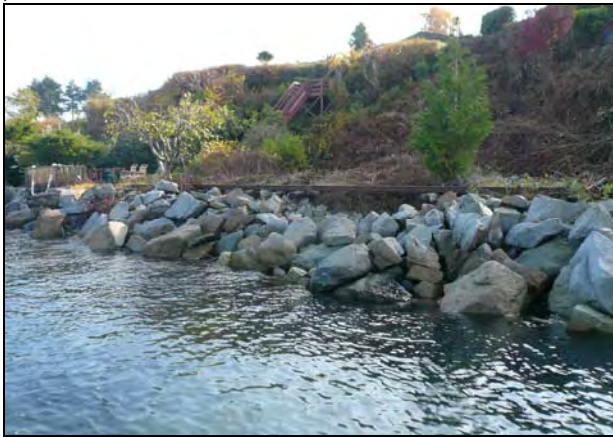
c) Modified by historic rail revetment

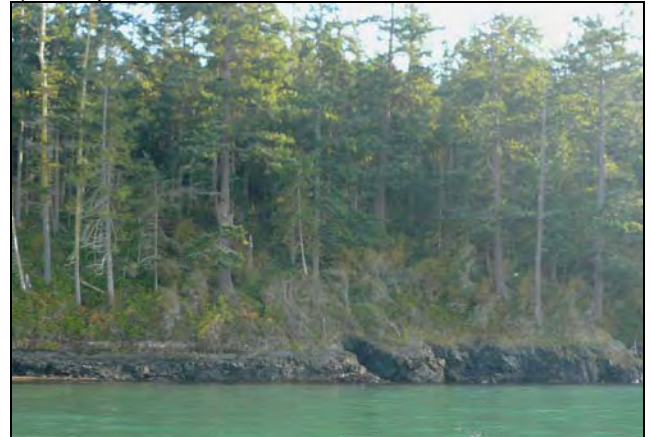
d) No Appreciable Drift

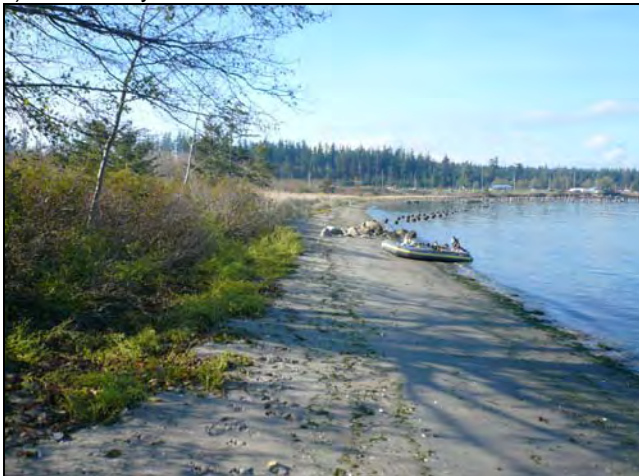
e) Accretion shoreform

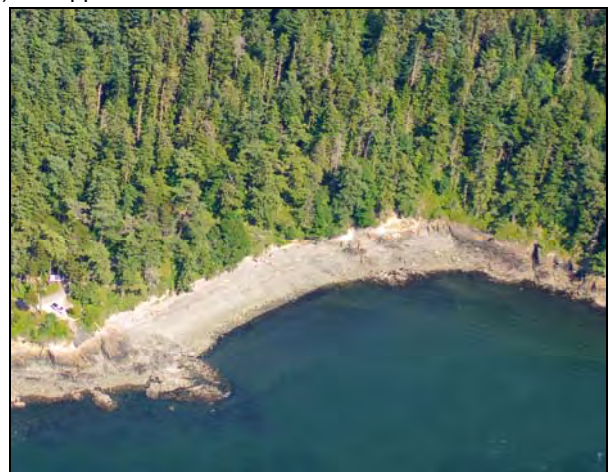
f) Pocket beach

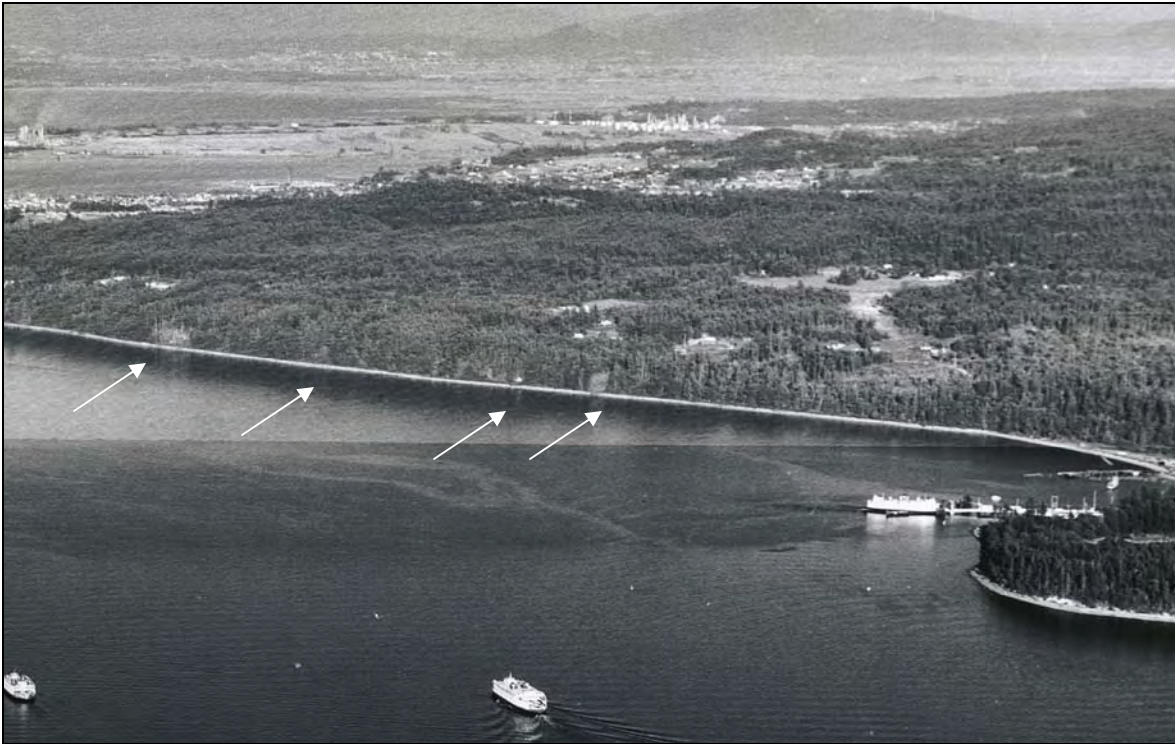
Figure 7. Historic feeder bluffs in cell SK-D-1-5 during 1960s. Feeder bluffs were modified at the time of the photo, however landslides appear to be visible (see arrows). Image courtesy of the Anacortes History Museum. Photo No. 5636.

The large accretion shoreform at Ship Harbor also receives sediment supplied from bluffs to the east. Drift cell SK-D-1-5 was recently mapped by CGS as a historic drift cell that existed prior to the installation of the Great Northern rail causeway, which impounded sediment throughout the cell. All of the historic sediment sources found within this cell are not currently functioning, thus currently drift is mapped as “no appreciable drift”. It should also be noted that the historic sediment sources found within this drift cell were some of the highest-ranking historic or current sediment sources in the entire North Fidalgo Island study area.

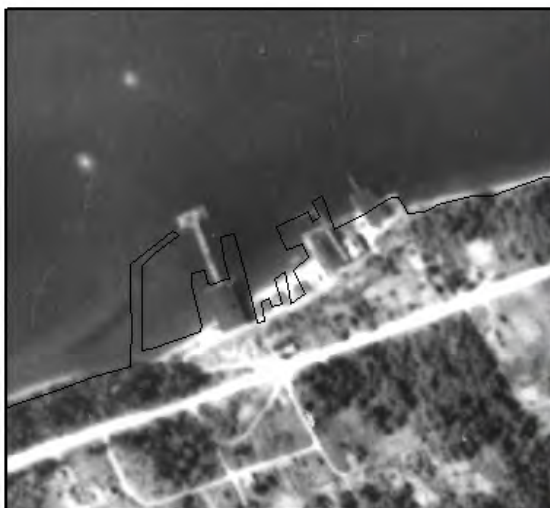
Figure 8. Lovric's boat yard in 1943. Shorezone shoreline displayed in black for reference to current configuration of shoreline (WDNR 2001).

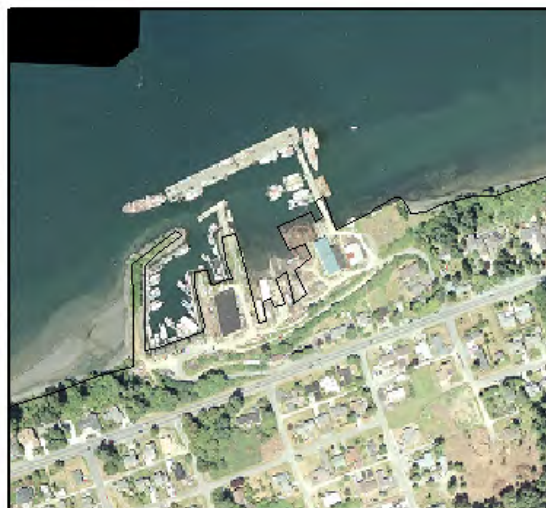
Figure 9. Lovric's boat yard in 2006. Note sediment accumulation west of westerly jetty/breakwater.

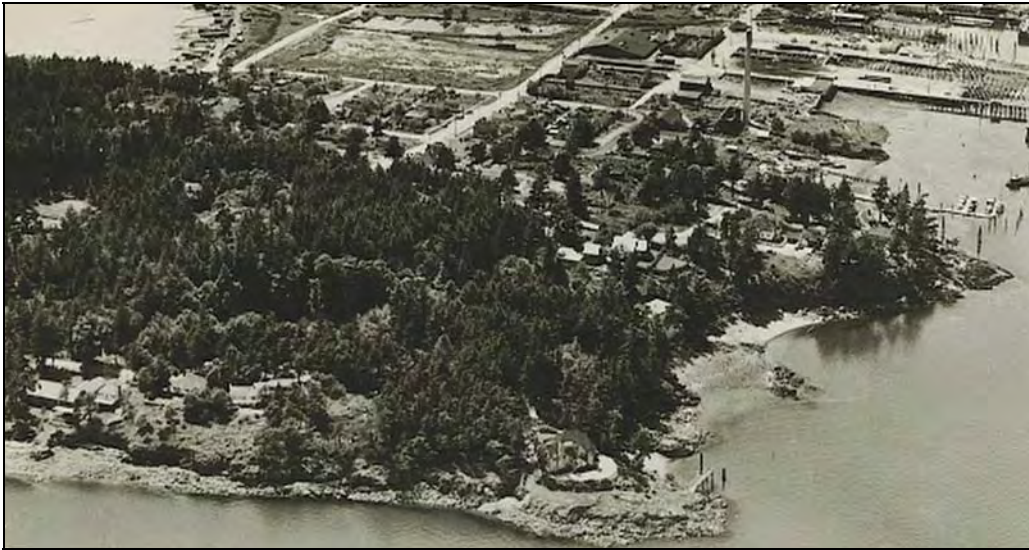
Figure 11. Historic view of Cap Sante shore. Year of photograph unknown. Photo courtesy of Anacortes History Museum. Photo No WF 0288.

SK-D-1-3/SK-D-1-4 is not technically a drift cell, as it is entirely comprised of bedrock shores, with the exception of two very small pocket beaches (representing just 2% of the cell). The bedrock is mapped as metagraywacke (marine metasedimentary rocks) of the Lummi Formation (WDNR – Division of Geology and Earth Sciences 2001). No sediment sources were mapped within this portion of the study area (Figure 11).

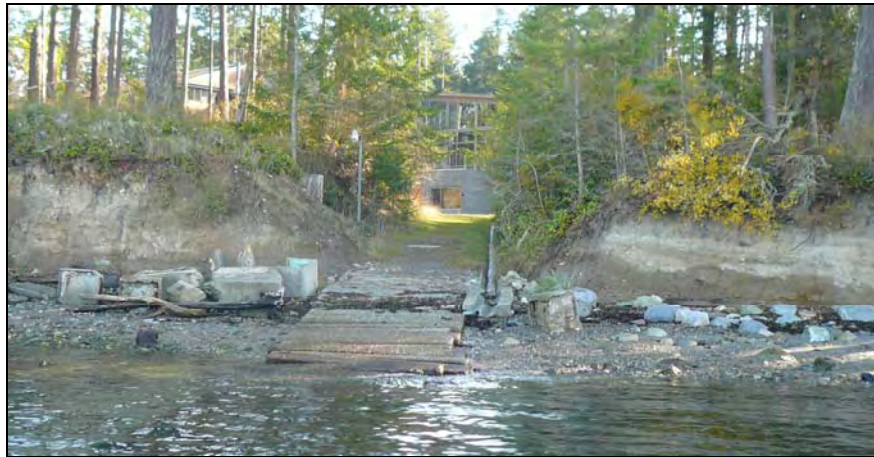
Figure 13. Shore modification unit ID 5, SK-D-2, protecting Shannon Point boat launch.

The two of the three top ranking restorable sediment sources in drift cell SK-D-2 appear feasible and would not likely preclude existing land uses. The top ranking opportunity in the drift cell had the most evidence of active bluff erosion, but measures only 31.5 ft in length. The bulkhead was comprised of concrete and rock and appeared to be constructed to protect the boat ramp at Shannon Point (Figure 13). This armoring likely provides little function as erosion control, as the adjacent bluffs appeared to be actively eroding at the time of the field visit.

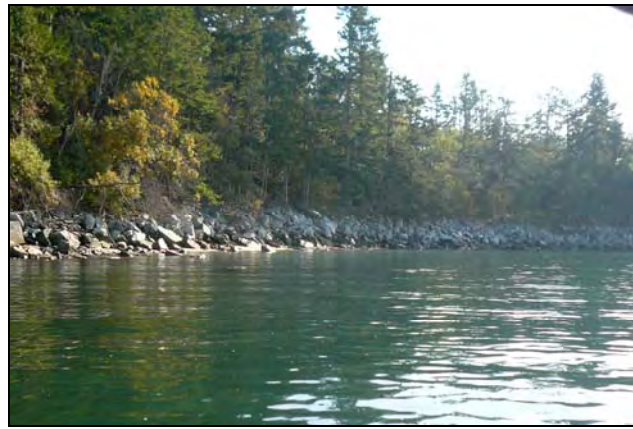
Figure 15. Armored (historic) feeder bluff along Shannon Point shore.

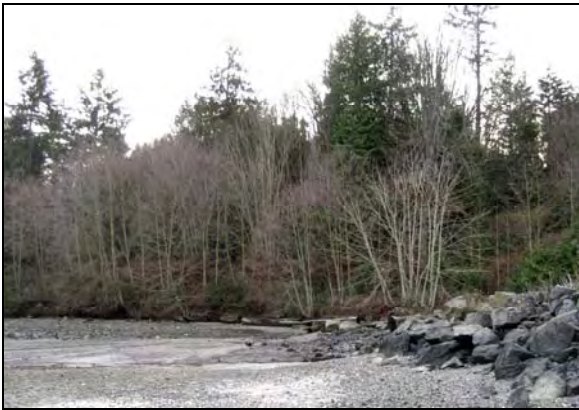
Figure 16. Modified historic feeder bluff along Tommy Thompson trail.

Restoration options within drift cell SK-D-1-1 are also limited by current land uses, or more specifically, the Tommy Thompson Trail. As mentioned earlier, the bluffs that historically supplied sediment to Weaverling Spit are impounded behind the original Great Northern railway revetment that currently functions as the Tommy Thompson trail. It is unlikely that the residents of Anacortes will be amenable to giving up the trail system to restore the cross shore connectivity, which will likely exacerbate the already eroding base of the spit. Erosion of the spit and larger accretion shoreform will progressively worsen under sea level rise conditions without a sediment source to replenish the beach. Continual beach nourishment may be required along the toe of the armoring to maintain beach habitats and the down-drift accretion shoreform. Both surf smelt and sand lance spawning have been documented along this reach of shore such that mitigating for the lost sediment supply should be regarded as a relatively high priority (WDFW 2000).

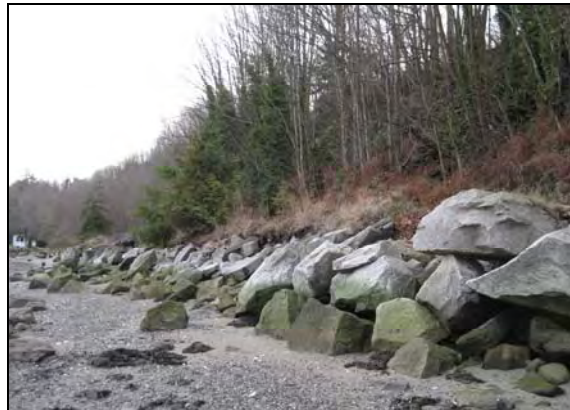
Figure 17. Modified historic feeder bluff along Tommy Thompson trail.

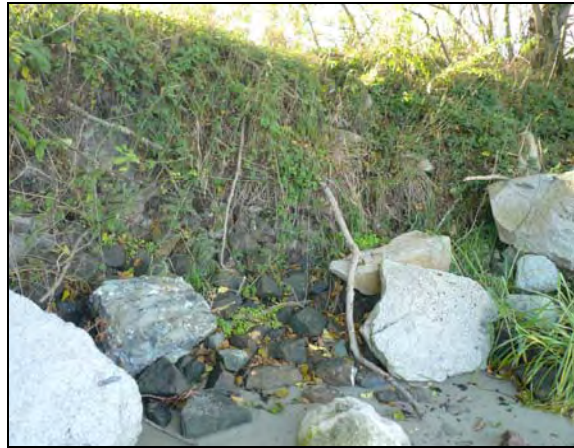
Figure 19. Armoring at base of dike/fill that impounds Cannery Lake wetland.

Cannery Lake, located just west of the Washington State Ferry terminal along the eastern shore of the Shannon Point property, is an intriguing coastal wetland, the historic configuration of which is largely unknown. Research into whether or not this coastal wetland was historically connected to the marine environment was inconclusive. However, the historic T-sheet appears to show a tide channel connecting the embayment to marine waters (on the eastern shore of the embayment, Figure 18) and the bank impounding the wetland appears to be constructed of fill as part of the historic railroad dike/revetment that runs along the North Fidalgo Island shore (Figure 19). Similarly configured coastal wetlands are frequently observed throughout the region however, it is very rare for a naturally occurring bank of moderate height to be observed waterward of a wetland, and the genesis of such a coastal feature is highly questionable. For these reasons and using the best professional judgment acquired from (cumulative) decades of local coastal expertise, it is the preliminary opinion of CGS staff that this “Lake” was originally an estuarine embayment. The restoration of the tide channel seems entirely feasible, though additional research should be undertaken to document and assess its historic condition, the appropriate tide channel configuration, and to determine the approximate tidal elevation to which it should be restored. It is likely that since its impoundment, the sedimentation rate within the wetland has increased due to the absence of tidal flushing.

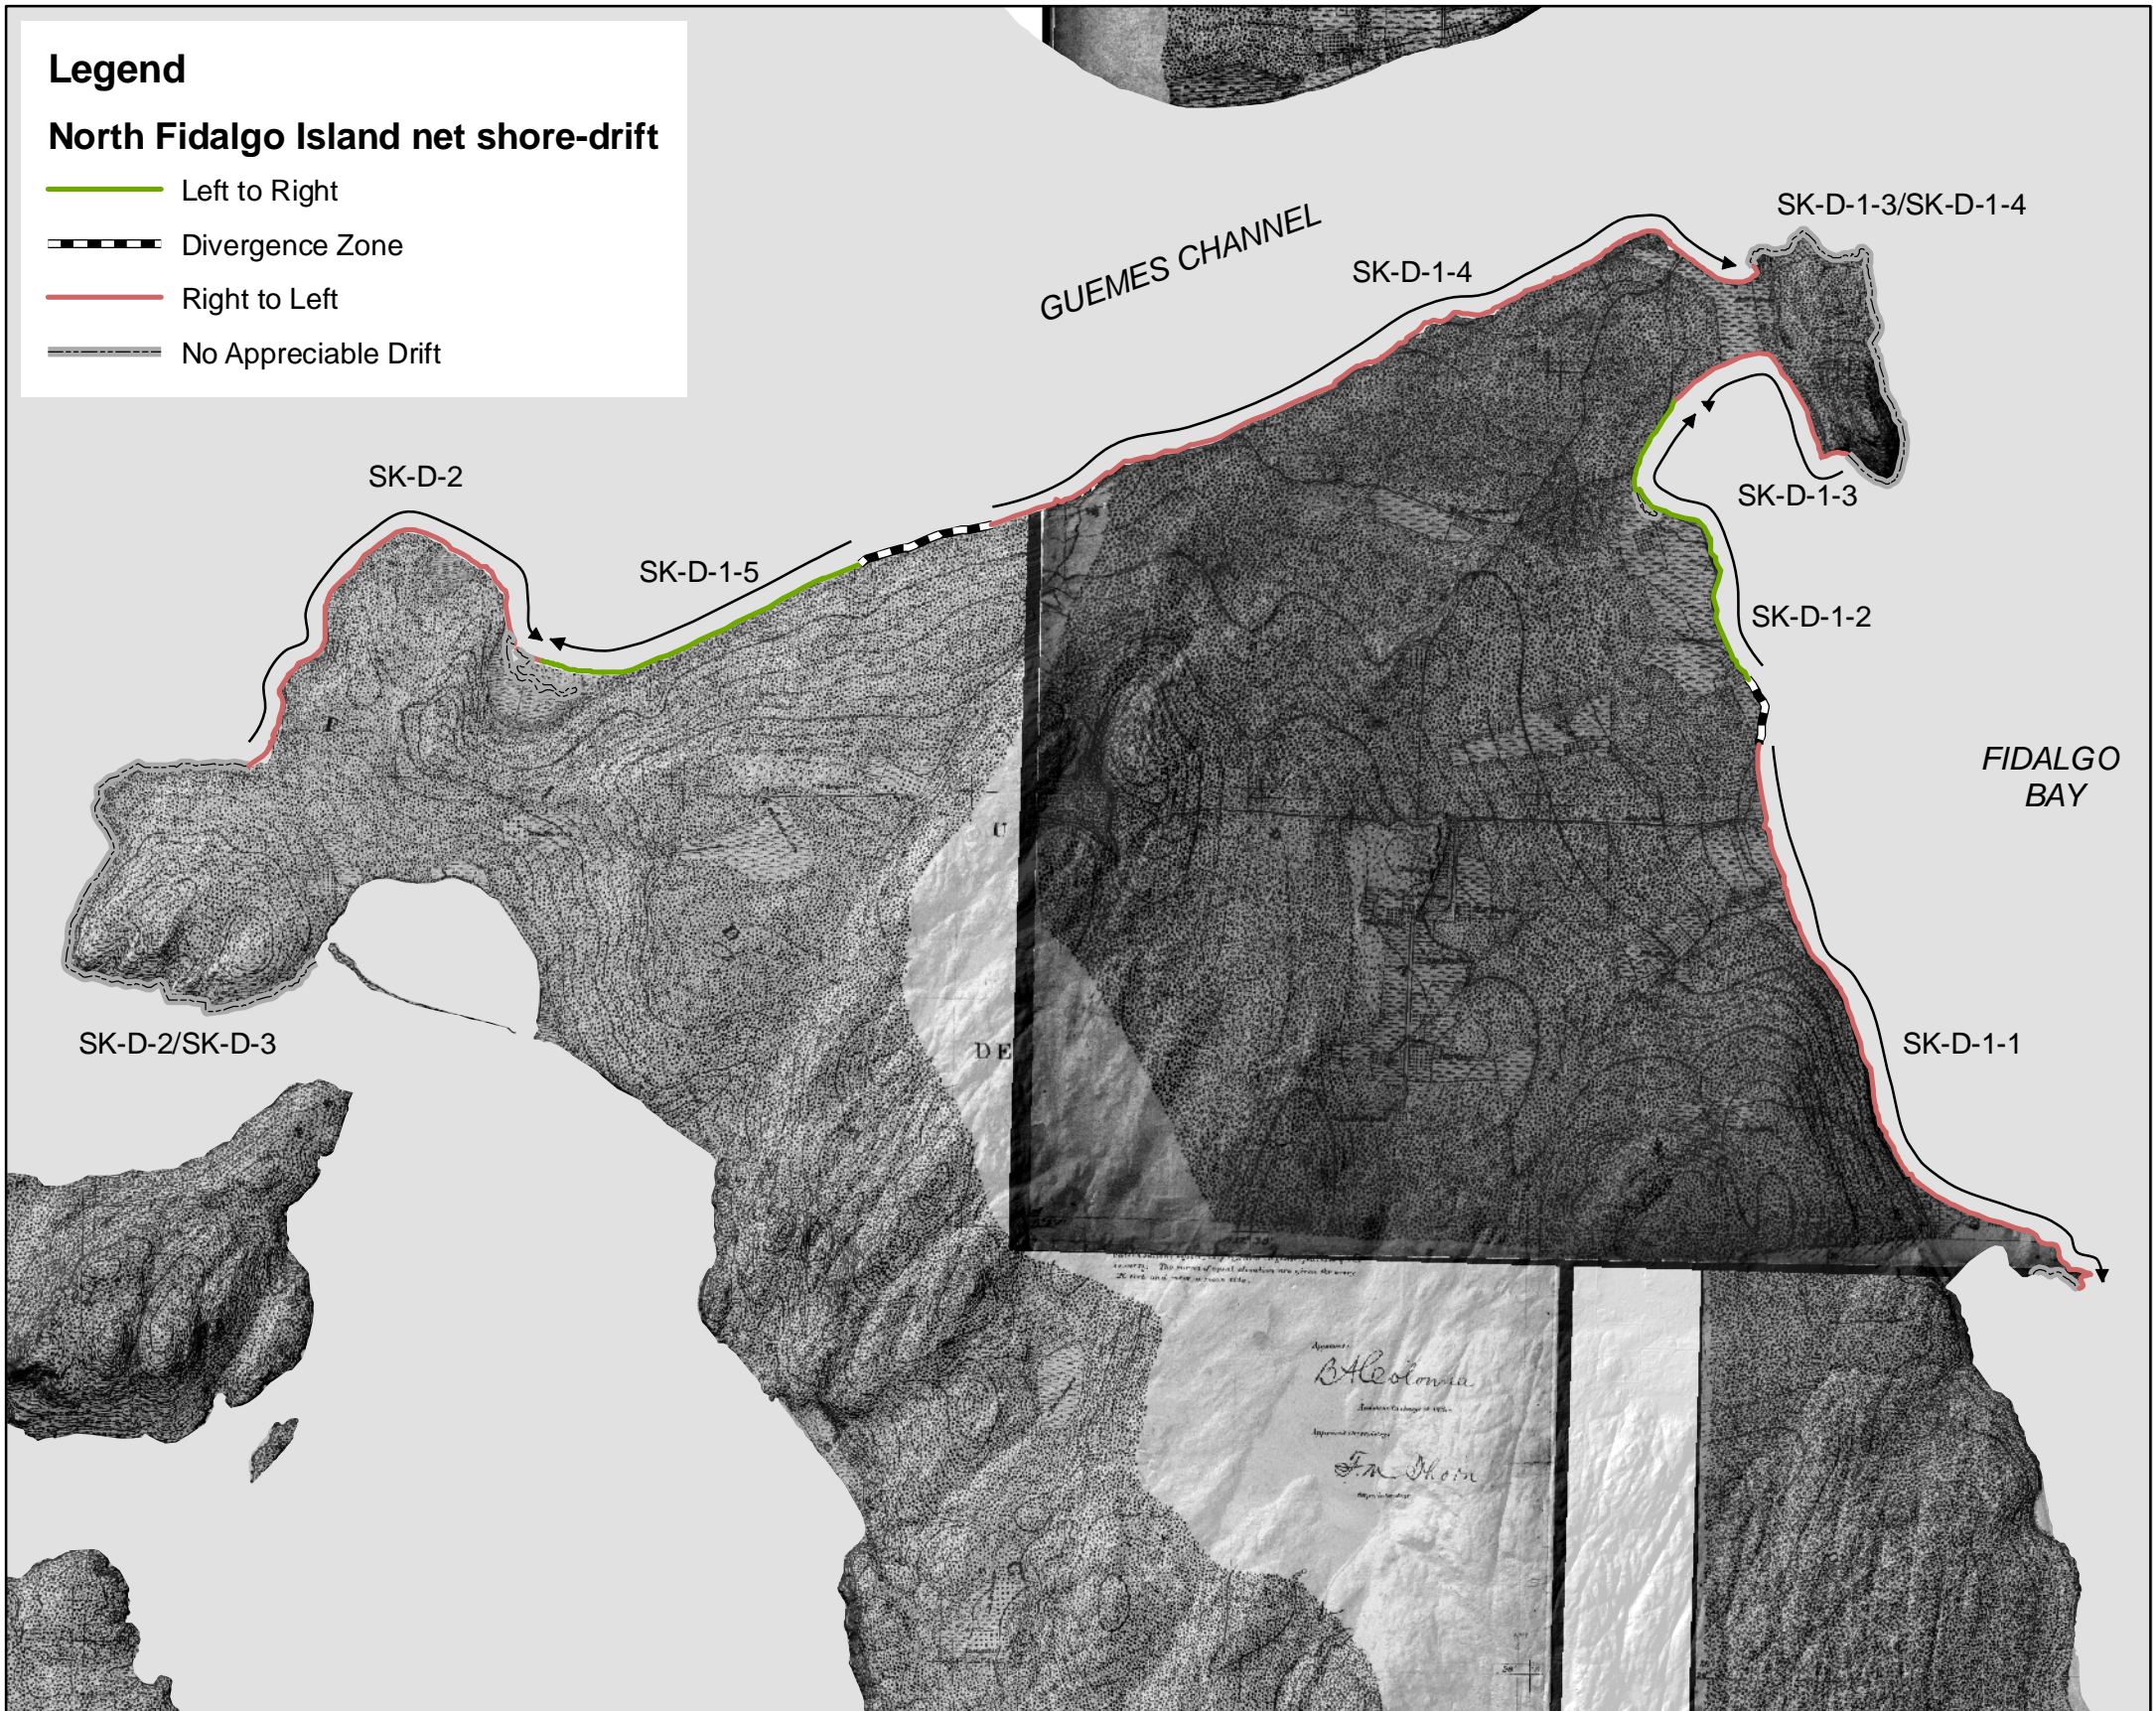
Figure 1b. Historic net-shore drift mapping along the North Fidalgo Island shores.
 North Fidalgo Island Geomorphic Assessment and Drift Cell Restoration Prioritization
 US C&GS T-Sheets with 2006 LiDAR hillshade shown

Based on field assessment methods (Jacobson and Schwartz 1981), previous mapping efforts and air photo interpretation, net shore-drift within the study area was revised by CGS in both its current and historic condition. Historic conditions net shore-drift mapping was originally conducted throughout the Puget Sound region by CGS, as part of a larger team of restoration scientists working for the Puget Sound Nearshore Partnership contracted through the US Army Corps of Engineers. Minor revisions were applied to produce the mapping displayed in Figure 1. Historic conditions mapping was snapped to the historic T-sheet shoreline (interpreted by Collins and Sheikh 2005) where the current shore deviated considerably from its historic position.

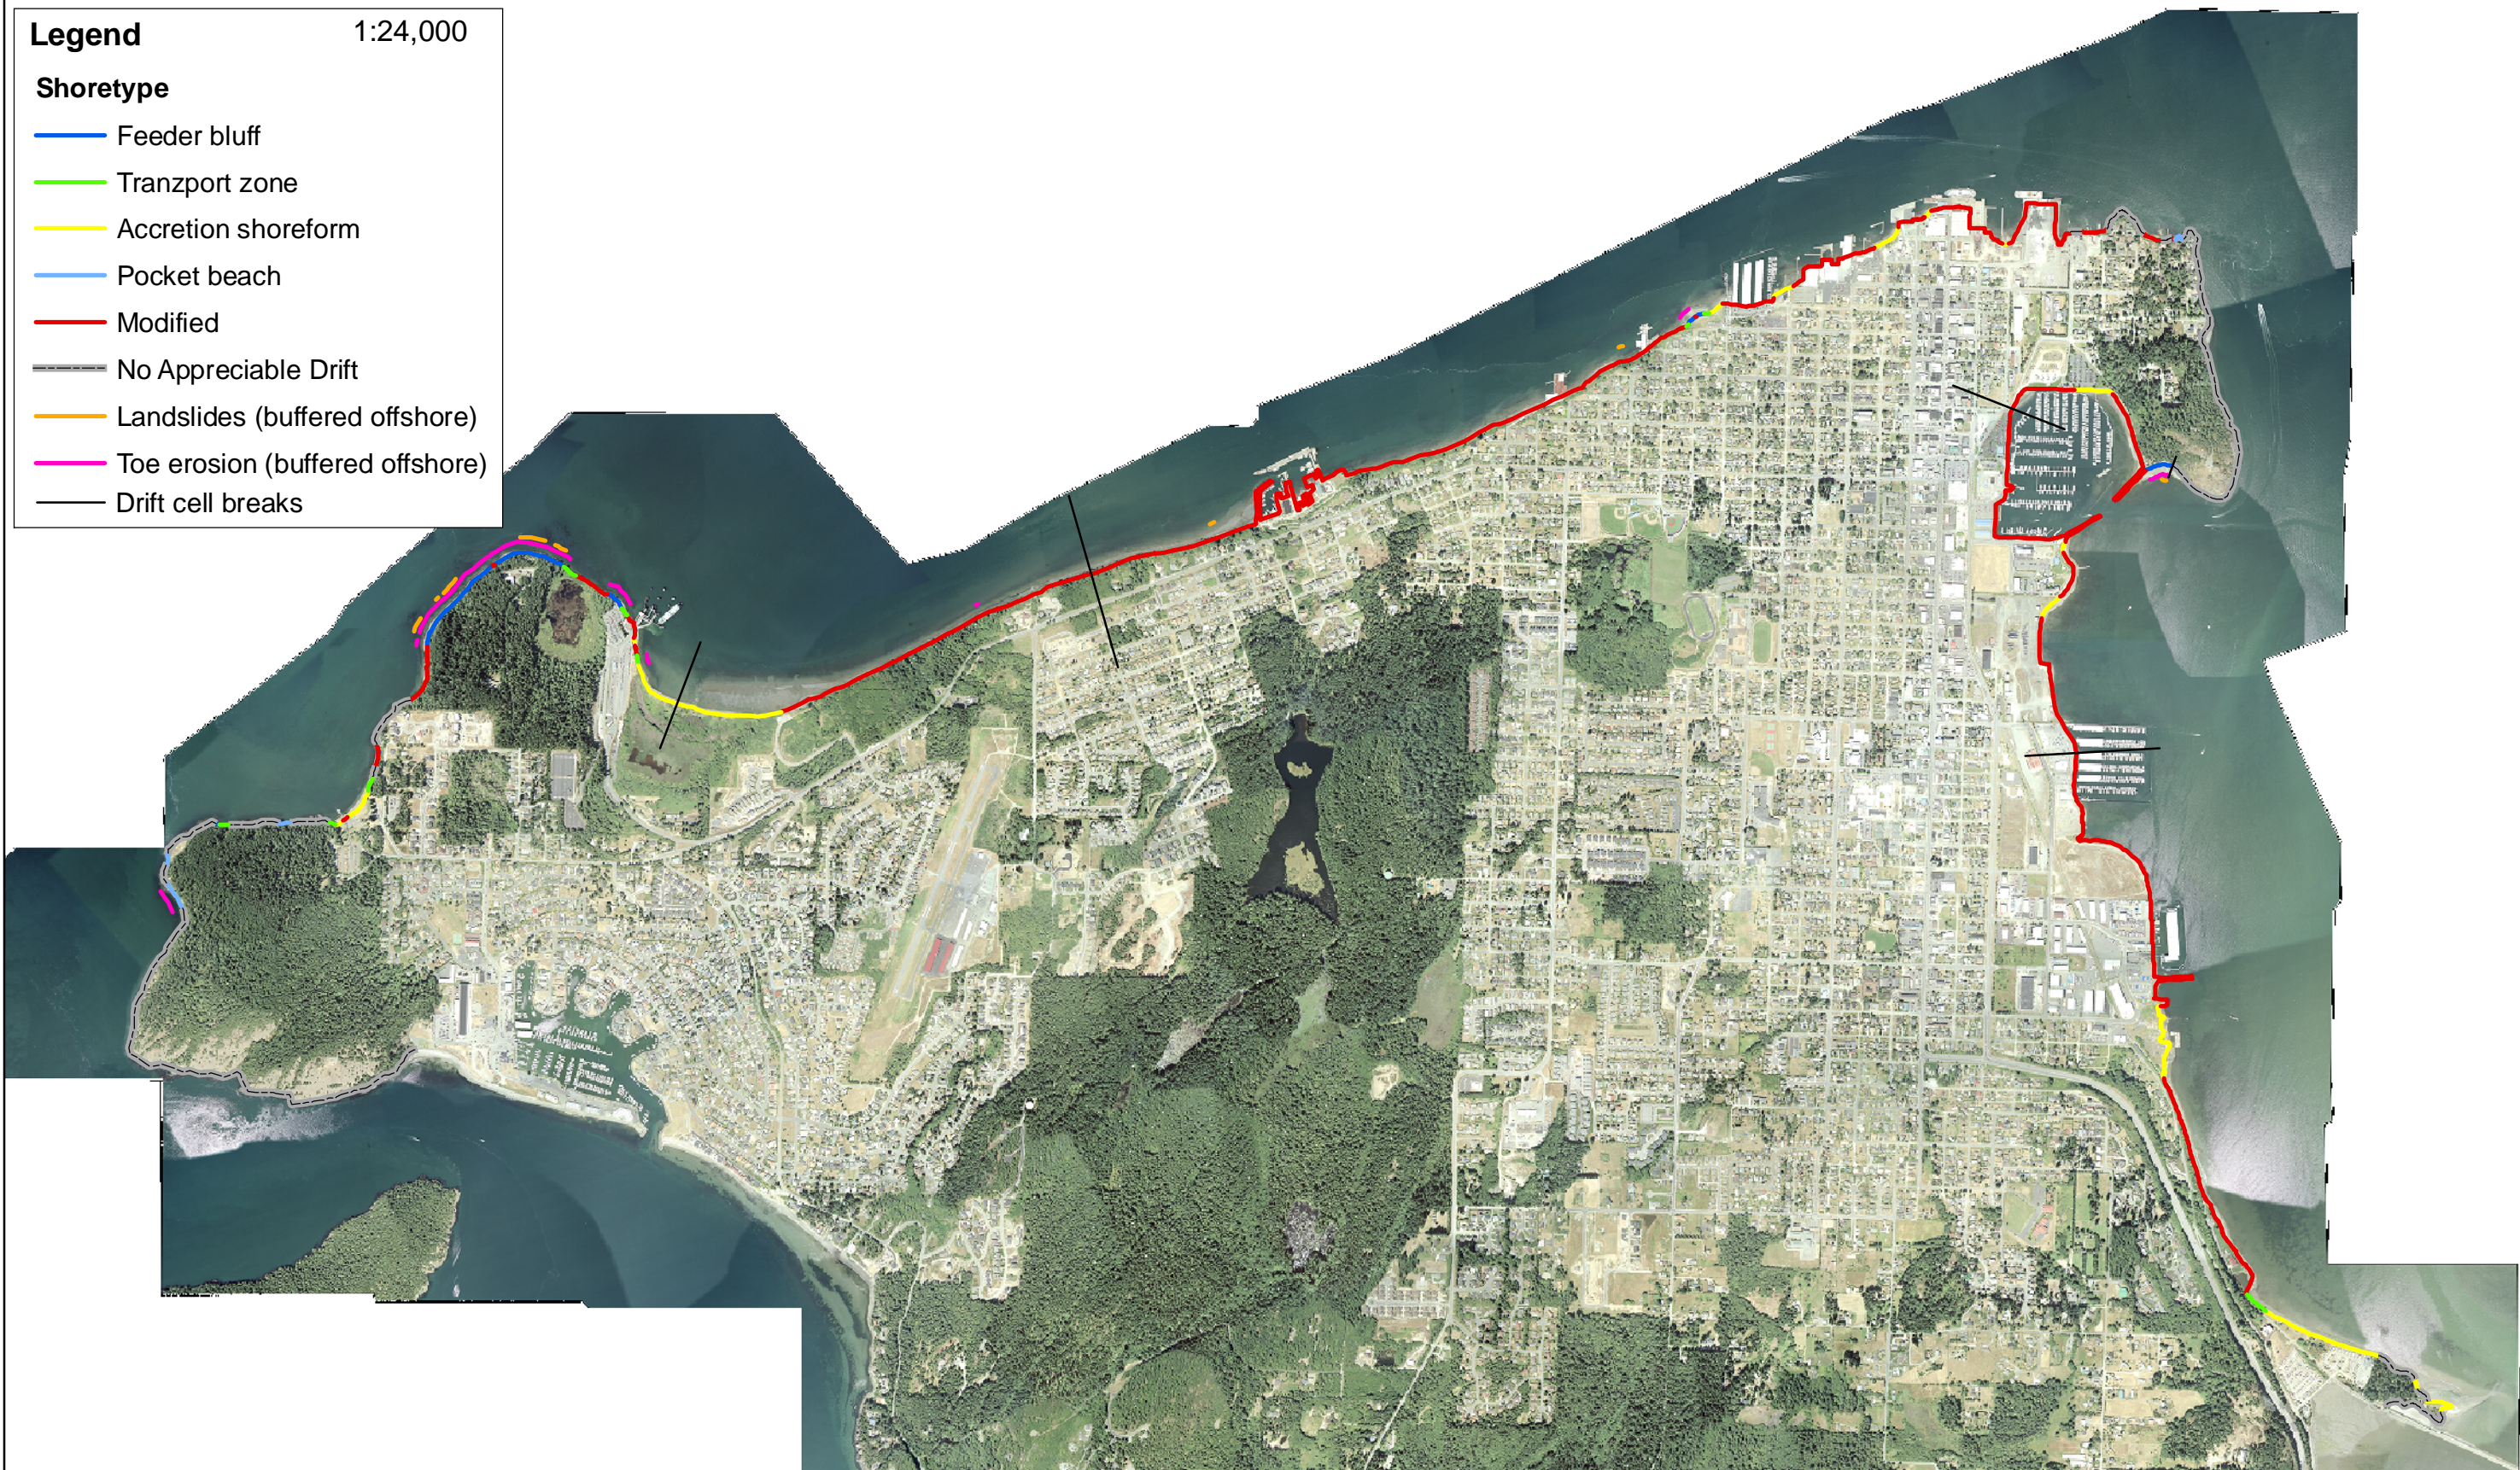
Figure 3. Current geomorphic conditions of the North Fidalgo Island shores.
 North Fidalgo Island Geomorphic Assessment and Drift Cell Restoration Prioritization
 2006 Skagit County orthorectified vertical air photo

The distribution of the shoretypes that make up each drift cell varied considerably across the study area. Sediment sources or feeder bluffs cumulatively made up only 5% of the study area in its current condition and were most abundant along the northwest shores of the study area near Shannon Point. Accretion shoreforms were scattered throughout the study area, cumulatively representing 13% of the area. Landslides and toe erosion were uncommon and were observed most frequently within the feeder bluffs surrounding Shannon Point. Detailed results of current conditions geomorphic mapping can be found in Table 8 and Figure 3.

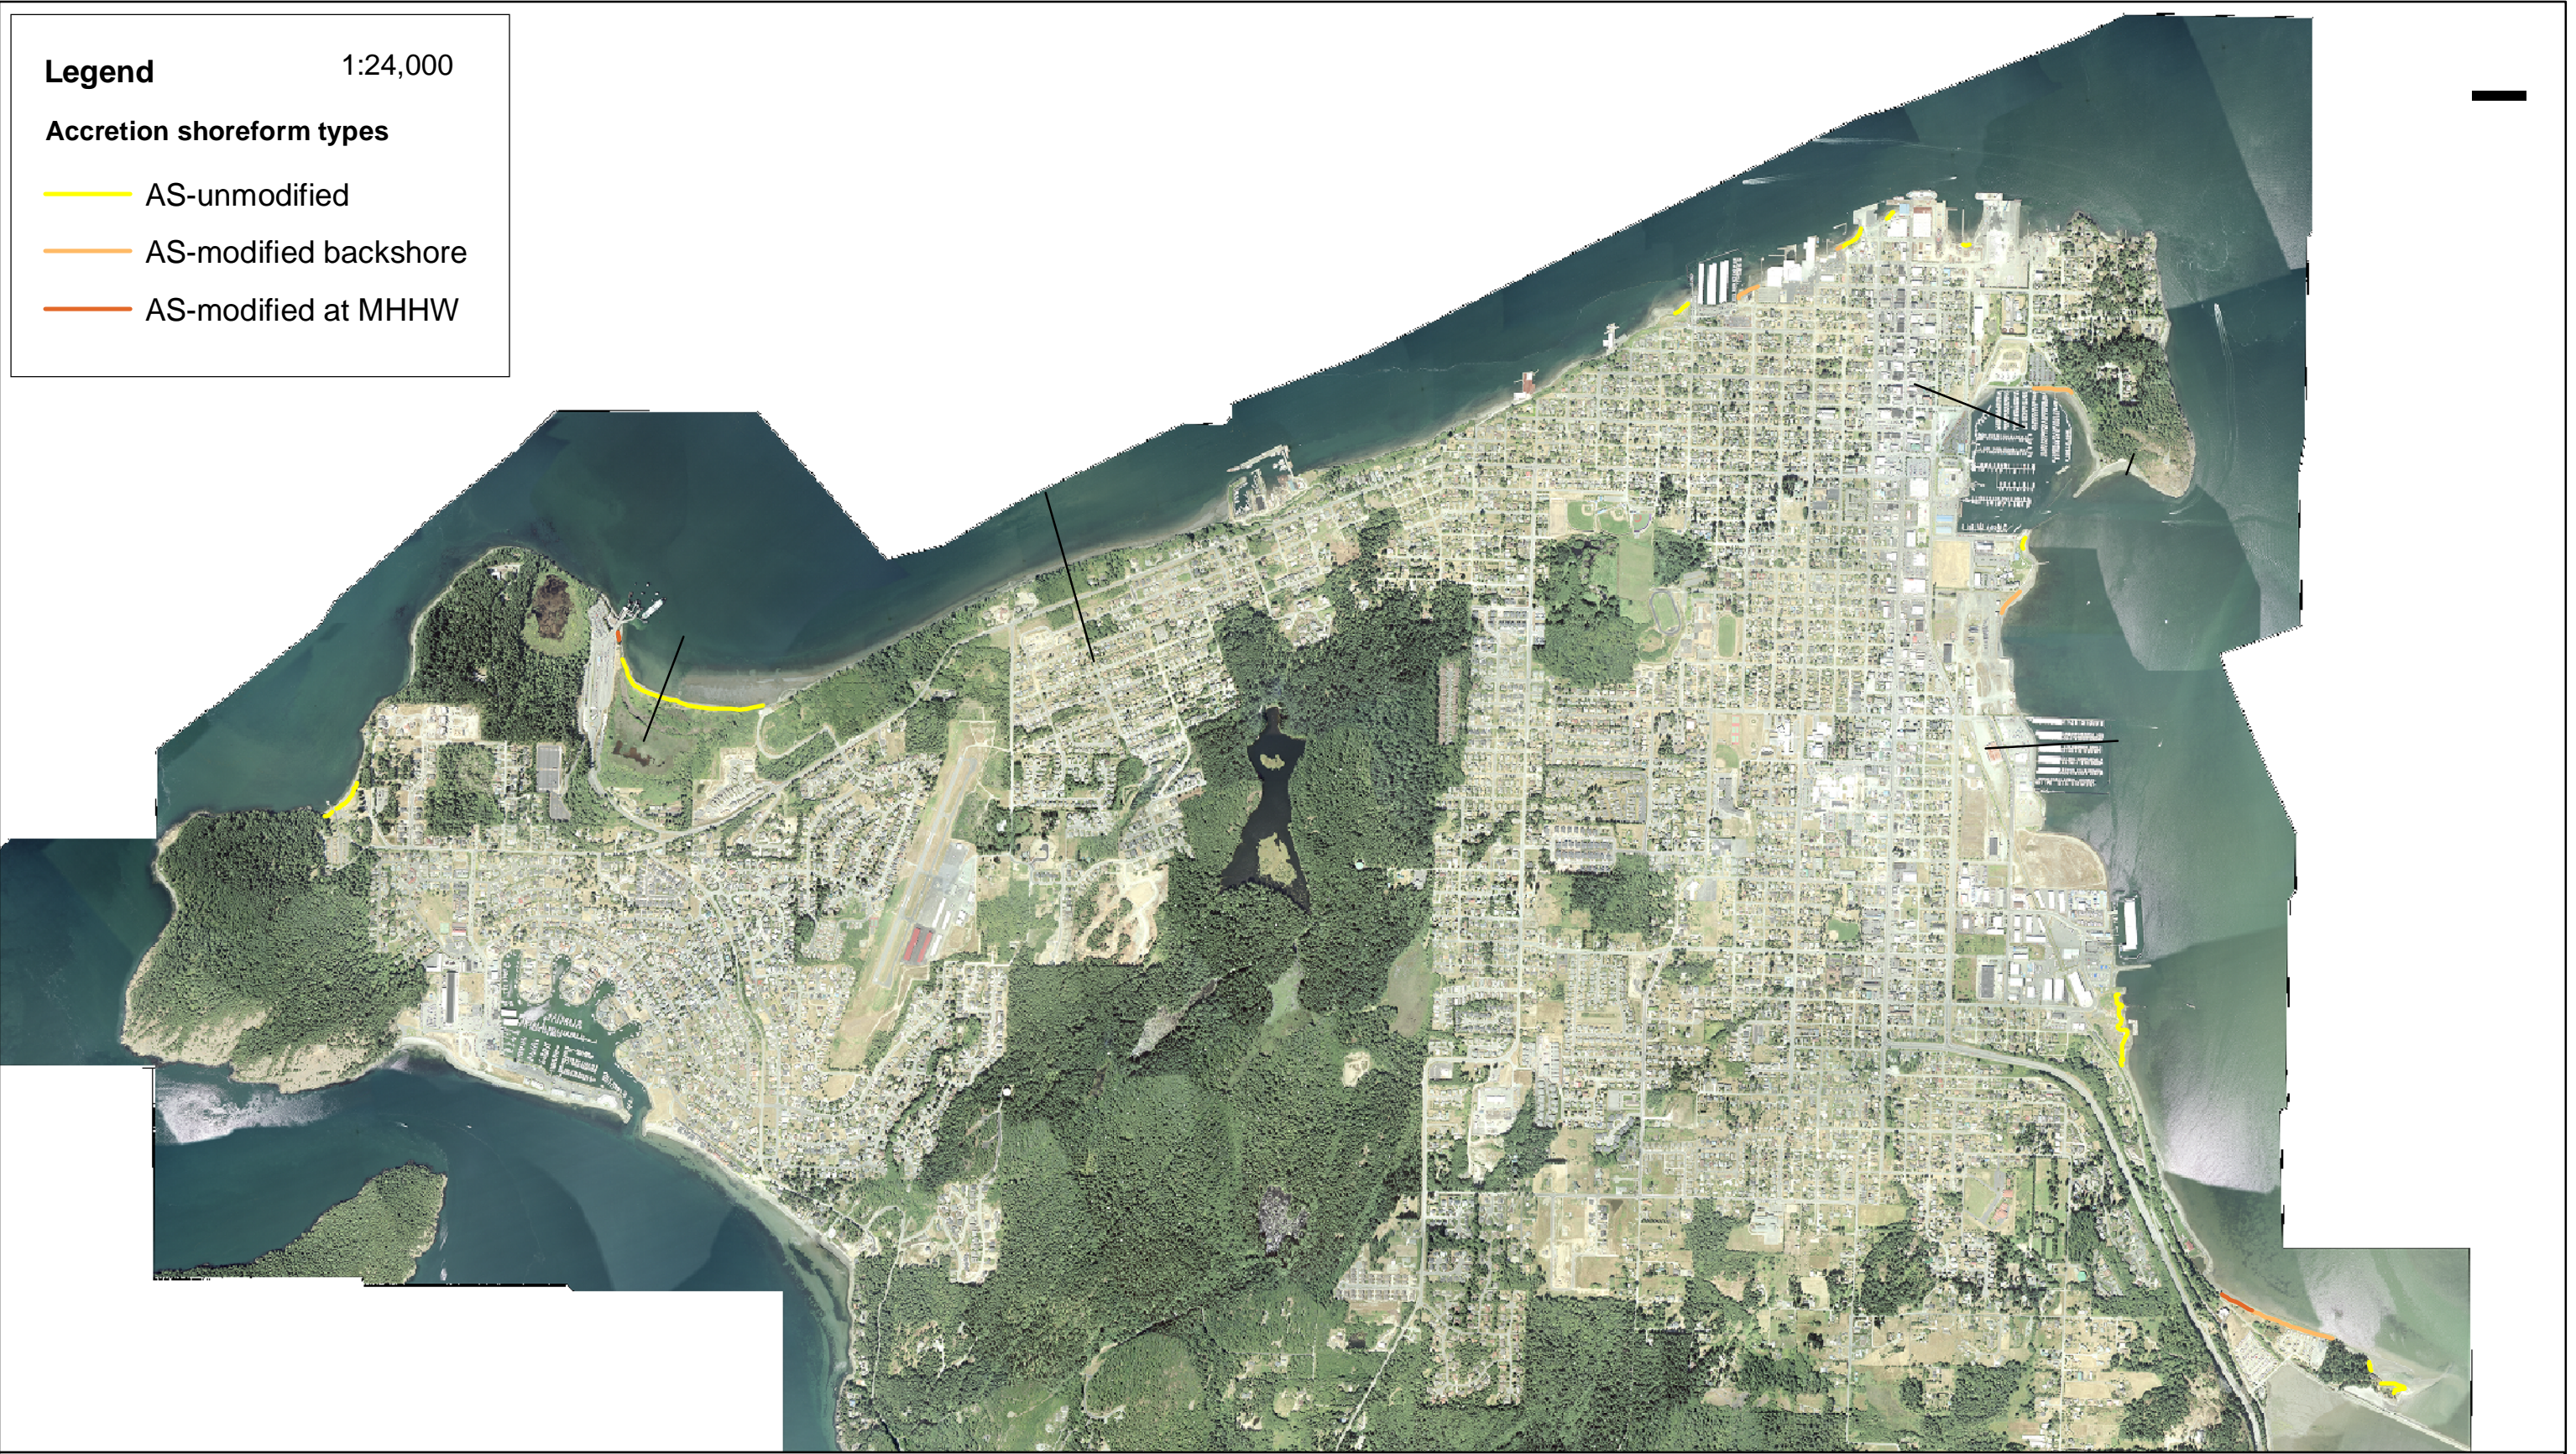
Figure 5. Modified accretion shoreforms elevation classes along the North Fidalgo Island shores.
