Investigation into the Historic Status of Cannery Pond and its Potential as a Future Pocket Estuary

Paul Dinnel and Hanna Seyl
Shannon Point Marine Center,
Western Washington University

PROJECT TITLE: Investigation into the Historic Status of Cannery Pond and its Potential as a Future Pocket Estuary

DELIVERABLES FOR TASK NO: 8, Investigation of Cannery Pond for Possible Restoration as a Pocket Estuary

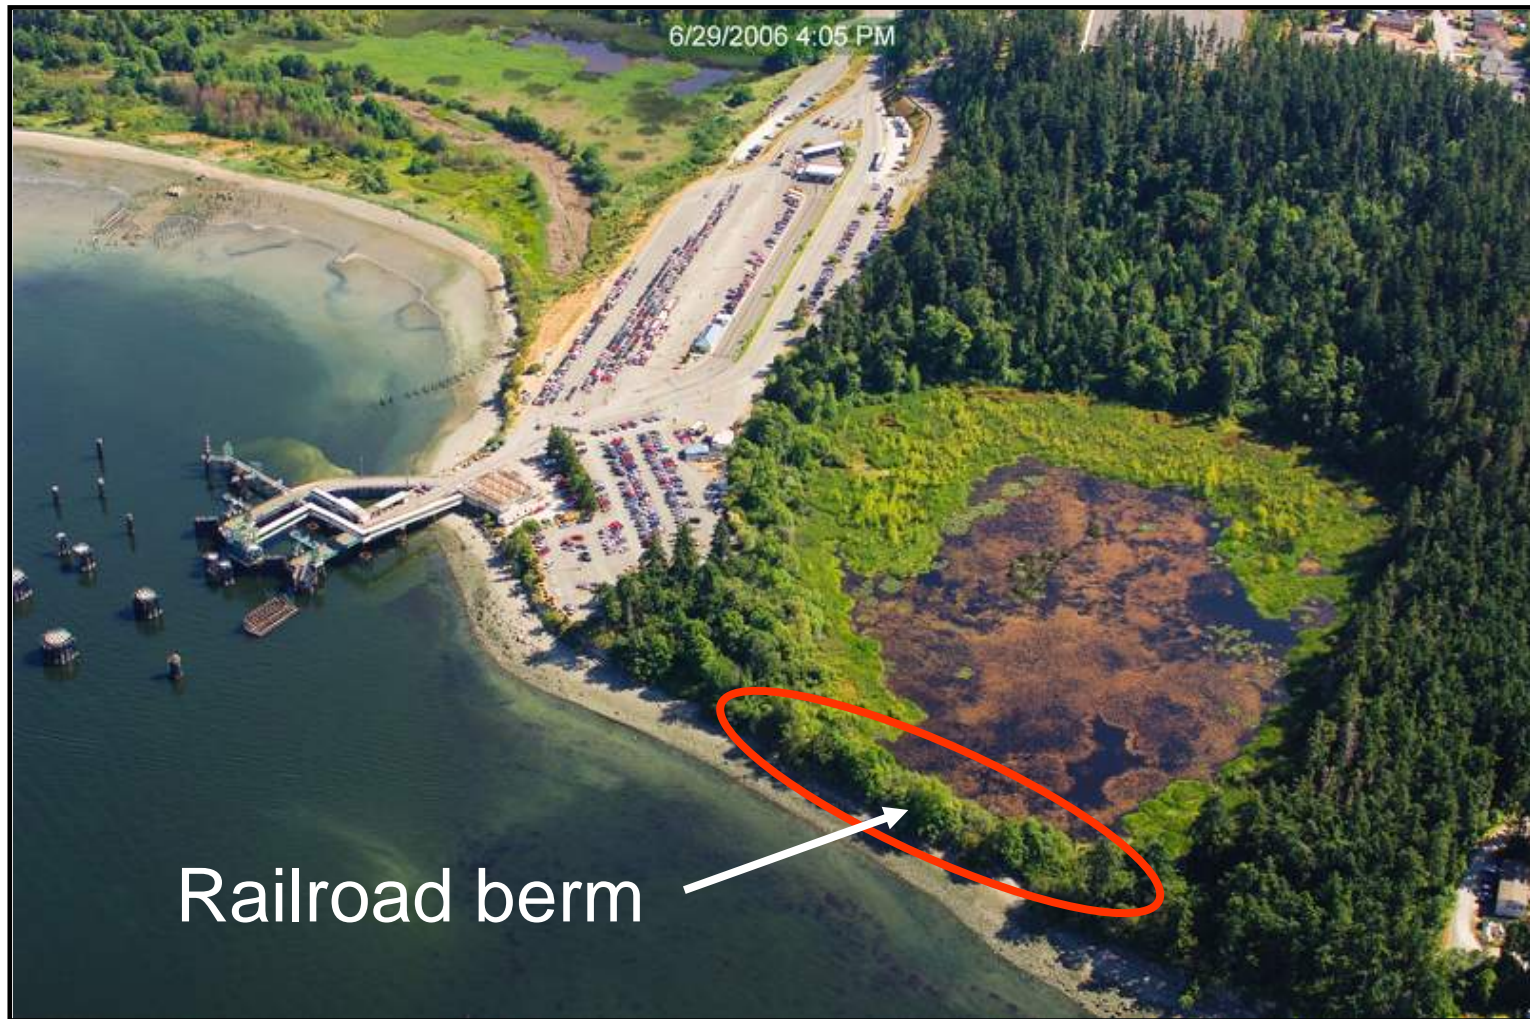
Figure 2. Overhead view of Cannery Pond situated between the Anacortes Washington State Ferry Terminal (left) and the Shannon Point Marine Center laboratories (lower right). The red oval shows the area where the shoreline was filled in 1891 to support railroad tracks running from Anacortes to Burrows Bay. Source: WDOE Shoreline Photo.

In 1891, a berm was built by the Burlington Northern Railway on the northern perimeter of the pond along Guemes Channel (Fig. 2). The base of the berm was built approximately at the Ordinary High Water Line (OHW), and varies in height between 3-5 m. There are historical remnants of railroad track running along the top of the berm, which is approximately 3 m across. The remaining boundaries on the northwest and southwest sides of the pond are dense forest areas primarily consisting of secondary growth, shrubs and wetland species, all of which lie within the Shannon Point Marine Reserve.

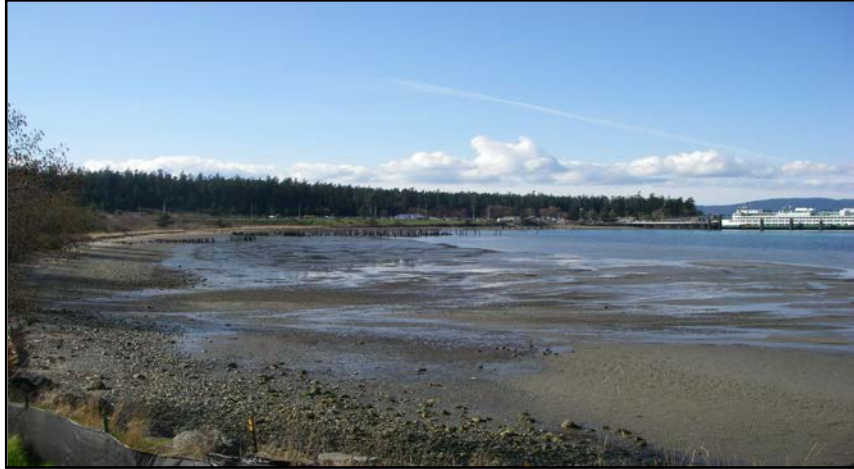
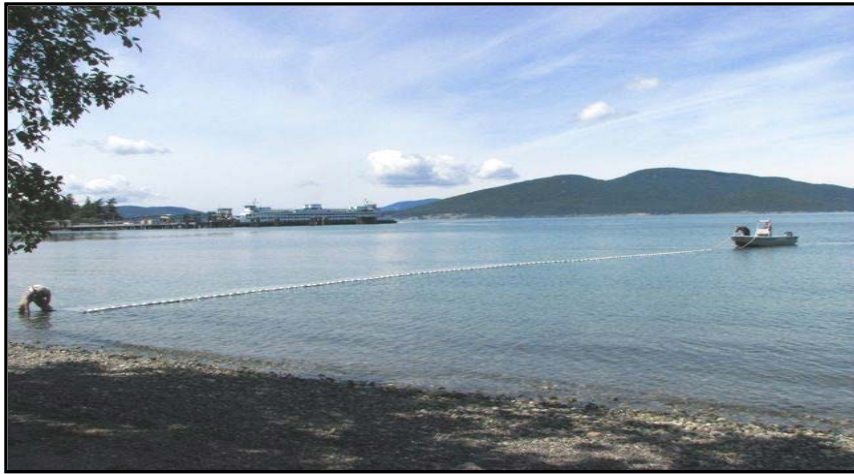
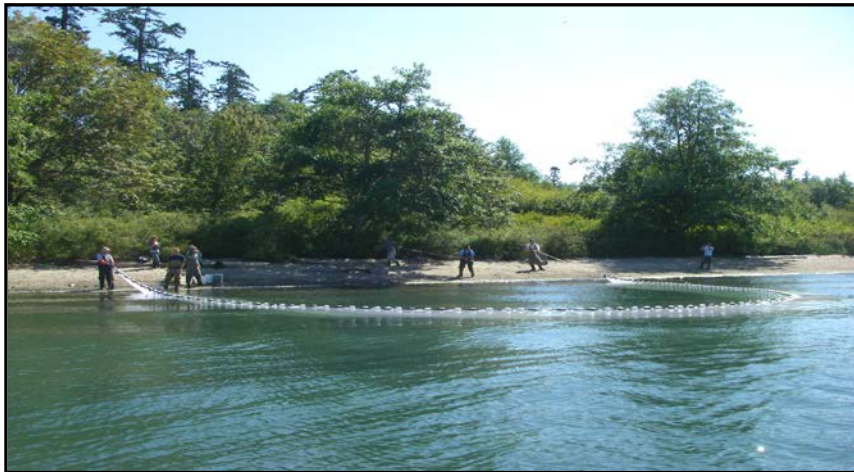
Figure 6. Photographs of the beach seine sampling at Ship Harbor (top). The middle photo shows the net set perpendicular to the shoreline (for four minutes) after which it is “pursed” and retrieved by volunteers on the shore (bottom).

The lines were then pulled by multiple hands to bring in the net. The net pulling speed was monitored in order to limit any fish escape, net flipping and loss of lines. The top line was pulled in somewhat faster than the bottom line, creating a billowing effect within the net. Both ends of the line were then brought together creating the purse effect. Once the purse was at a reasonable size, the area within the net was cleared of seaweed and other debris in order to find the fish better. Buckets filled with seawater collected at the site were then used to hold the fish that were found within the net. Once the net was clear of all fish, it was aligned once again for another sample run.

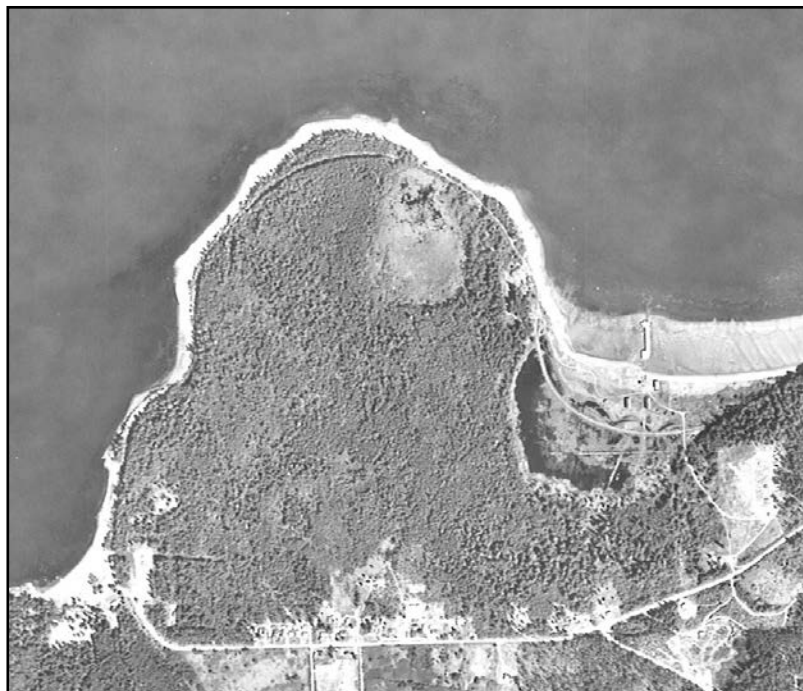
Figure 8. 1956 photograph of Cannery Pond, which shows the remnants of the railway line constructed through Ship Harbor and around Shannon Point in the late 1800s. Source of the photograph is unknown.

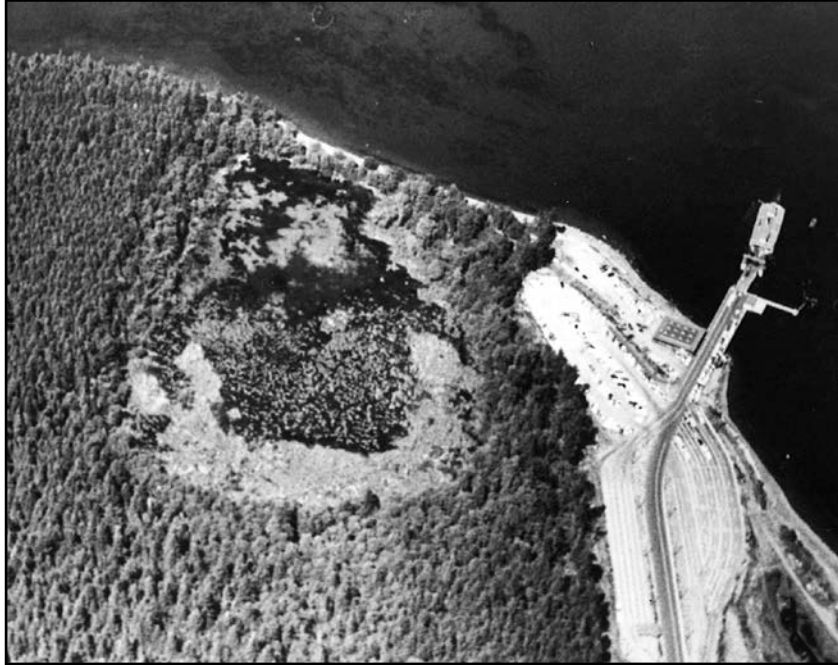
Figure 9. 1970 photograph of Cannery Pond showing the recent construction of the San Juan Island Ferry Terminal between Shannon Point and Ship Harbor. Source unknown.

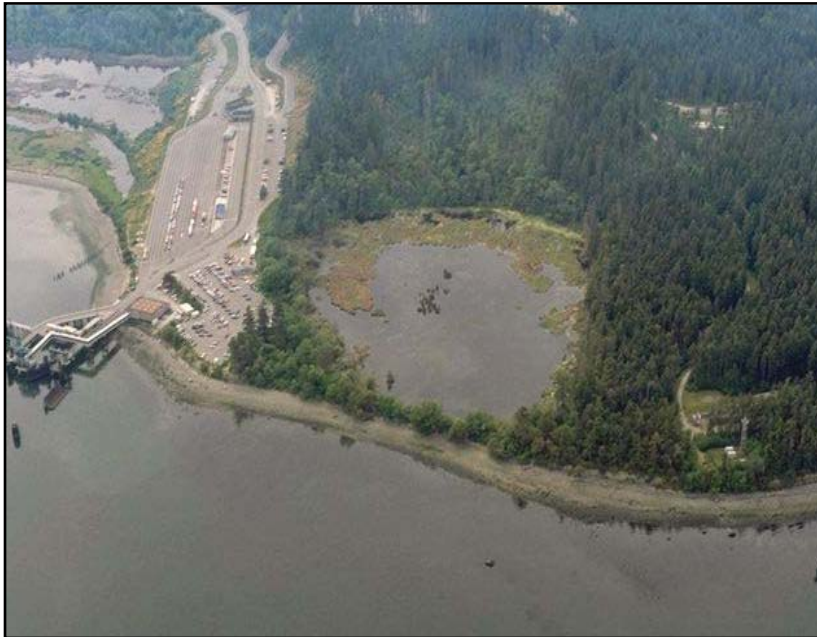
Figure 10. 1994 photograph of Cannery Pond showing an expanded San Juan Island Ferry Terminal. Source unknown.

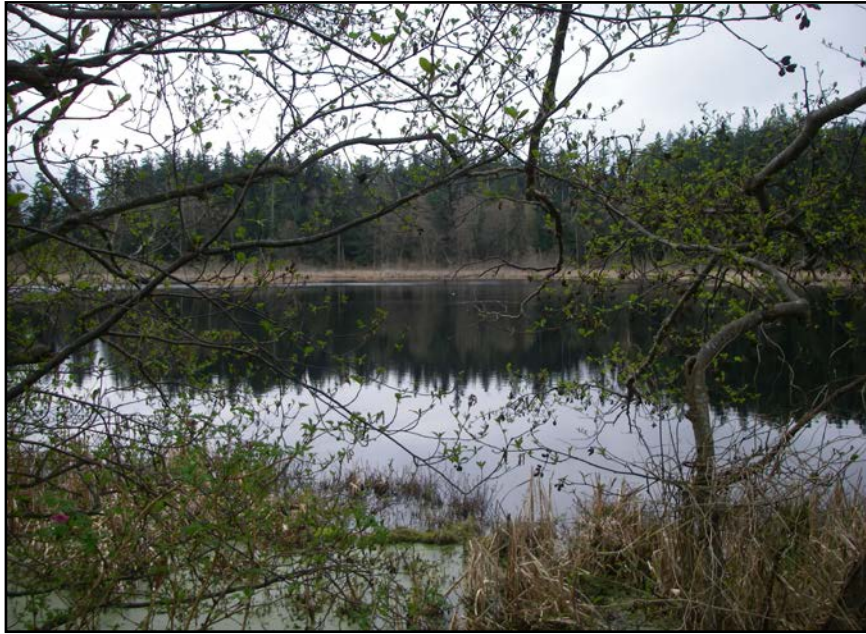
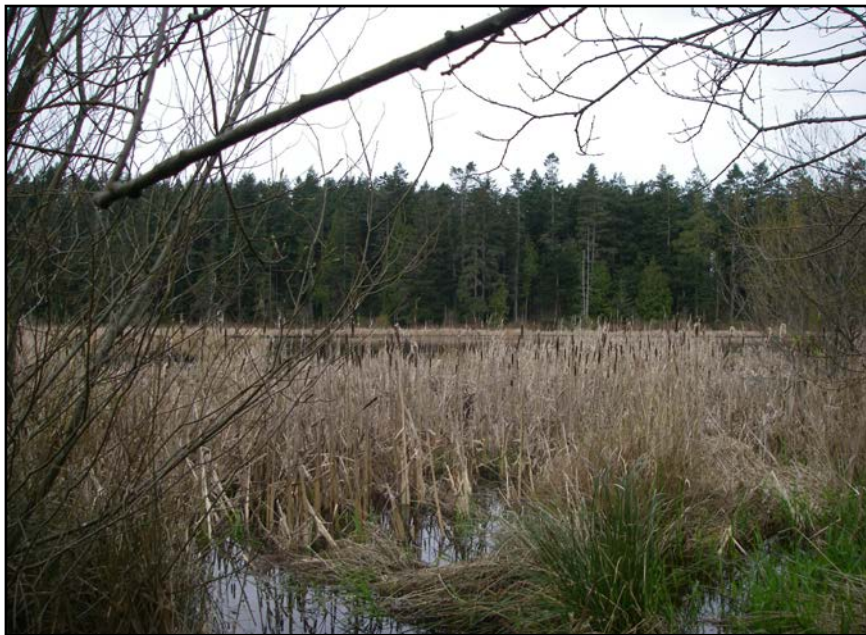
Figure 14. Photographs of Cannery Pond showing the central open portion of the pond (top) and the floating mats of vegetation dominated by cattails along the northern portion of the pond (bottom).

The central portion of the pond is generally open water (with seasonal algal mats present), with floating vegetative mats extending along the southern portion of the pond (Fig. 14). The mats are dominated by cattails and have smaller shrubs such as coontail, pondweed, duckweed, and mats of blue-green algae (Parsons 1997). The cattails also form smaller mats that are interspersed on and submerged under the lake surface. Clusters of lily pads are present along the eastern portion of the pond. Students also conducted surveys of the buffer area around the pond and found that tree species included red alder (*Alnus rubra*) and cottonwood (*Populus balsamifera*) (WWU 1999).

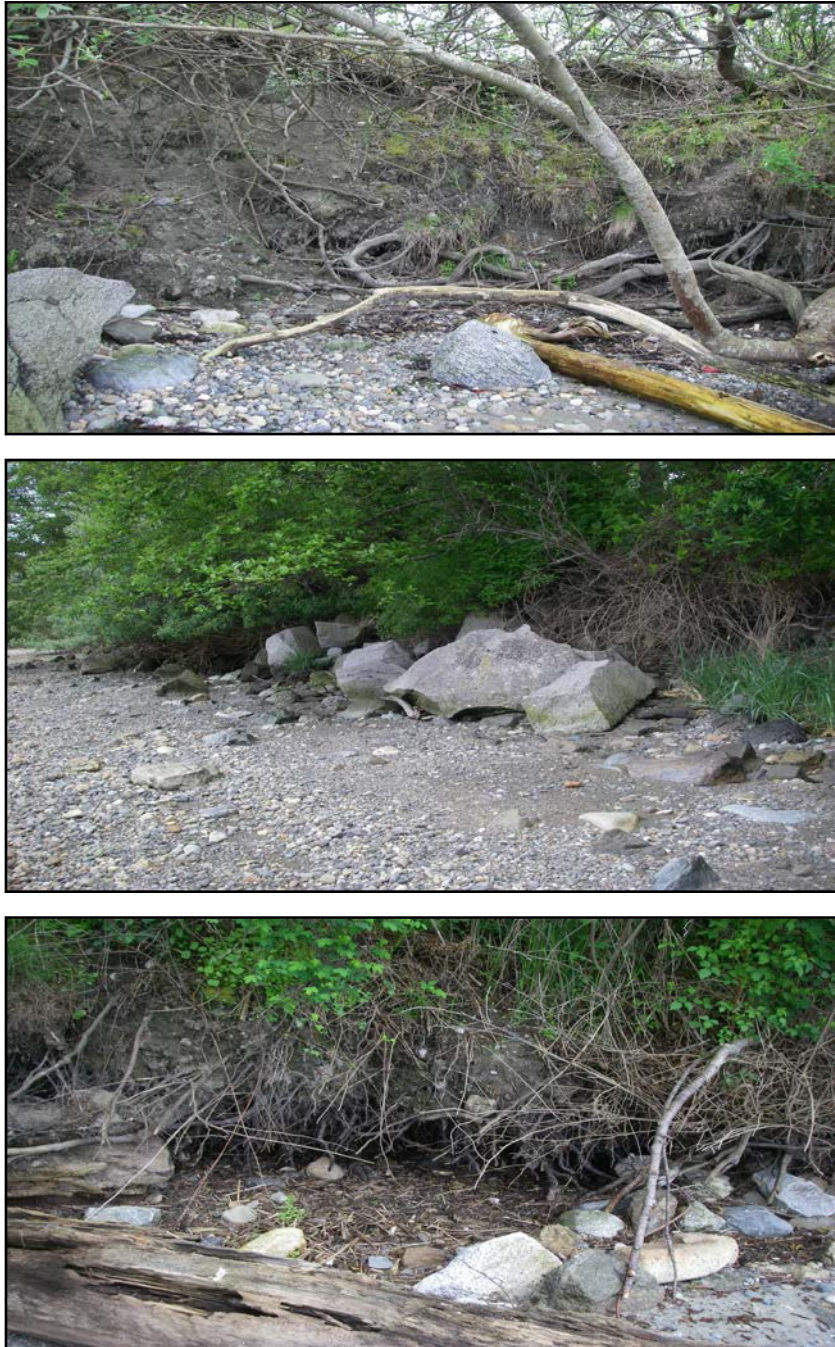
Figure 16. Series of photographs of the Guemes Channel side of the railroad berm showing the unconsolidated nature of the filled area that has been eroded as much as 3-4 meters in places (top), the presence of some riprap (middle) and undercutting of the berm caused by wave action (bottom).

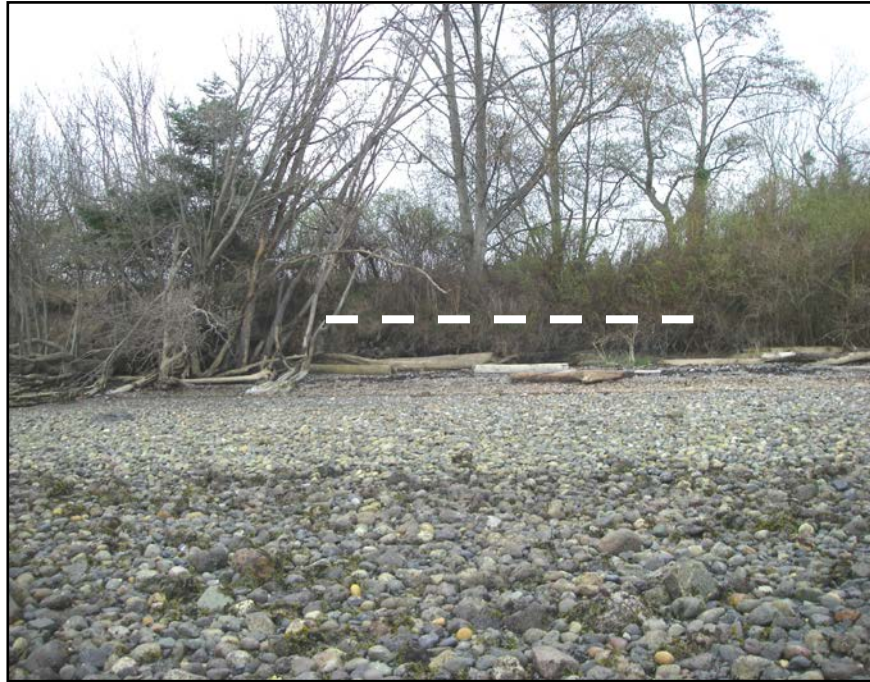
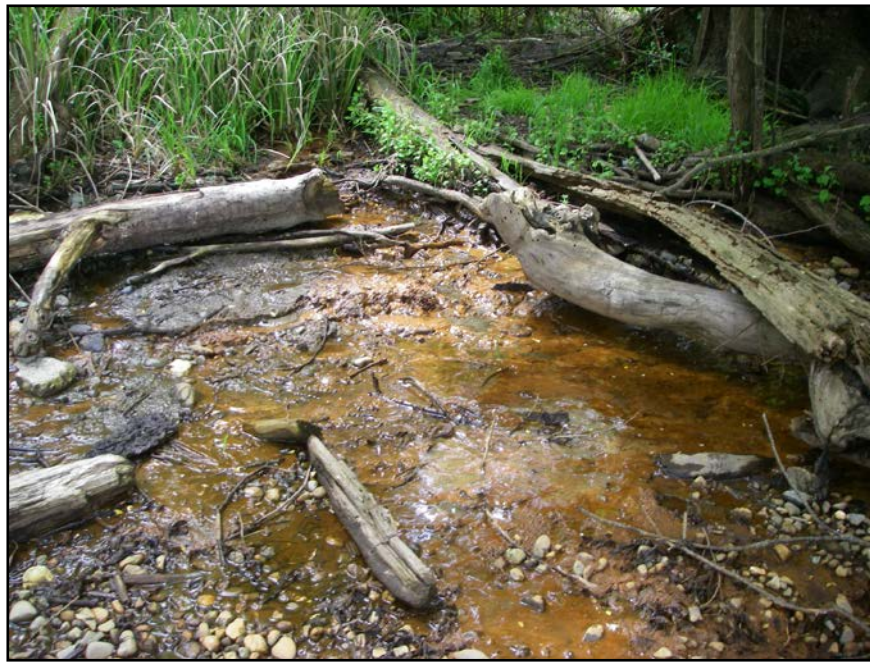
Figure 18. Guemes Channel side of the railroad berm (top) showing the approximate water level (about 1 meter above the upper shoreline -- white dashed line) in Cannery Pond behind the berm. The bottom photo shows an area of seepage through the berm on the west end of the fill area. Seepage was estimated at about 1 to 2 liters/minute.

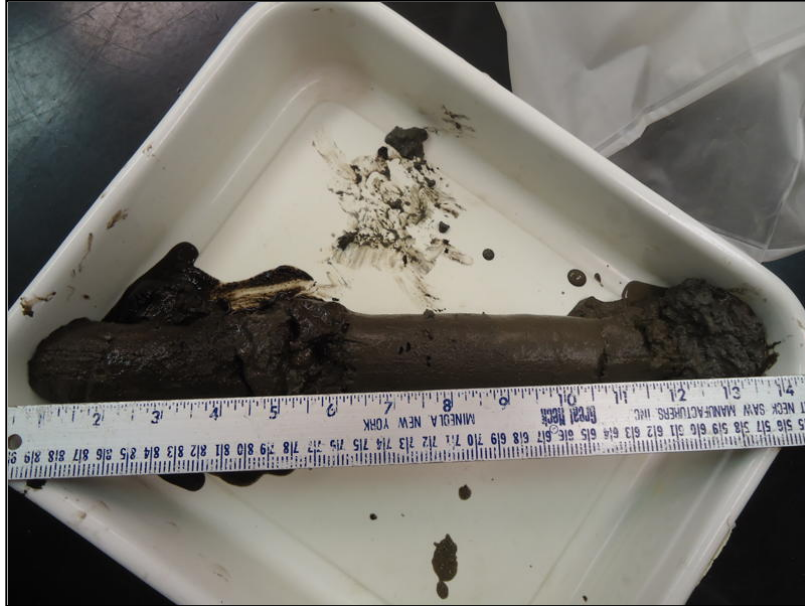
Figure 19. Photograph of a representative bottom core from Cannery Pond. The core surface (right) was typically loosely consolidated organic materials while the lower sections of the core was composed of organic materials, silt, and silt and or sand (varied by core).

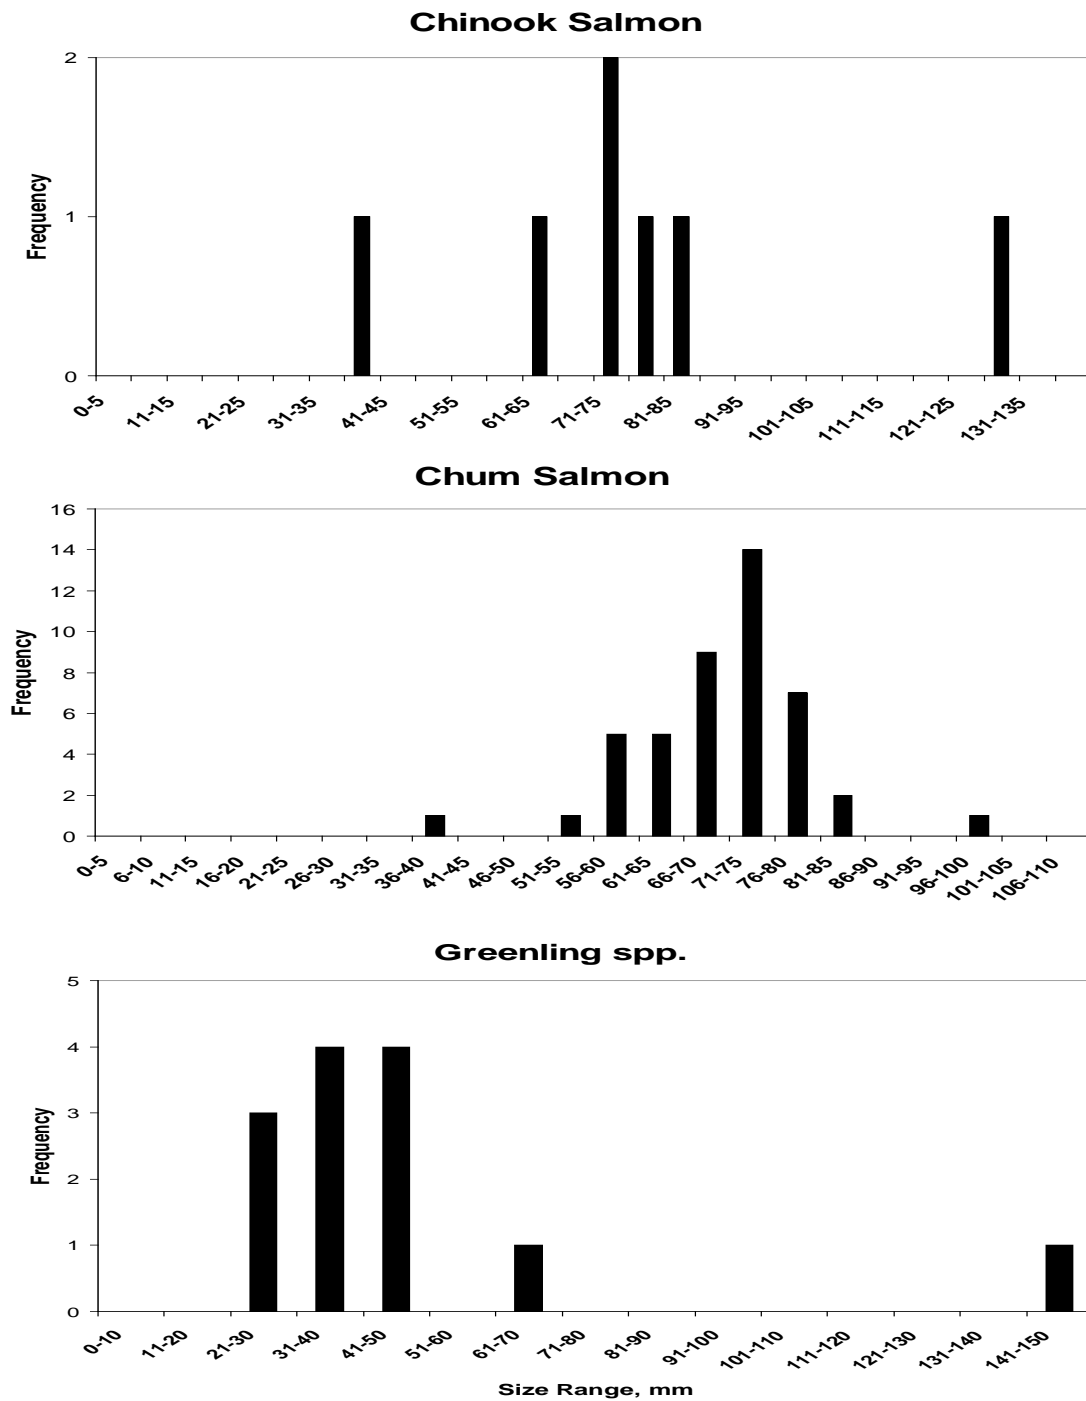
Figure 21. Length-frequency histograms for all Chinook salmon, chum salmon and greenlings caught in the beach seine samples at Cannery Pond (Jan.-- Feb.) and Ship Harbor (March – December) in 2010.

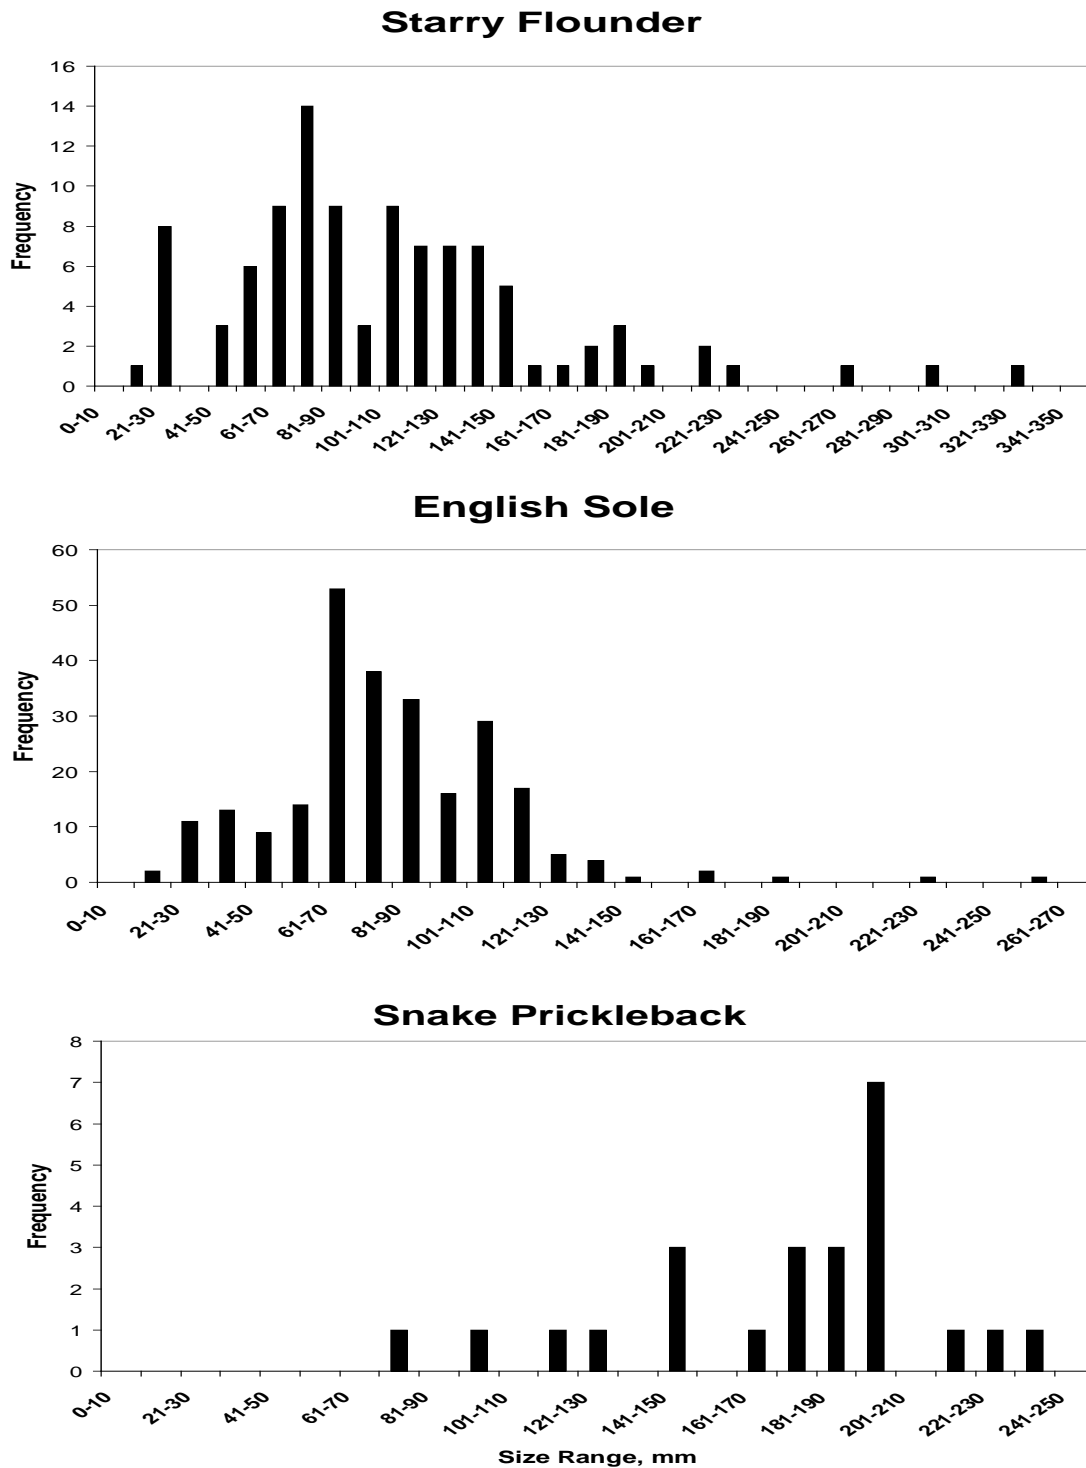
Figure 22. Length-frequency histograms for all starry flounder, English sole and snake pricklyback caught in the beach seine samples at Cannery Pond (Jan.-- Feb.) and Ship Harbor (March – December) in 2010.

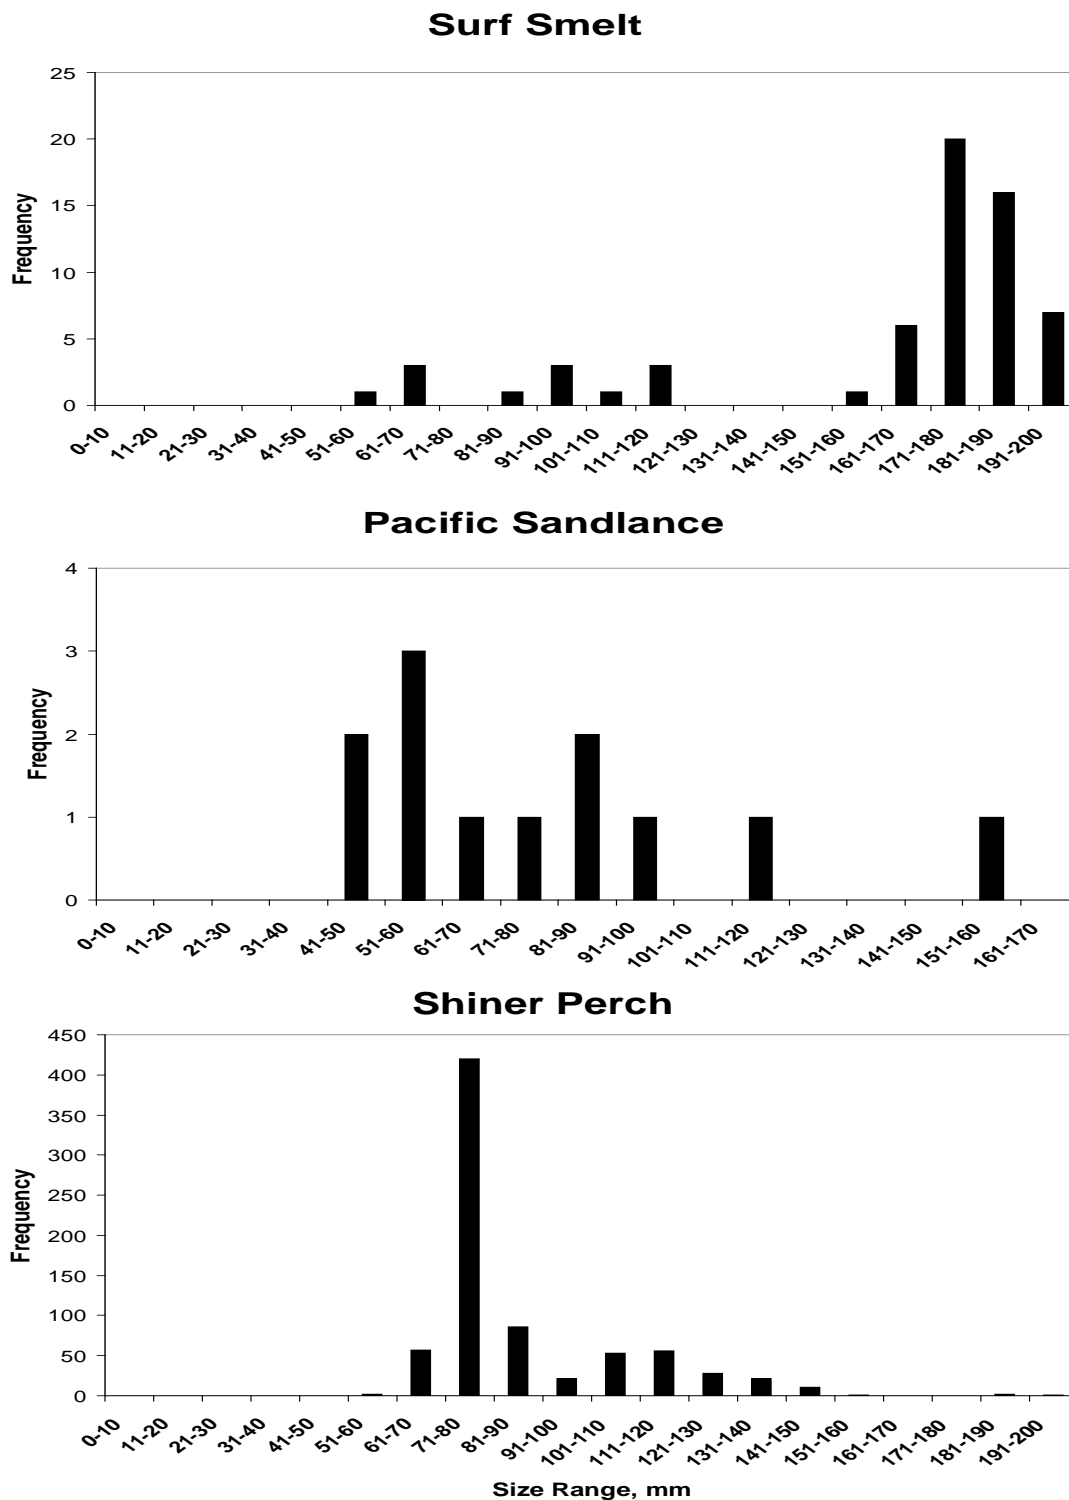
Figure 23. Length-frequency histograms for all surf smelt, Pacific sandlance and shiner perch caught in the beach seine samples at Cannery Pond (Jan.-- Feb.) and Ship Harbor (March – December) in 2010.

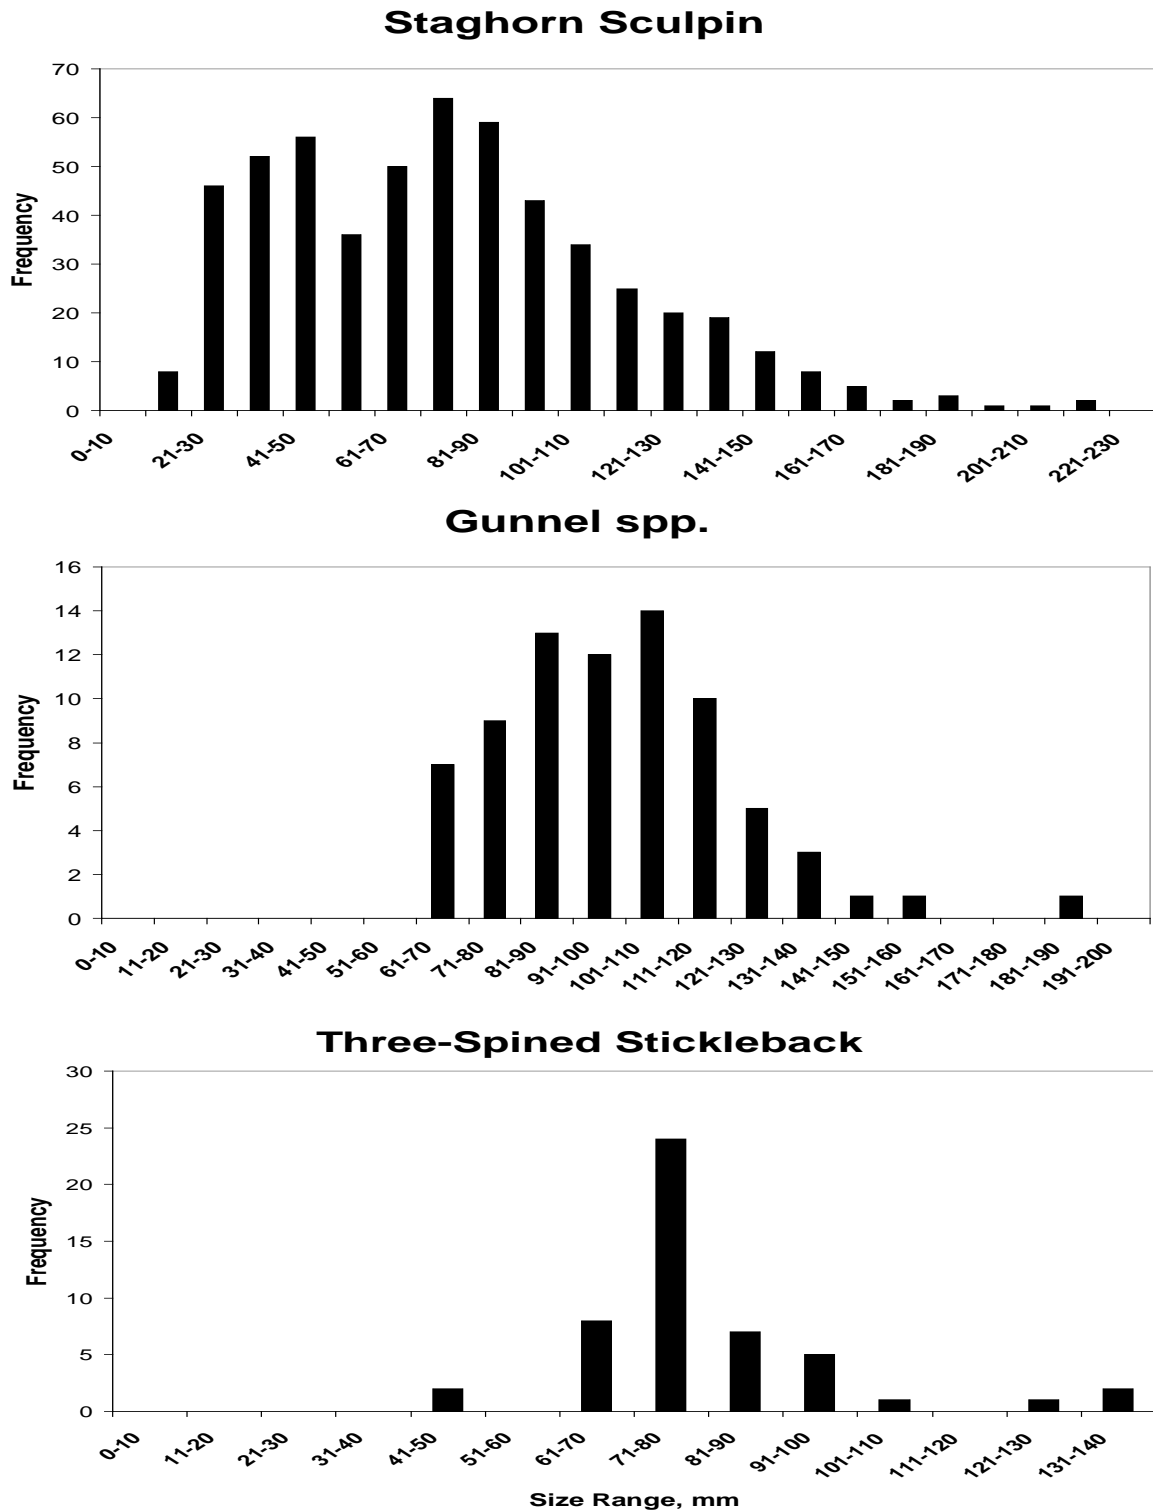
Figure 24. Length-frequency histograms for all Pacific staghorn sculpin, various species of gunnel and three-spined stickleback caught in the beach seine samples at Cannery Pond (Jan.-- Feb.) and Ship Harbor (March – December) in 2010.
