GRANT TITLE: Northwest Straits: MRC Year 8 Administration and Action Projects

TASK NO: 3.1 Kayak Point County Park Restoration

SCOPE OF WORK and COST PROPOSAL Kayak Point Restoration Feasibility and Design Phase 2 (with Sea Level Rise Assessment)

Kayak Point County Park Restoration Feasibility Assessment Snohomish County, Washington

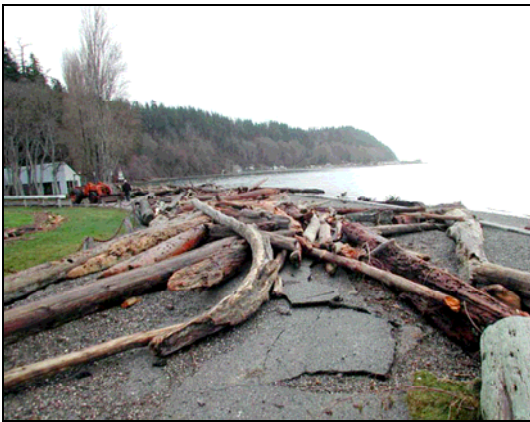
Figure 3. Large woody debris and overwash deposit at southwest point from 2/4/06 storm. *Photo courtesy of Snohomish County Parks and Recreation Dept.*

Over the past two years, winter storms have had a significant impact on the site, particularly along the southern shore of the park (Figures 3-6). Large woody debris and wave scour has severely damaged the loop road several times, resulting in the county questioning the long-term sustainability of the current road position. Shore modifications originally constructed to curb erosion and protect the road, have also incurred damage. A previously buried sheet-pile wall with concrete cap is exposed in several places, and poses a potential hazard to those recreating along this popular public shore. Additionally, the sheet-pile bulkhead appears to be altering, and perhaps exacerbating, erosion during high water events and storms.

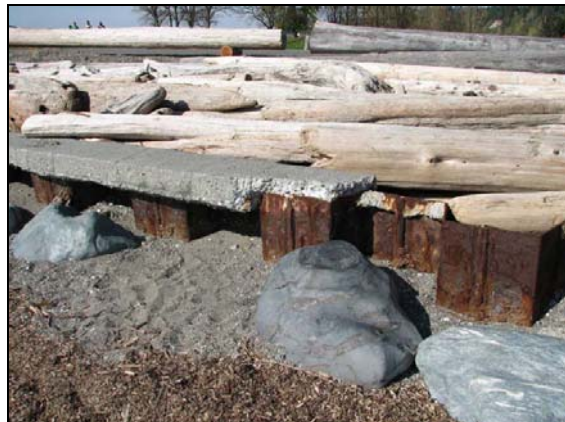
Figure 4. Exposed sheet pile and concrete cap bulkhead following 2/4/06 storm, which was previously buried. *Photo courtesy of Snohomish County Parks and Recreation Dept.*

- The concrete cap over the sheet pile wall has routinely needed repair. Two days following a recent repair to the concrete cap, it was damaged again and again exposed and in need of repair.

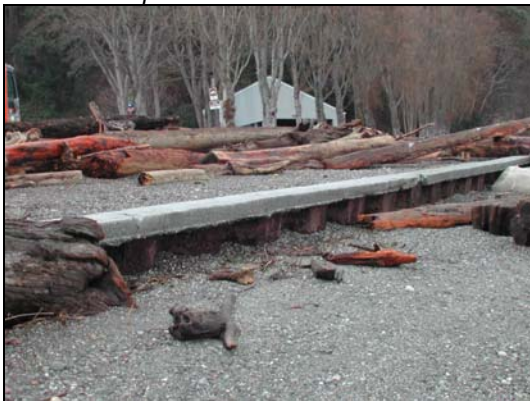
Figure 5. Exposed sheet pile bulkhead along southern shore following 2/4/06 storm. *Photo courtesy of Snohomish County Parks and Recreation Dept.*

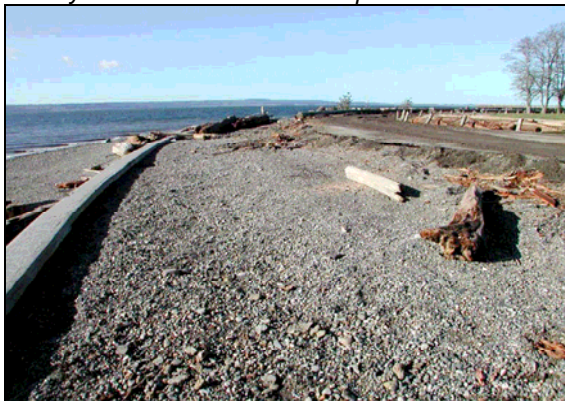
Figure 6. Exposed bulkhead and southwest loop road. Note landward extent of large woody debris following 2/4/06 storm. *Photo courtesy of Snohomish County Parks and Recreation Dept.*

- Two ft or more of sediment and other debris filled the southeast picnic shelter following the 2/4/06 storm.
- Water scoured holes under the southwest loop road resulting in considerable damage.
- The north end of the park has lost a little bit of beach material, but to a much lesser degree than the erosion that has taken place along the south shore.
- Water encroachment is more of an issue at the north end of the Park.

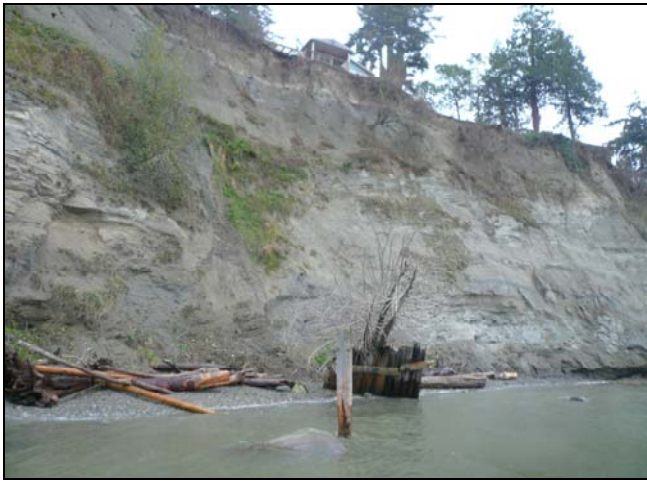
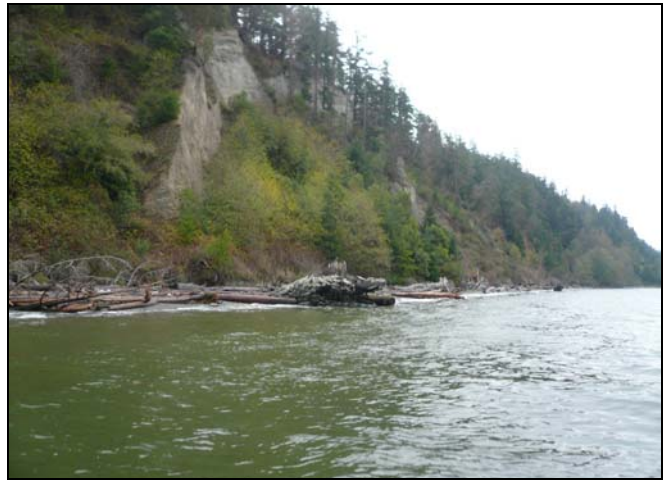
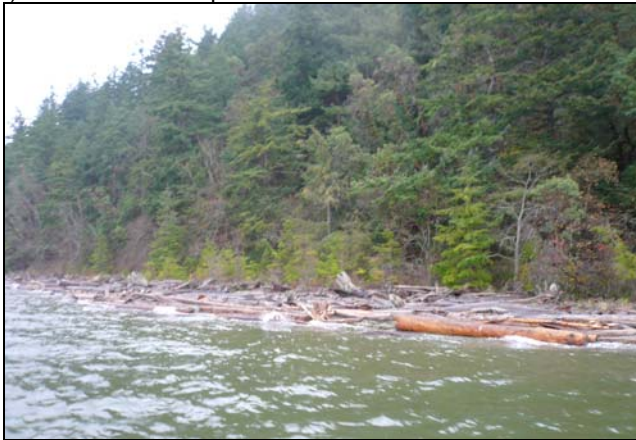
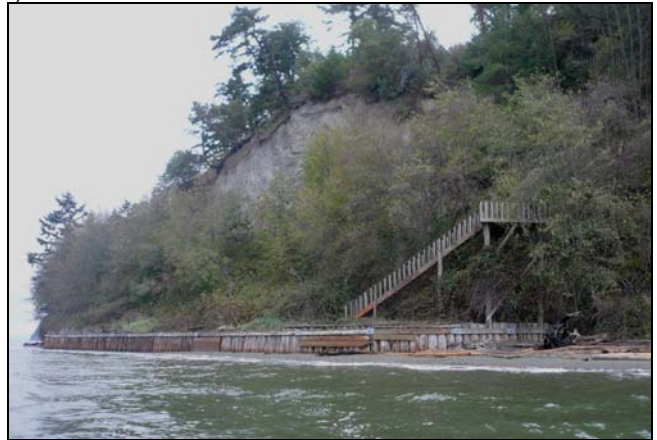
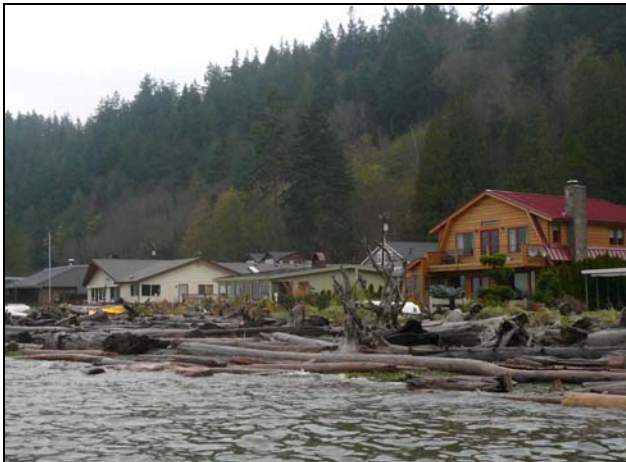
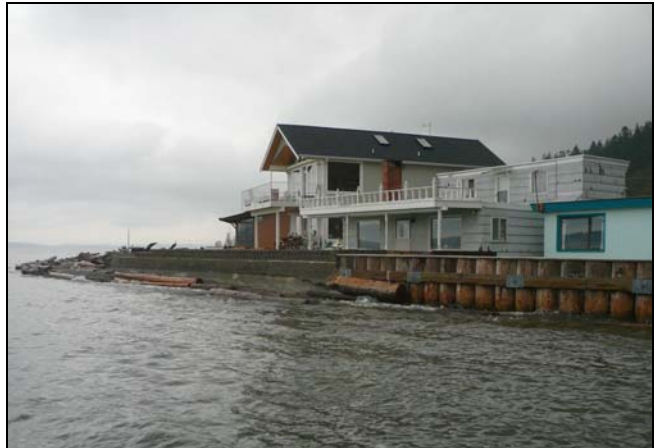
a) Feeder bluff exceptional

b) Feeder bluff

c) Transport zone

d) Modified shore

e) Accretion shoreform

f) Modified accretion shoreform

Figure 7. Photos of representative geomorphic shoretypes for the Kayak Point area. (CGS 2007 field photos).

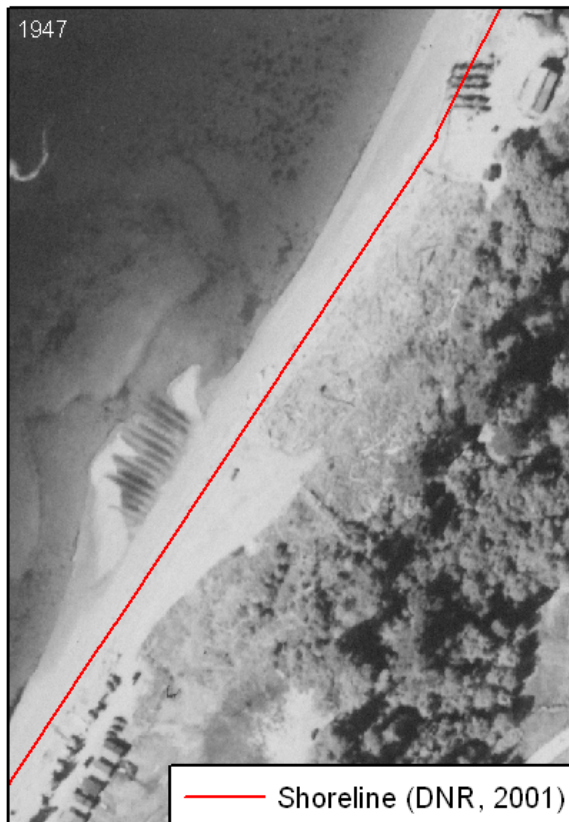
Figure 11. 1947 air photo of the north shore of Kayak Point County Park. Note structures on lower beach, recent fill area (located just landward), and extensive backshore driftwood deposition. *Photo courtesy of Snohomish County.*

The 1947 photo shows somewhat altered conditions as there appears to be several dark, linear “structures” in the lower beach, at profile B (Figure 10). Sediment appears to have been moved to or possibly built up against the structures to both the south and north, with additional regrading of the upper beach, landward of the structures. These alterations, which may have been for aquaculture, are not visible in any of the other photos. The shore change analysis of the toe of the beachface affirms these lower beach modifications, with considerable accretion documented at profile B from 1947-1965, while a more moderate rate of accretion was noted along profile A (the northern-most shore) (Figure 13).

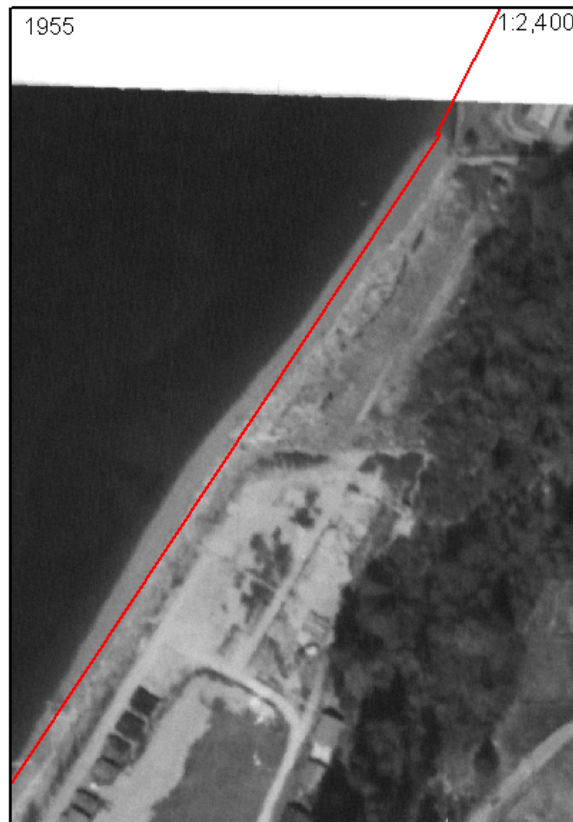
Figure 12. 1955 air photo of the north shore of Kayak Point County Park. Note changed configuration of fill area, narrower driftwood deposit, and installation of shore modification along northernmost shore. *Photo courtesy of Snohomish County.*

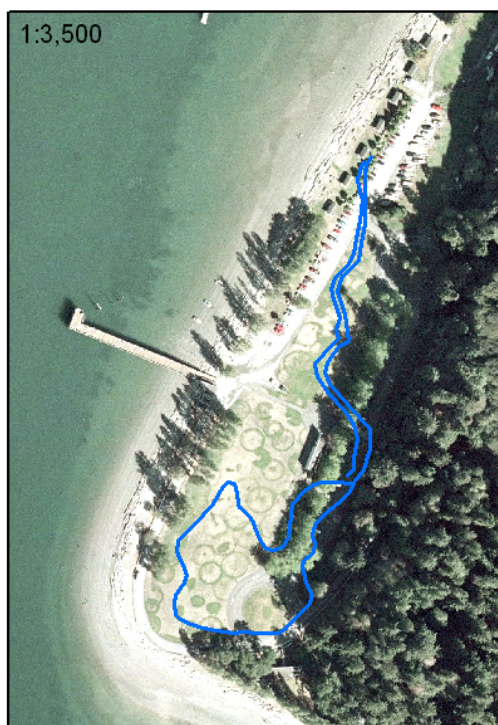
Figure 16. Digitized position of lagoon and marsh adapted from Collins and Sheikh (2005) displayed on 2003 photo. Photo courtesy of Snohomish County.

Shore change trends in the south portion of the Park (profiles D and E, Figure 10) were considerably different from the north shore. Shore change results consistently documented landward erosion of profile E (the southernmost profile) and intermittent recession of the logline along profile D. The net measured change along profile E equated to 28 ft of erosion, while the logline along profile D had a net accretion of 8 ft (Table 13). Erosion was greatest prior to 1965; it then slowed during later years. This was probably due to the installation of erosion control structures that began to control the migration of the shoreline and alter the character of the backshore. Considerable fill was placed in the backshore of the southern end of the park, which was historically the location of a lagoon with a tide channel that drained the lagoon to the north (USC&GS 1886, Figures 15 and 16).

- The historic lagoon (Figures 15 and 16) was filled by sluicing material down the bluff from the upland portion of the park to create the lawn area that exists today. Originally the fill material was contained by an old tanker hull, which later failed and was removed.
