PROJECT TITLE: Northwest Straits Project: Snohomish Marine Resources Committee  
Operations and Projects

# **Port Susan Marine Stewardship Area Armor Removal Assessment Report for Snohomish County Marine Resources Committee**

**Prepared by: Coastal Geologic Services, Inc.**

**July 30, 2015**

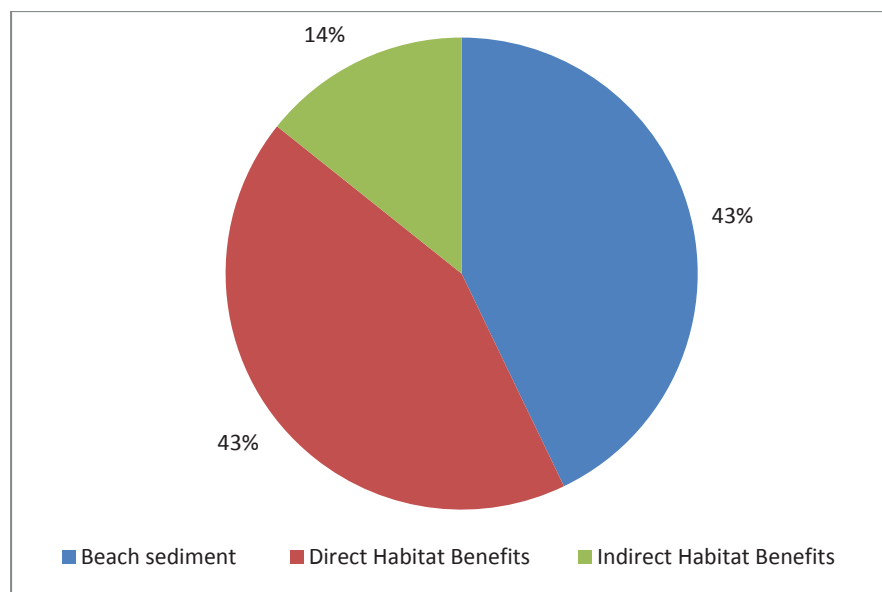
**Figure 3.** Scoring categories for the benefits of armor removal for bluffs

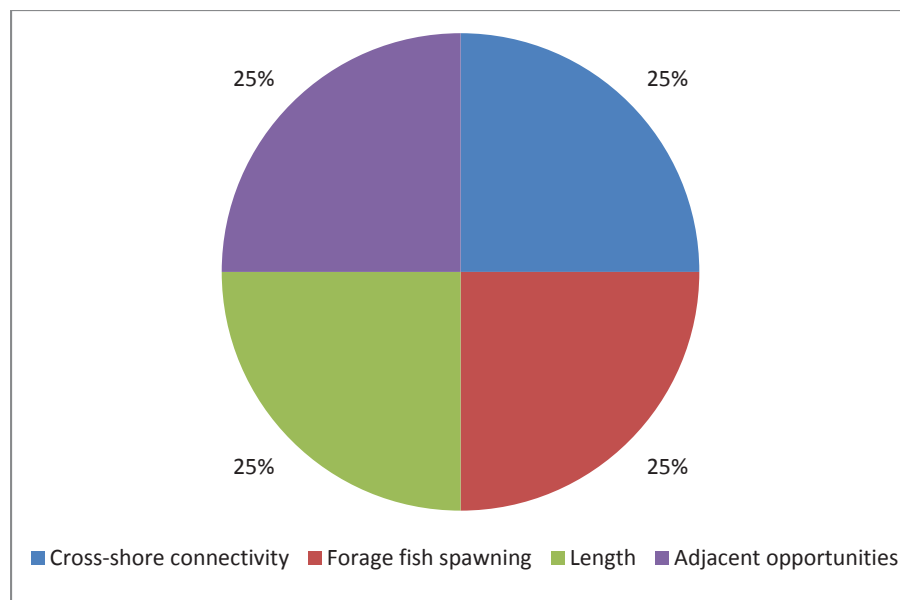
**Figure 4.** Scoring categories for the benefits of armor removal for accretion shoreforms

Armor removal on accretion shoreforms results in different ecological responses which are captured in Table 4. Accretion shoreform parcels could score a maximum of 60 points with equal portions of the score addressing benefits associated with restored cross-shore connectivity, forage fish spawning area, shoreline length, and the presence of adjacent opportunities (Figure 3). Restored cross-shore connectivity refers to the degree of recovered marine riparian area potentially resulting from armor removal. The relative benefit of cross-shore restoration that can be achieved was associated with how far the existing armor infringes on the upper beach and intertidal areas. For bluffs, the benefit of restored cross-shore connectivity is represented in the sediment supply restoration and indirect habitat benefit metrics. Parcels in which armor was located above MHHW (abbreviated as modified backshore or MB) would have the least potential restored cross-shore connectivity. Shores with armor at approximately MHHW would have moderately restored cross shore connectivity. And shores where armor extends lower into the intertidal, waterward of MHHW (referred to as modified intertidal or MI) would result in the most restored cross-shore connectivity.

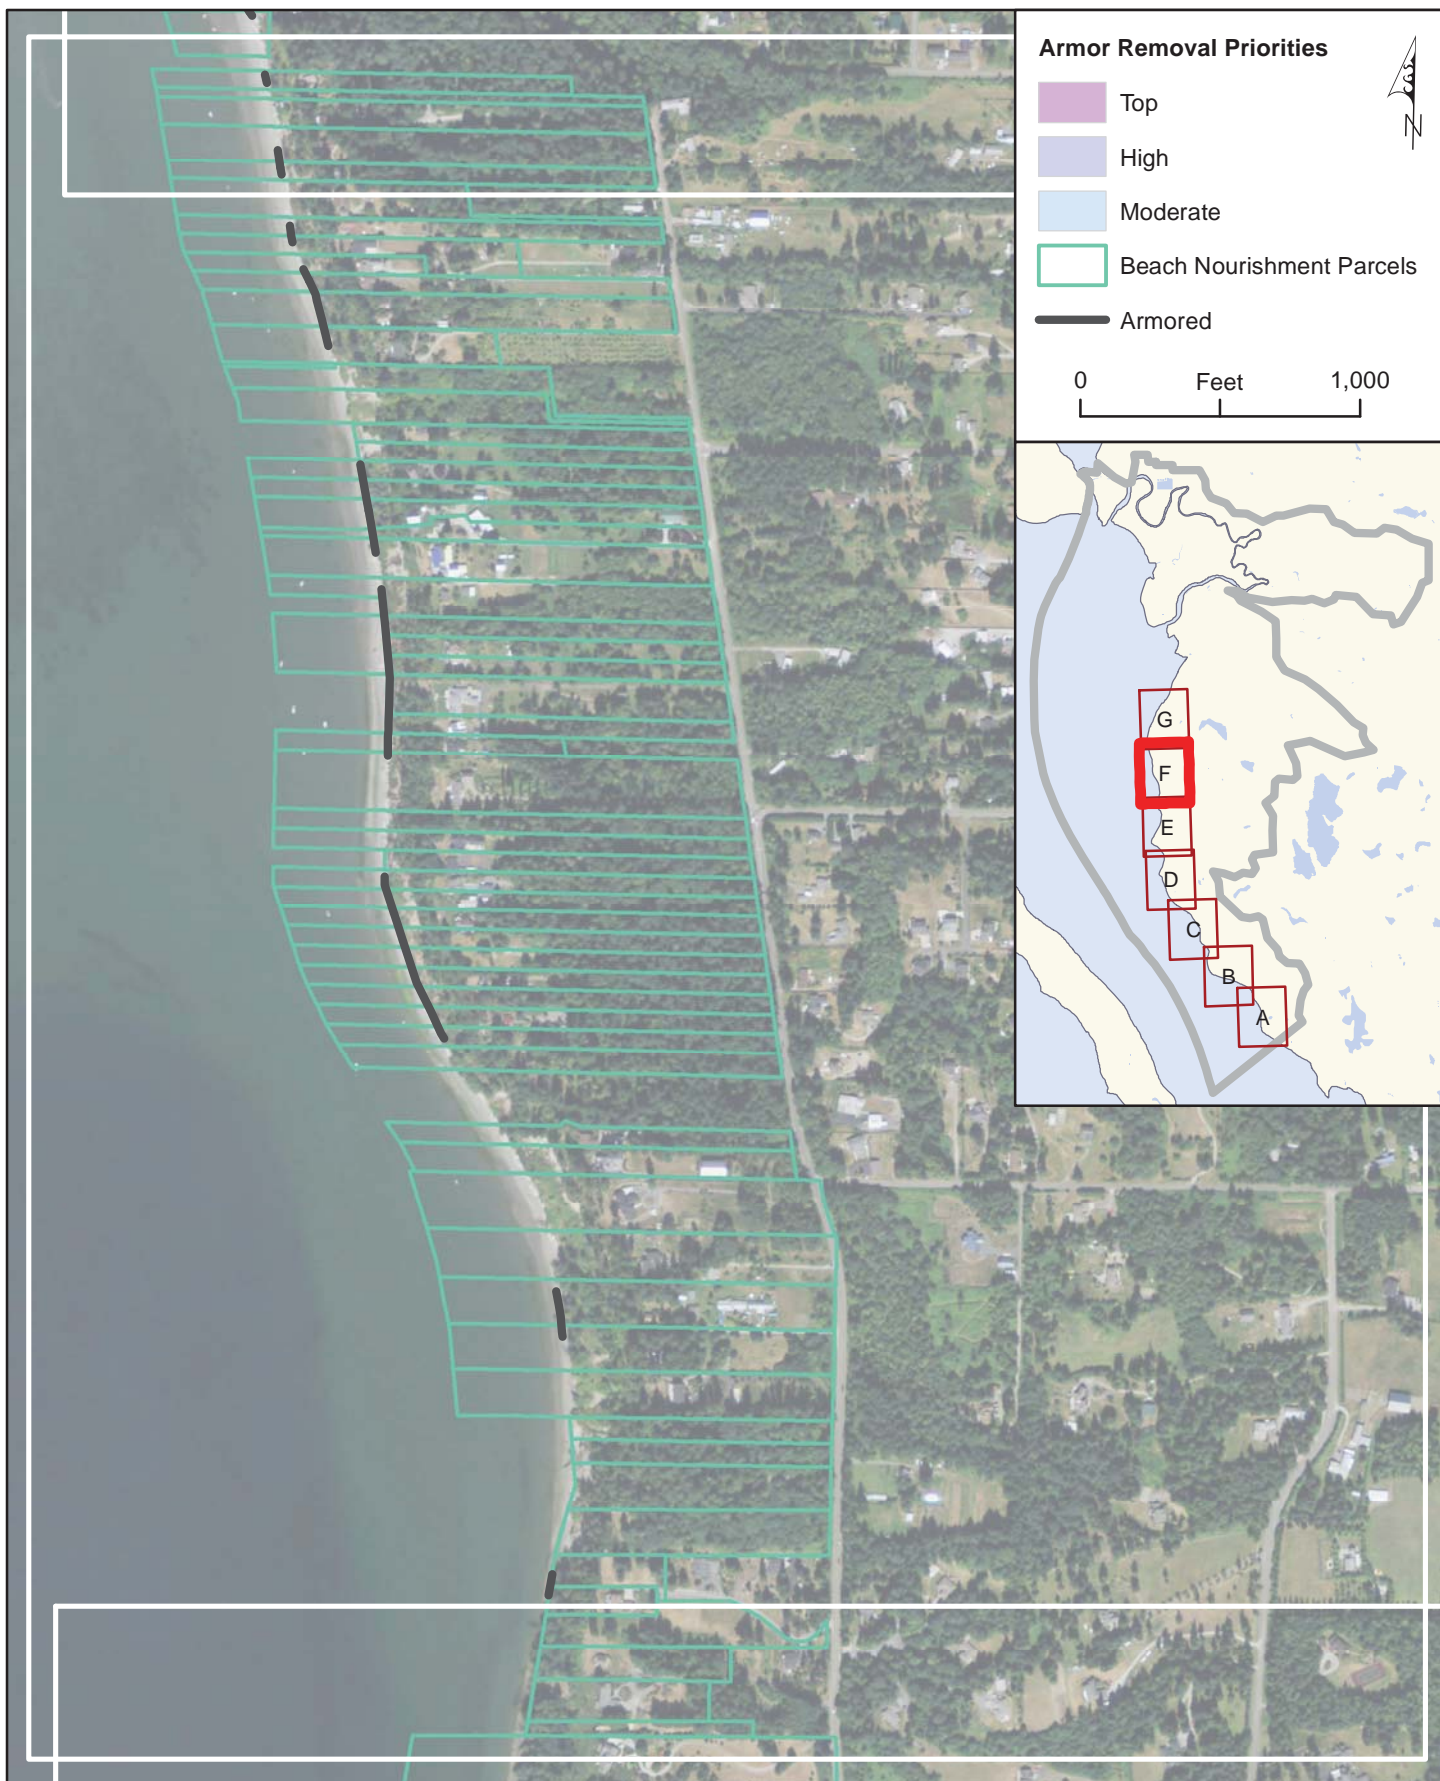
**Map 8F.** Beach nourishment opportunities within the Port Susan MSA.  
*Aerial background courtesy USDA NAIP program (2011)*  
*Parcel boundaries are approximate and based on GIS layers*  
**Port Susan Marine Stewardship Area Armor Removal Assessment**

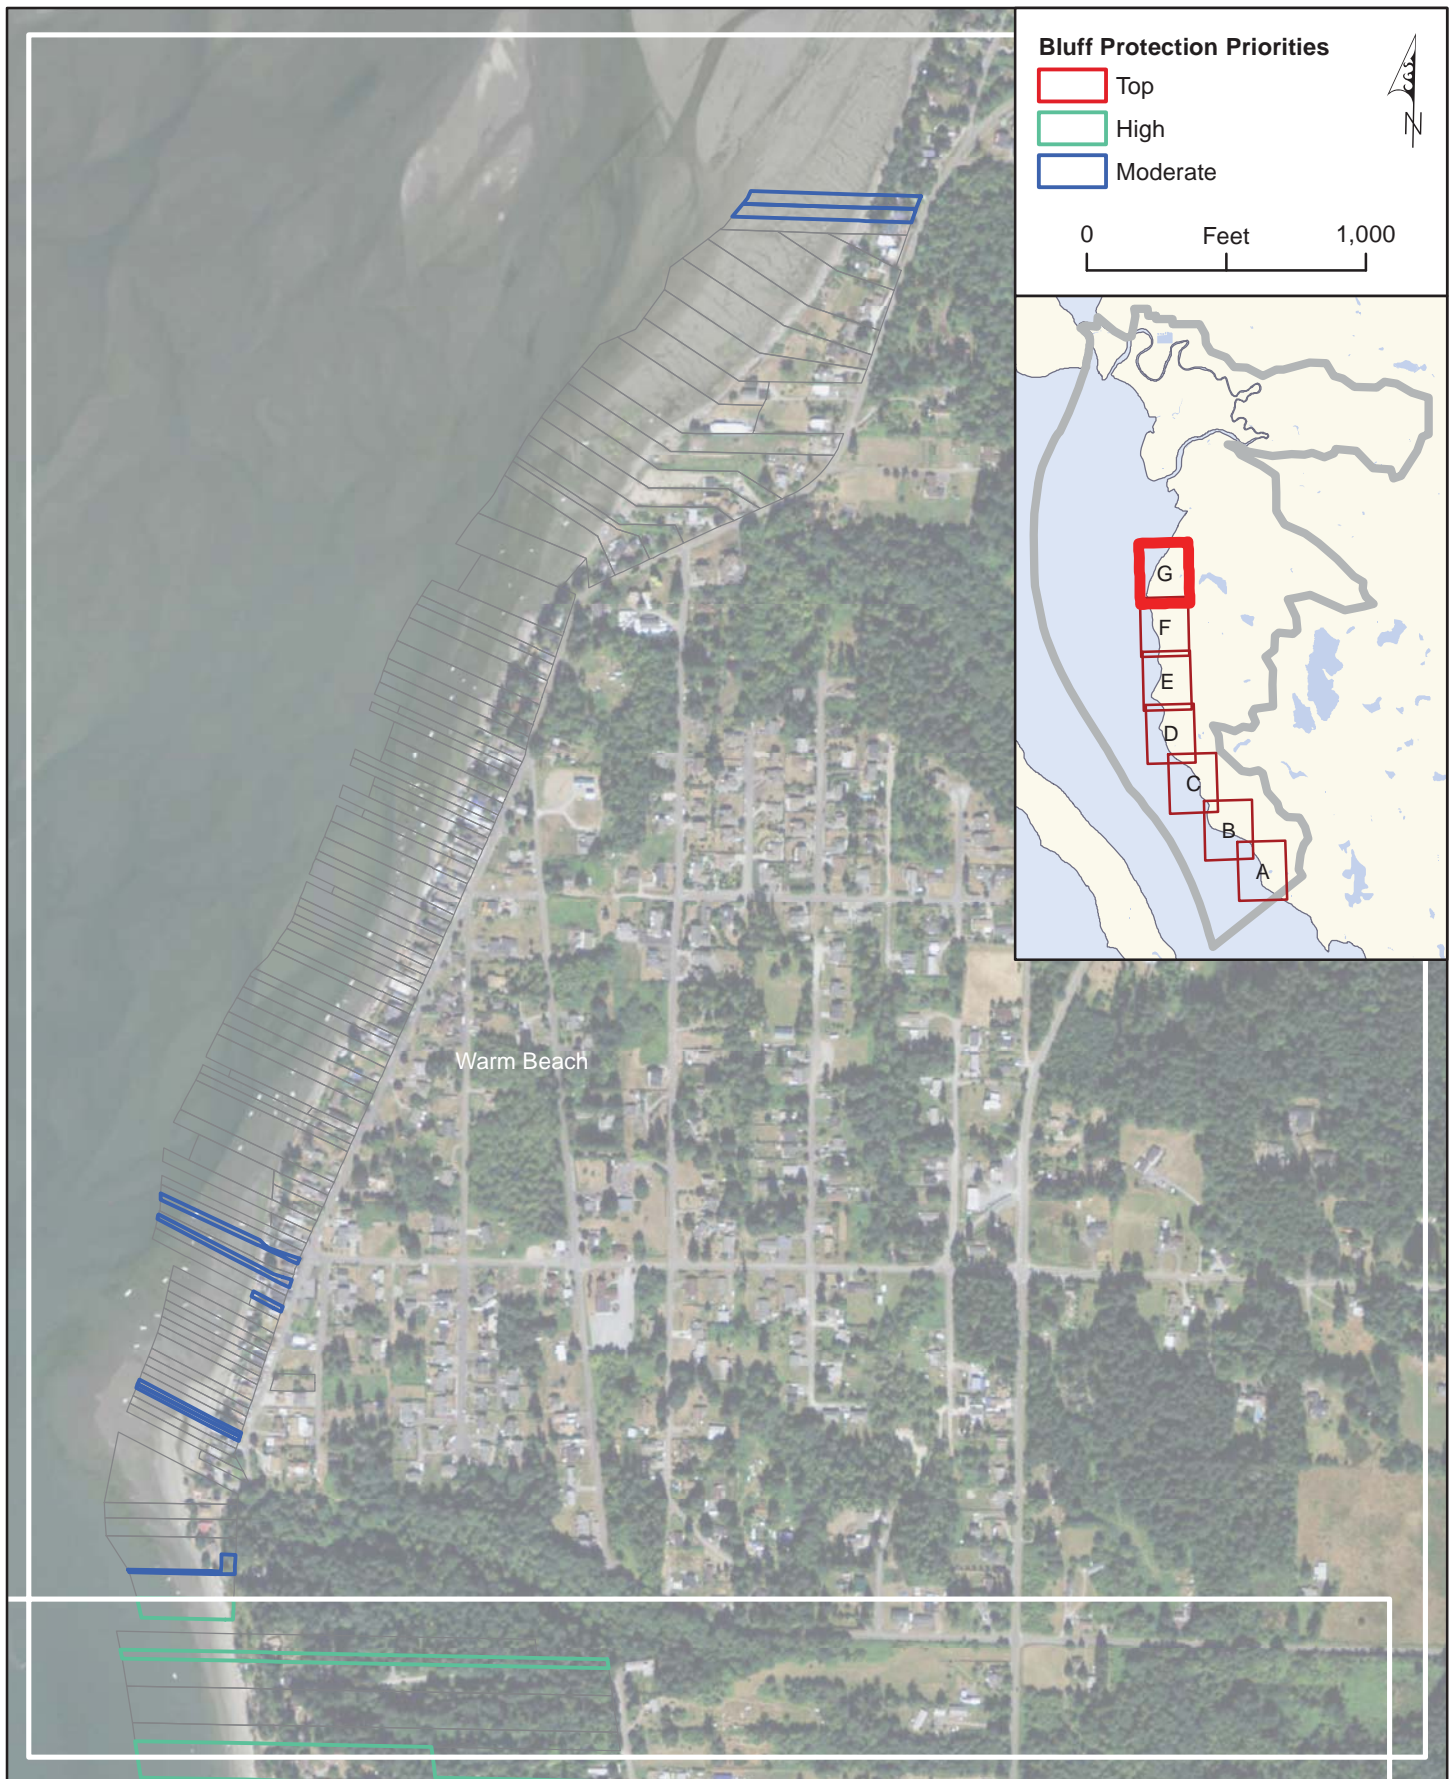
**Map 9G.** Bluff protection priorities within the Port Susan MSA.  
*Aerial background courtesy USDA NAIP program (2011)*  
*Parcel boundaries are approximate and based on GIS layers*  
**Port Susan Marine Stewardship Area Armor Removal Assessment**
