# Installation and Monitoring of a Storm Water Antimicrobial Unit at Bay View, Washington

June 2011

PROJECT TITLE: Installation and Monitoring of a Storm Water Antimicrobial Unit at  
Bay View, Washington

DELIVERABLES FOR TASK NO: 3, Low Impact Development

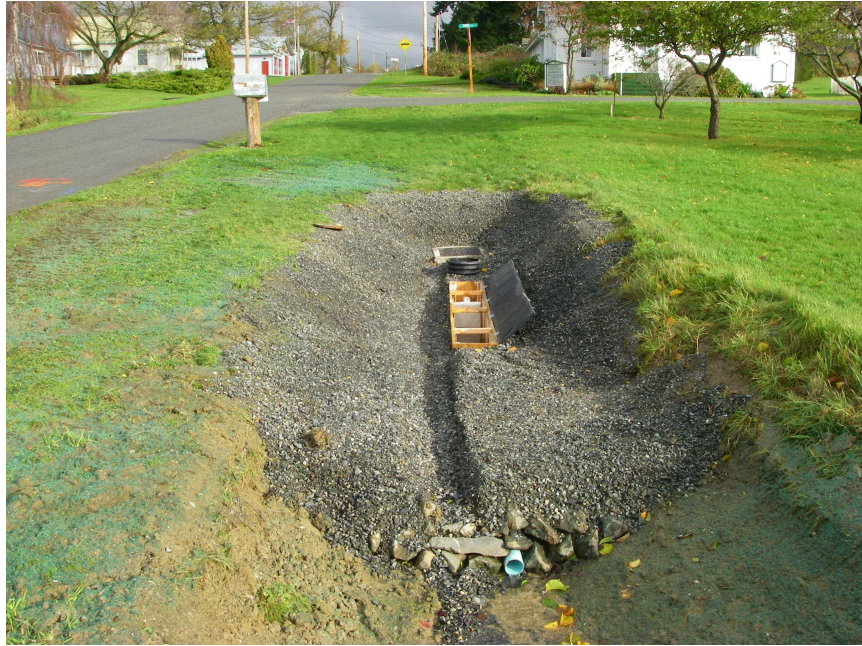
Figure 1. Location of the Smart Sponge<sup>®</sup> SWAT unit in Bay View.

The original concept of installing a fairly large experimental SWAT unit at the boat ramp next to Rozema Boat Works in Bay View was negated once the project engineers investigated the site in mid 2010 because of excessive seawater intrusion into the site during very high tides. This resulted in relocation of a smaller SWAT unit approximately two blocks east and uphill of the original site.

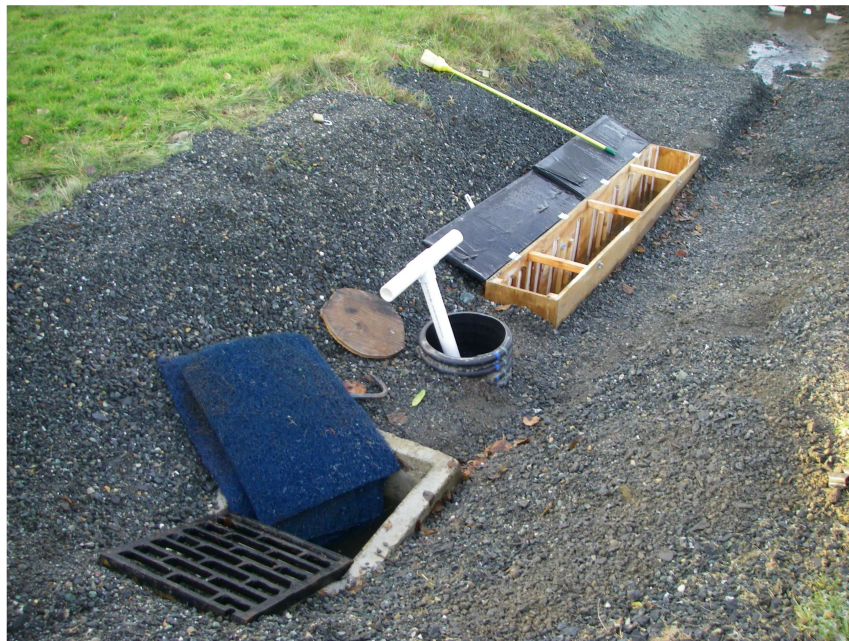
Figure 2. Detail of the SWAT experimental unit installed at Bay View. The sediment retention sump (with filter material) is in the foreground. In the middle is the well holding the 2" PVC flow control valve and the SWAT experimental trough is in the background.

The new uphill site was especially interesting because it was in a roadside ditch that had been converted to a bioswale structure to "treat" a small portion of the overall storm water flow being carried inside an underground pipe. A plan evolved to install a much smaller and less expensive experimental unit to test the smaller amount of diverted storm water at this location. The plan was initiated by providing Skagit County Public Works (SCPW) personnel with conceptual drawings of the proposed experimental unit. SCPW then constructed the unit and installed it at the specified location. The unit consists of a plywood flow through trough measuring 8' long x 14" wide x 18" deep with a sediment settling sump (30" length x 24" wide x 32" deep) installed inline prior to the experimental trough (Figures 1-2). The inflow line to the trough is 2" PVC and the outflow is 4" PVC. A 2" PVC valve was installed between the sediment sump and the experimental trough to control the flows. "Horse hair" air conditioning filter material was inserted into the sediment sump to assist with removal of sediments that might clog the Smart Sponge<sup>®</sup> media.

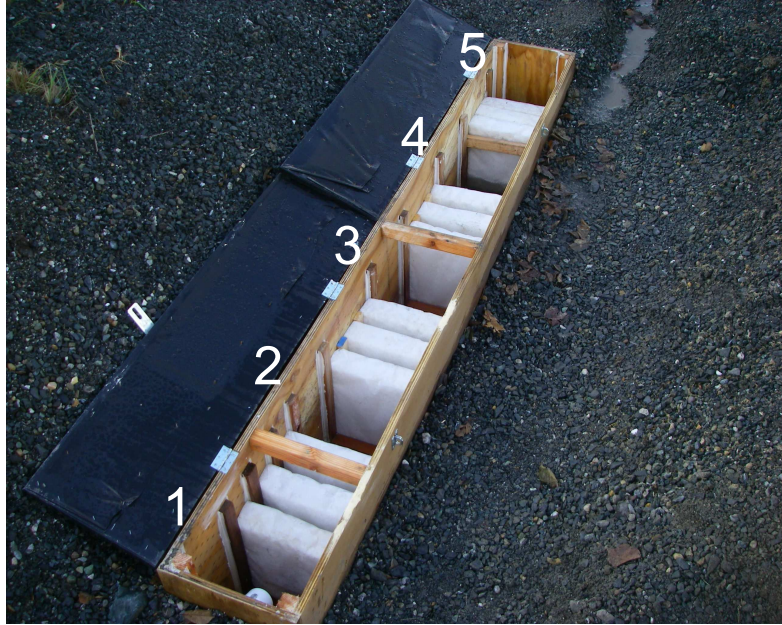
Figure 3. The SWAT experiment trough with the Smart Sponge® paks installed. The design allows the water to flow through up to 12 paks. If the leading paks clog due to sedimentation, then the storm water will flow over the clogged paks to the next sets. The white numbers indicate the locations where coliform and turbidity samples were collected, #1 being the influent and #5 being the effluent.

The first experiment was designed to test the efficiency of a series of Smart Sponge<sup>®</sup> paks to remove fecal coliforms from Bay View storm water. Twelve Smart Sponge<sup>®</sup> paks, each measuring one foot square x 3 inches deep, were placed in series in the experimental trough (Fig. 3). Gaps were left between each pak to allow us to assess how much clogging the paks were experiencing and to allow us to collect fecal coliform samples between sets of 3 paks. The experiment began on 6 December 2010 when the flow rate into the trough was set at 32 liters/minute. Samples for fecal coliforms and turbidity were collected daily for four days at the trough influent, effluent and at three locations between each set of 3 paks (Fig. 3). The flows through the trough were monitored to assess how many paks the water was running through versus how many of the paks were being overflowed due to sedimentation.

Table 1. Bay View Smart Sponge<sup>®</sup> fecal coliform and turbidity monitoring -- Experiment #1. Twelve Smart Sponge<sup>®</sup> paks were inserted in series in the experimental trough. Monitoring was for fecal coliforms and turbidity daily. See Figure 3 for the locations of the five sampling points.

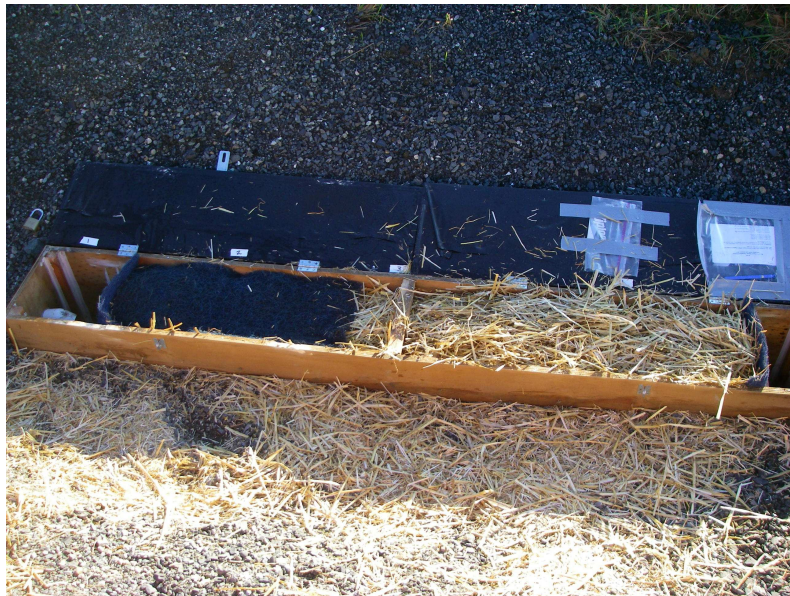
Figure 4. Following clogging of the Smart Sponge® Paks with sediment during a heavy rainfall, a second experiment was set up to test the ability of straw to act as a pre-filter for the Smart Sponge® media.

Because we found that the Smart Sponge<sup>®</sup> paks clogged with sediment rather quickly, we set up a second experiment to test the possibility of using straw to pre-filter the storm water to remove some of the clogging sediments. For this experiment, we removed the Smart Sponge<sup>®</sup> paks and replaced them with straw, which was then covered with a layer of horsehair filter material (Fig. 4). This experiment was started on 17 December 2010 and ran until 4 February 2011 with flow rates varying from 2 to 20 liters/minute. During this time, we monitored the flow of water through the straw, measured the depth of water in the influent compartment and collected occasional samples to measure turbidity.

Experiment #2 was carried out over a 50 day period from December 2010 to early February 2011. For this experiment the trough was completely filled with straw (Fig. 4) to determine if this matrix could be used to filter sediments out of the storm water prior to its contact with the Smart Sponge<sup>®</sup> media. The sediments in the storm water did not clog the straw matrix during the test period, but also did not have a noticeable effect on turbidity values between the influent and effluent ends (Table 2). However, when the straw experiment was disassembled, we noted that the straw had trapped a substantial amount of sediment underneath and within the straw matrix. Therefore, future experiments will be set up using a straw pre-filter and then Smart Sponge<sup>®</sup> matrix that has been removed from the covering material.

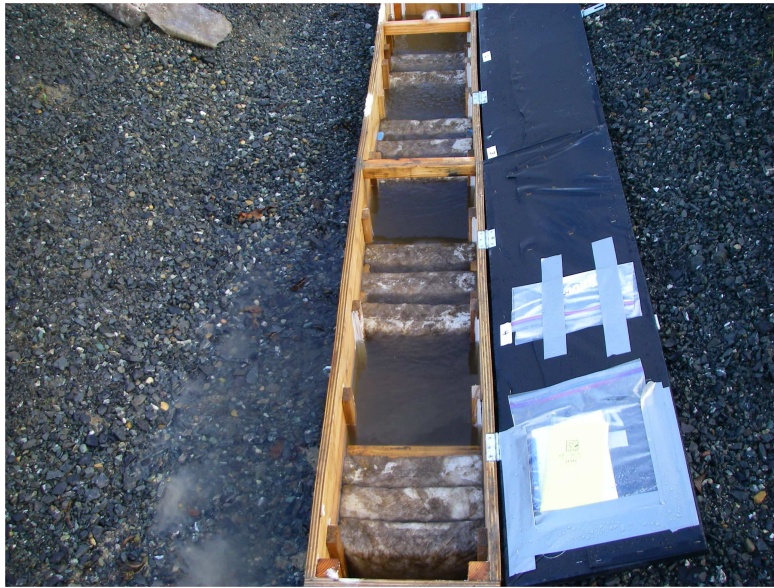
Figure 5. Photograph showing sediments coating the covers of the Smart Sponge® paks following a period of very high storm water flows.

the Smart Sponge<sup>®</sup> media did nothing to reduce bacterial loading (Table 1). Experiment #1 was terminated at day 4 due to rapid sedimentation of the Smart Sponge<sup>®</sup> pak covers, which resulted in the storm water overflowing all 12 of the paks instead of flowing through them (Fig. 5). Sediment also made its way inside the pak covers into the matrix of the filter media (Fig. 6).

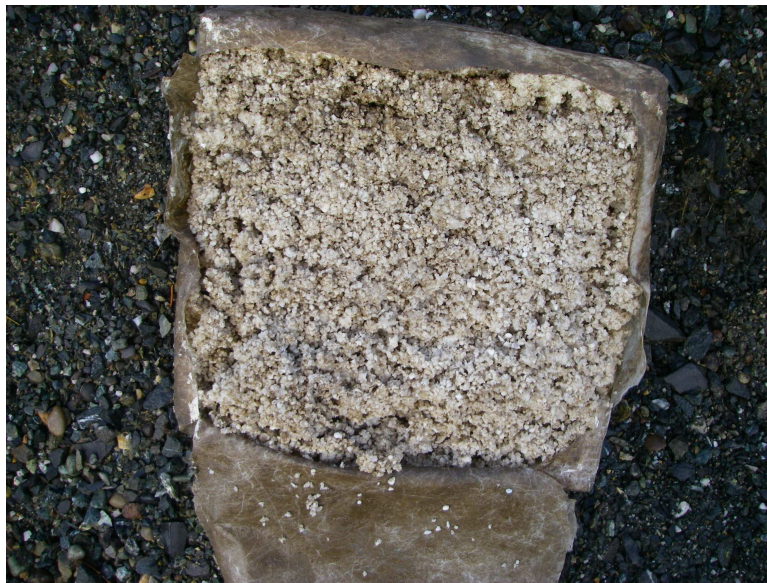
Figure 6. Photograph showing the popcorn like filter matrix inside the Smart Sponge® paks following a period of very high storm water flows. Note the accumulation of fine sediments within the filtration matrix.
