TASK NO: 3.1 Chuckanut Village Marsh Restoration

**WETLAND  
CHARACTERIZATION:  
CHUCKANUT VILLAGE MARSH**

**NORTHWEST ECOLOGICAL SERVICES, LLC**

The scope of this project is to provide a wetland characterization of Chuckanut Village Marsh to assist in the decision matrix for a proposed culvert removal project. The characterization includes a wetland rating, a general functional review, a survey of the marsh and immediate vicinity topography, and habitat mapping. It also includes an analysis of existing conditions, proposed action alternatives and recommendations based on the collected data.

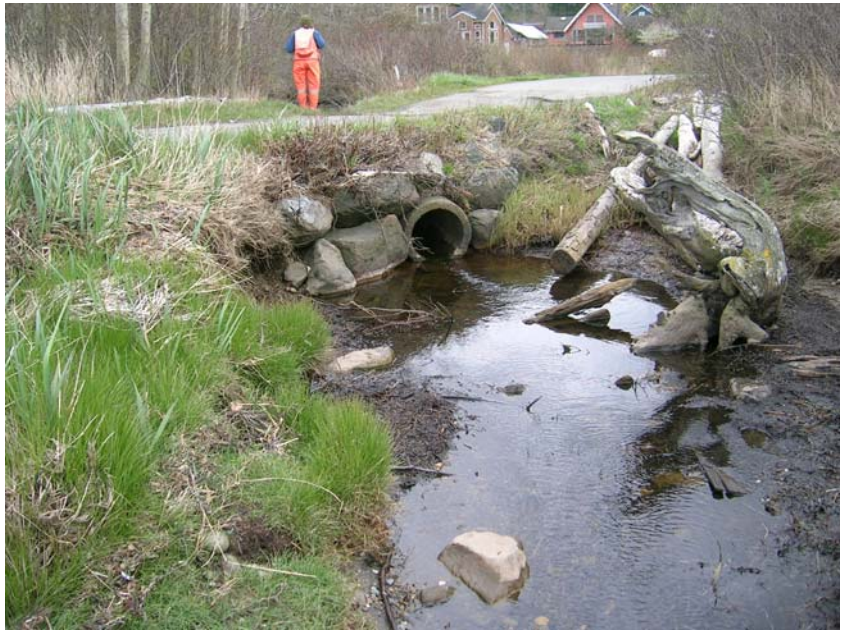
Photo 1. Downstream end of Fairhaven Avenue culvert. Low tide.

Field observation and topographical data indicate the culvert does not appear to limit flow significantly into or out of the marsh, except possibly during extreme events of high water and storm surge. The marsh does not have enough low elevation area to have a large enough tidal prism that would otherwise make the culvert a limiting factor to tidal water flow. This conclusion is based on observations at an incoming and high +8.8 ft MLLW tide (field notes, Appendix C). So the culvert does not appear to significantly change estuarine conditions during most times, but the extreme high water events may be altered in the marsh as flow may be impeded. This could result in a minor shift in the plant communities if the culvert were removed/replaced, which could have a minor affect on functions for juvenile salmon. Removal of the culvert would also allow juvenile salmon access into the estuarine wetland and thereby increase the area of estuarine wetland habitat available for rearing at periods of high tidal elevations. Juvenile salmon may however become stranded in the wetland if they fail to move downstream as the tide is receding. This is a common condition of estuarine wetlands and saltmarshes and the Chuckanut Village Marsh has refuge and cover with undercut banks and some overhanging vegetation.

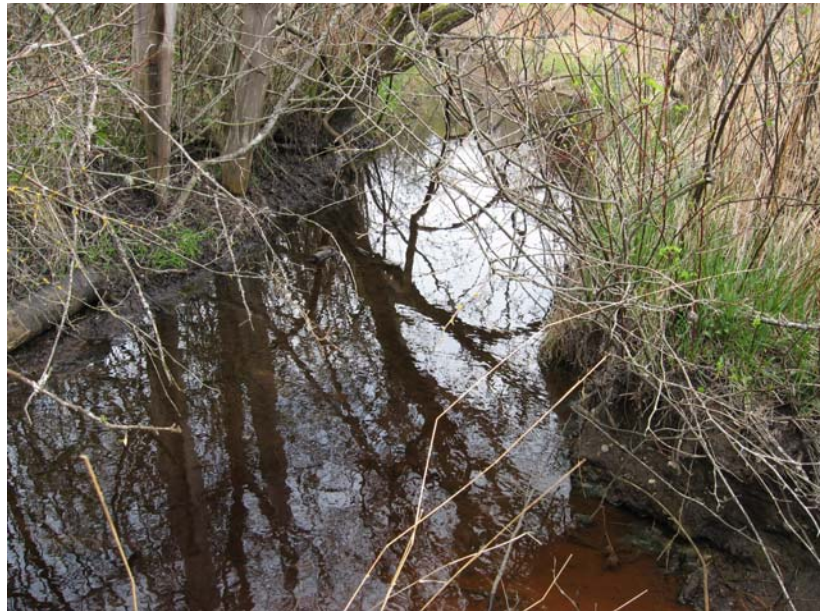
Photo 2. Marsh ditch at intersection between two primary ditches. Low tide.

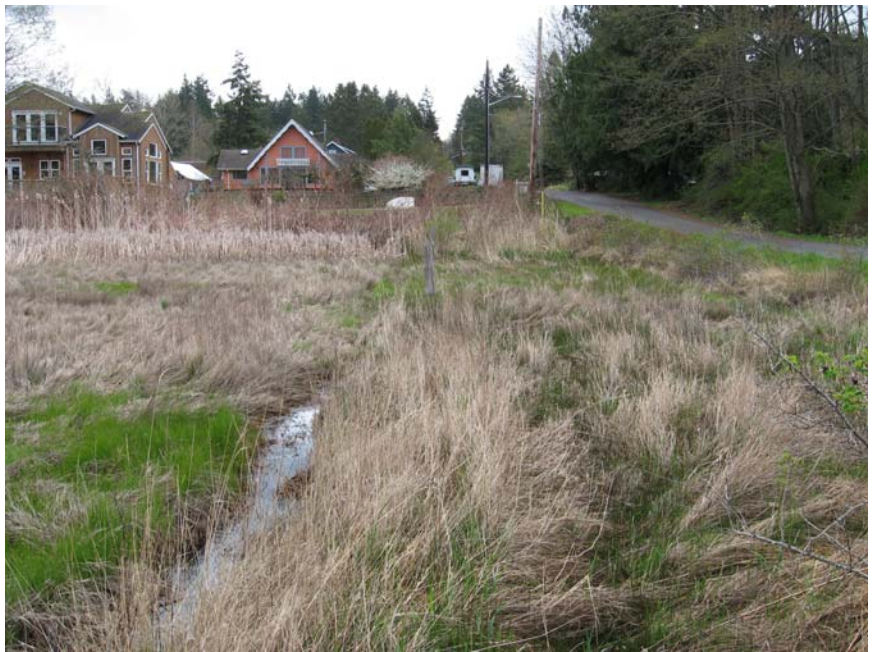
Photo 3. View east from Ditch intersection. Viewing southern ditch. Juncus Unit on right of ditch; PEM Distichlis Unit left of ditch; PEM Typhus unit ahead and left of ditch. Low tide.

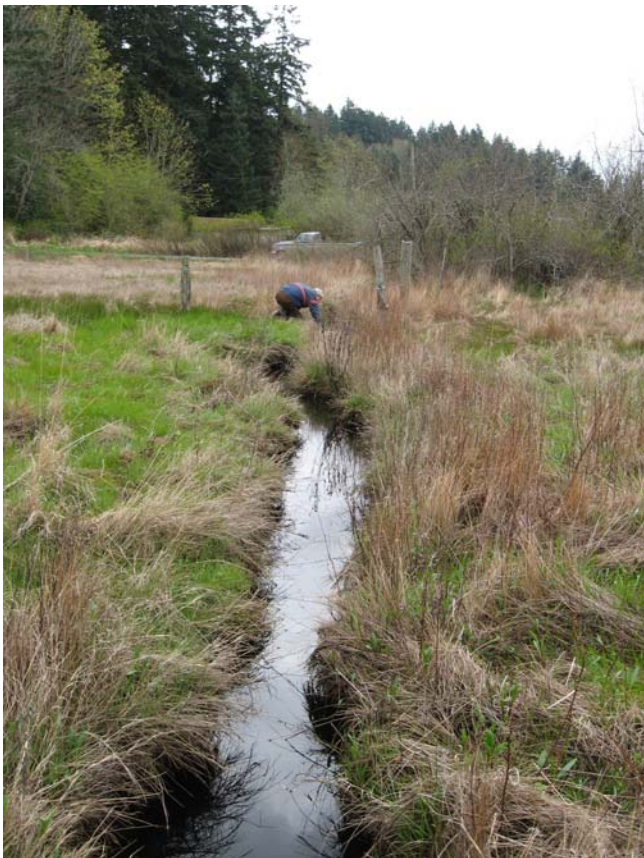
Photo 3. View south from middle of north/south ditch. From from PEM Juncus unit into PEM Distichlis Unit. Low tide.

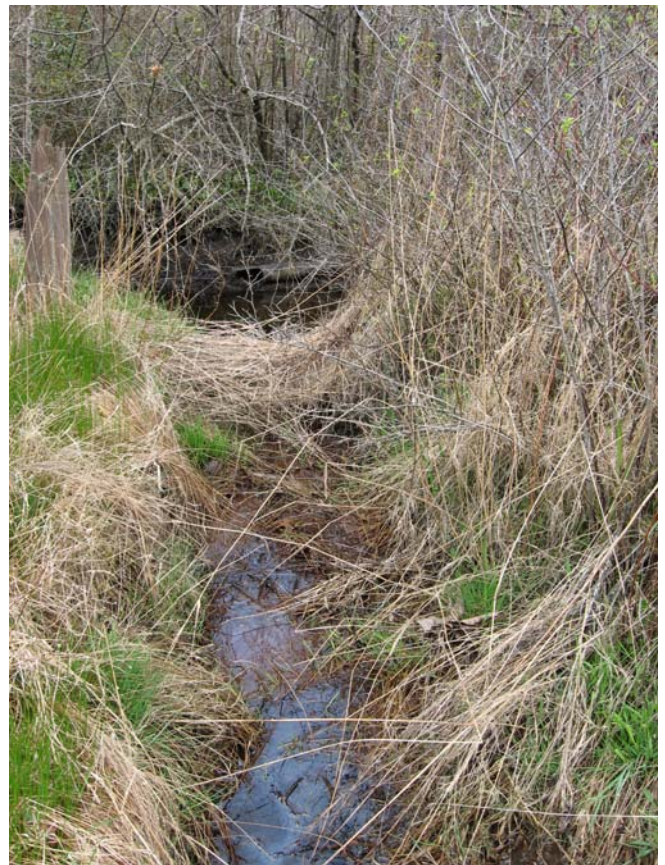
Photo 4. View south. Detail north/south ditch about 30 feet upstream of ditch intersection. Low tide.

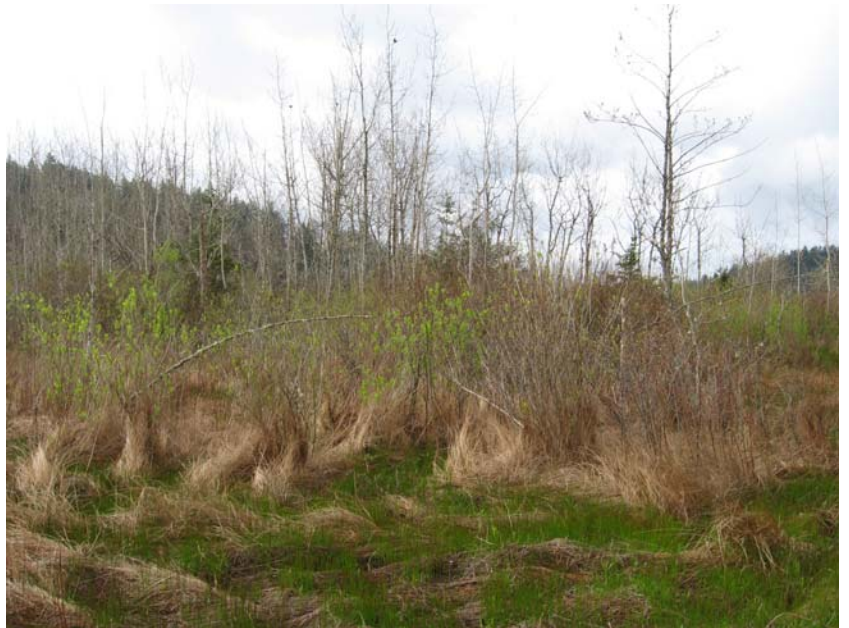
Photo 5. View west from PEM Juncus Unit view PSS Deciduous Shrub Unit. Low tide.

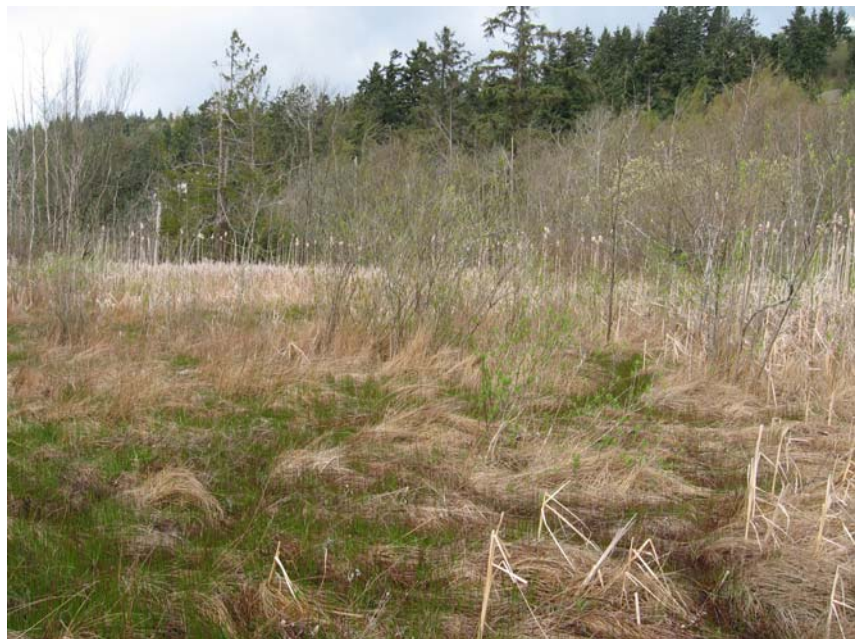
Photo 6. View northwest into PEM Typha Unit. Low tide.

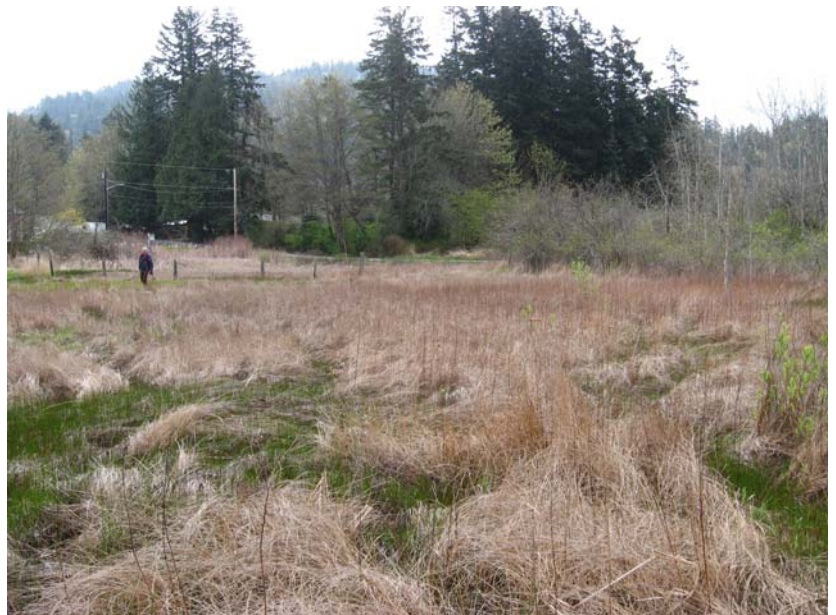
Photo 7. View south into PEM Juncus Unit. Low tide.

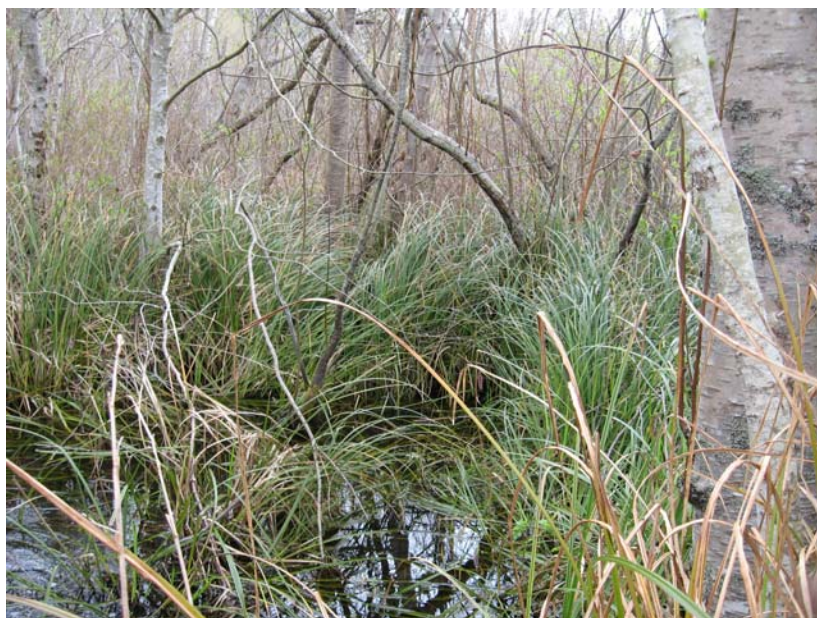
Photo 8. Detail in Palustrine Forested Community. Low tide.

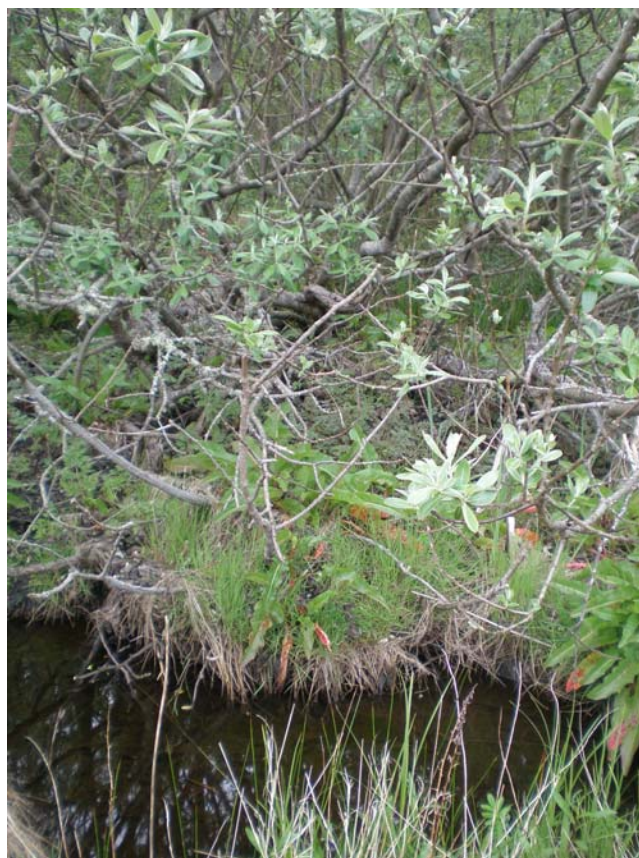
Photo 9. Detail in Palustrine Scrub-Shrub community in the Salix Unit. Note surface water channel. Low tide.

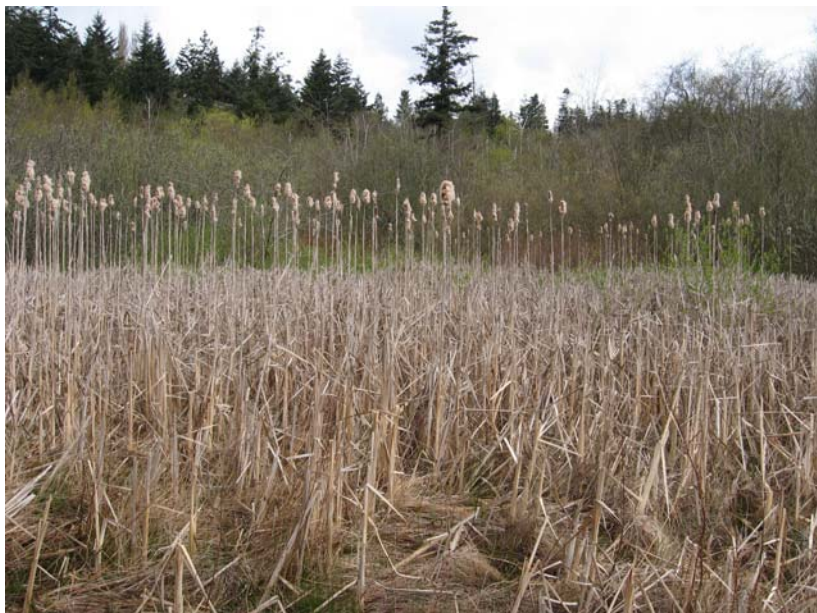
Photo 10. View north into Palustrine Emergent community, Typha Unit. Low tide.

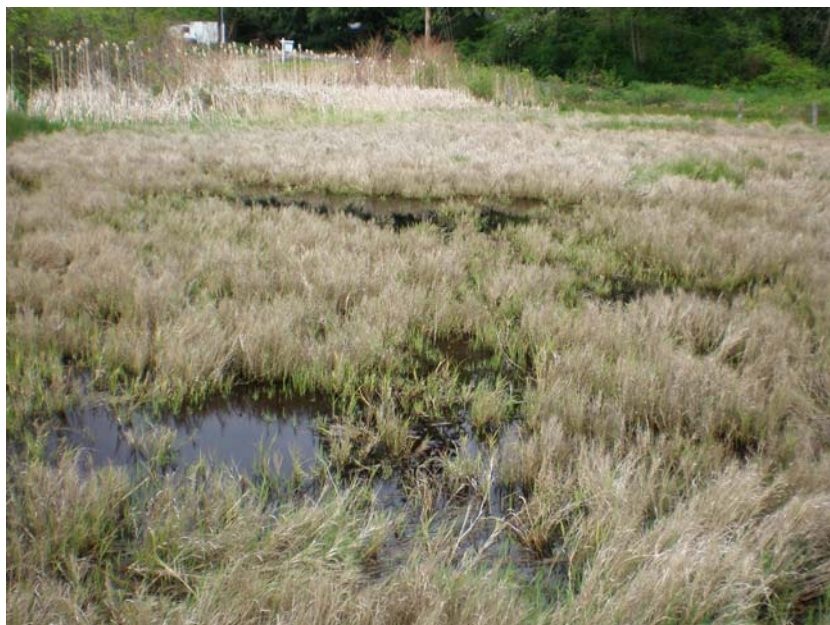
Photo 11. Detail of Palustrine Emergent community, Distichlis Unit. Photo taken after day of heavy rains. Pools had tannic water with mosquito larvae. Low tide.

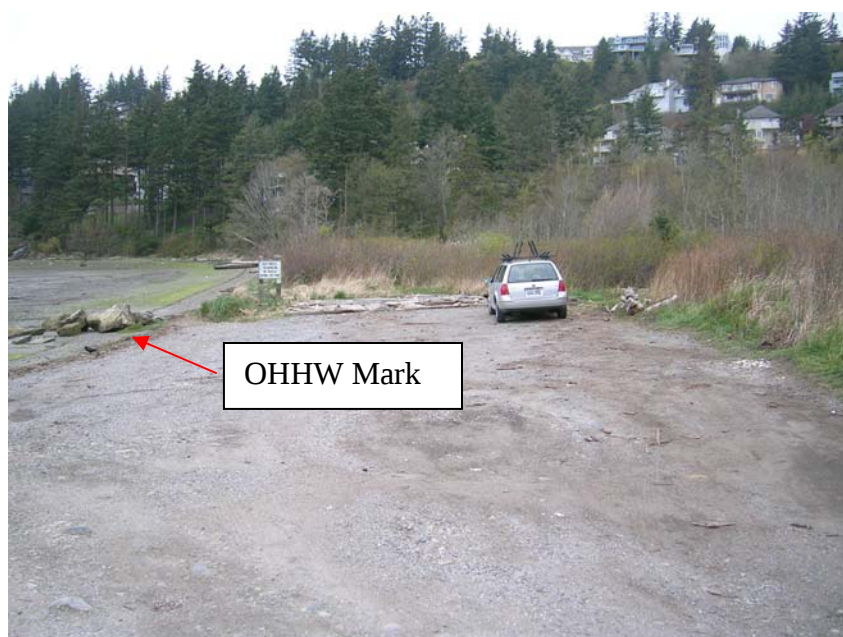
Photo 12. Detail of existing parking area and Upland Shrub community. Low tide.
