PROJECT TITLE: Whatcom Marine Resources Committee Operations and Projects

DELIVERABLES FOR TASK NO: 4.5 (Chuckanut PIC final report)

# WHATCOM MARINE RESOURCES COMMITTEE CHUCKANUT POLLUTION, IDENTIFICATION AND CORRECTION (PIC)

*2017-2018 Final Report*

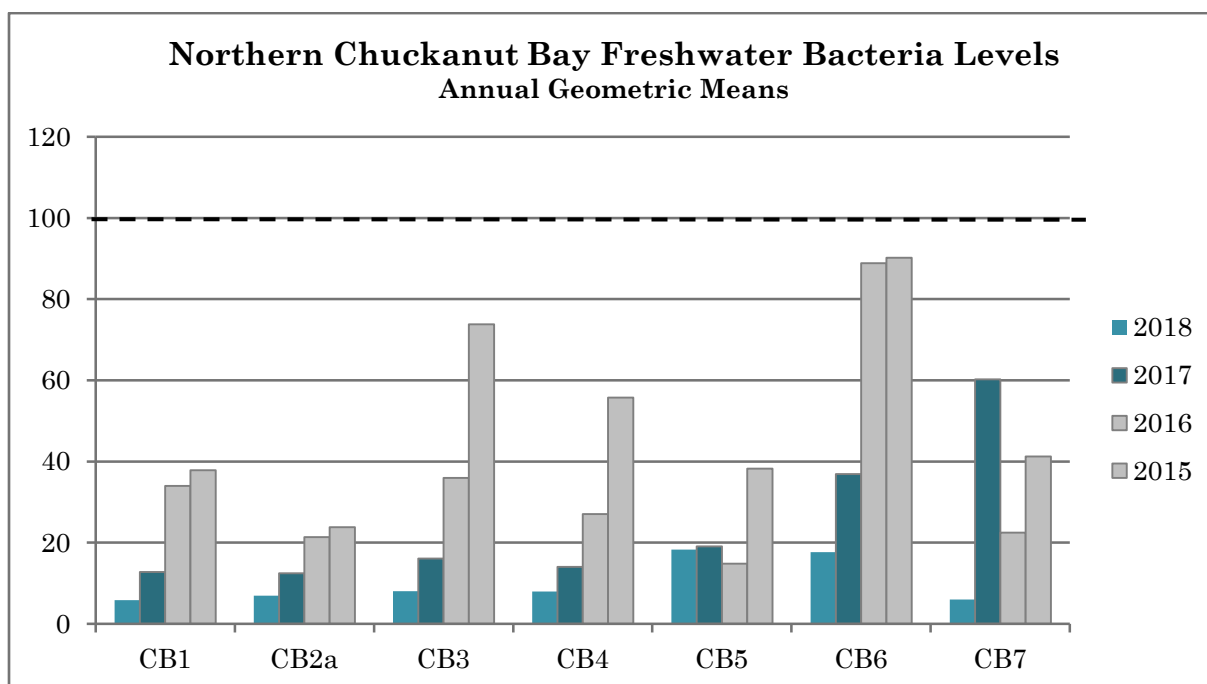
**Figure 2: Fecal coliform annual geometric means at routine Northern Chuckanut Bay watershed freshwater stations (2015-2018).** Bars indicate annual fecal coliform geometric and dashed black line indicates the water quality standard. All stations meet the geometric mean standard for fecal coliform bacteria. Blue bars illustrate the reduced geometric means observed over the past two years at all stations except CB7 in 2017.

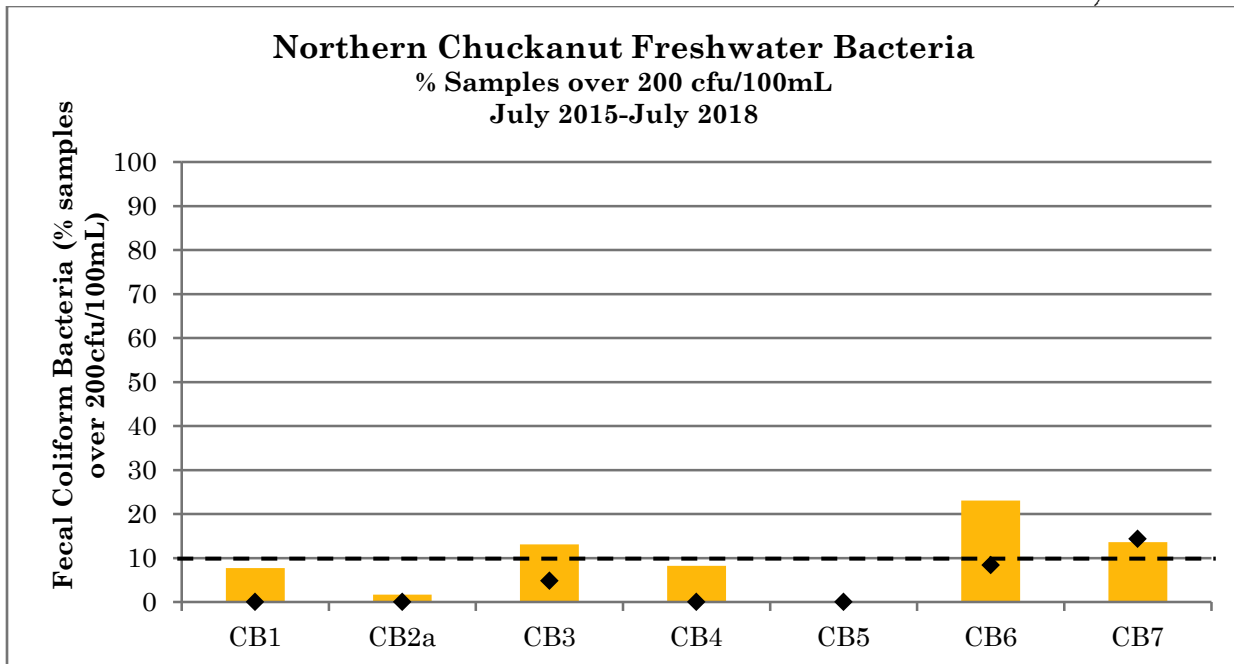
**Figure 3: Percent of fecal coliform results above 200cfu/100mL at Northern Chuckanut Bay freshwater stations.** Bars indicate percent of samples collected over the past three years with fecal coliform results over 200 cfu/100mL. Black diamonds indicate the percent of samples over 200cfu/100mL in the last 12 months. Black diamonds below the top of the red bar indicate a declining number of bacteria spikes. The black dashed line indicates the water quality standard.

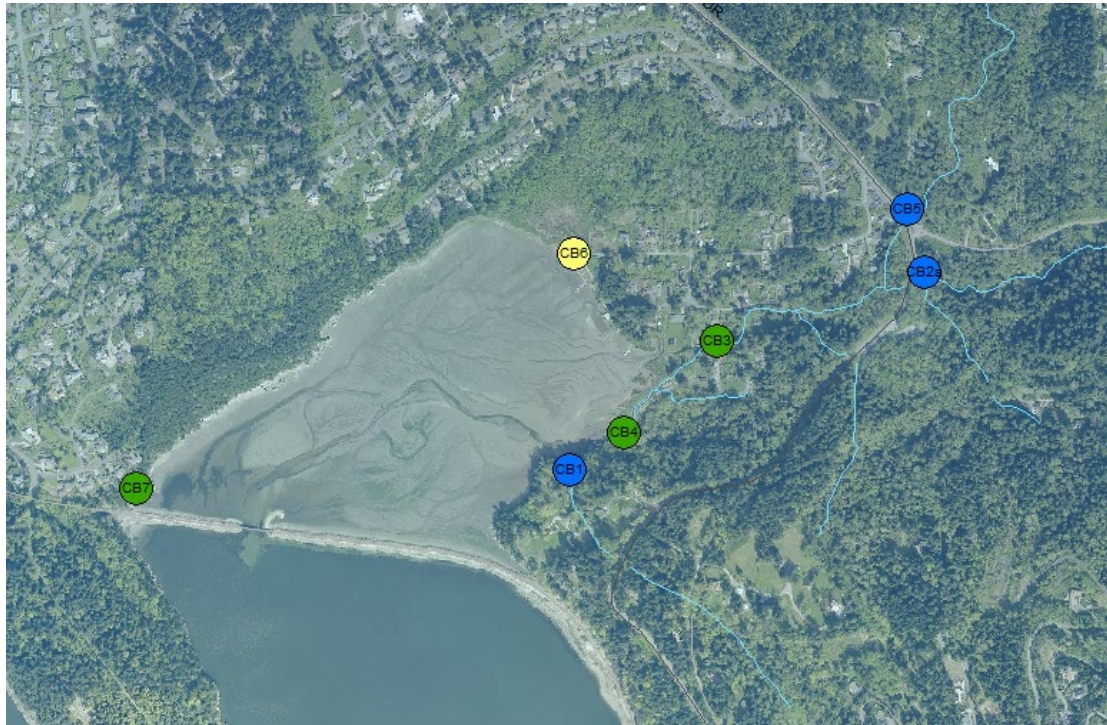
**Figure 4: Status of fecal coliform bacteria at Northern Chuckanut Bay freshwater stations.** Blue dots indicate sites with geometric mean < 20 cfu/100mL, green dots indicate sites with geometric means between 20 and 40 cfu/100mL, and yellow dots indicate sites with geometric means > 40 cfu/100mL.

between 40 and 60 cfu/100mL. All freshwater sites are well within the fecal coliform geometric mean standard.

Figures 4 and 5 illustrate the differences in patterns observed between the freshwater and marine stations. The freshwater stations adjacent to the marine station CM2 are all meeting water quality standards for fecal coliform. However, fecal coliform levels observed at CM2 are elevated with an estimated 90<sup>th</sup> percentile four times the standard for fecal coliform. Thus, a special study was established to evaluate bacteria results in the shoreline areas immediately adjacent to CM2 to help determine the zone impacted by elevated bacteria levels and potential areas with bacteria sources.

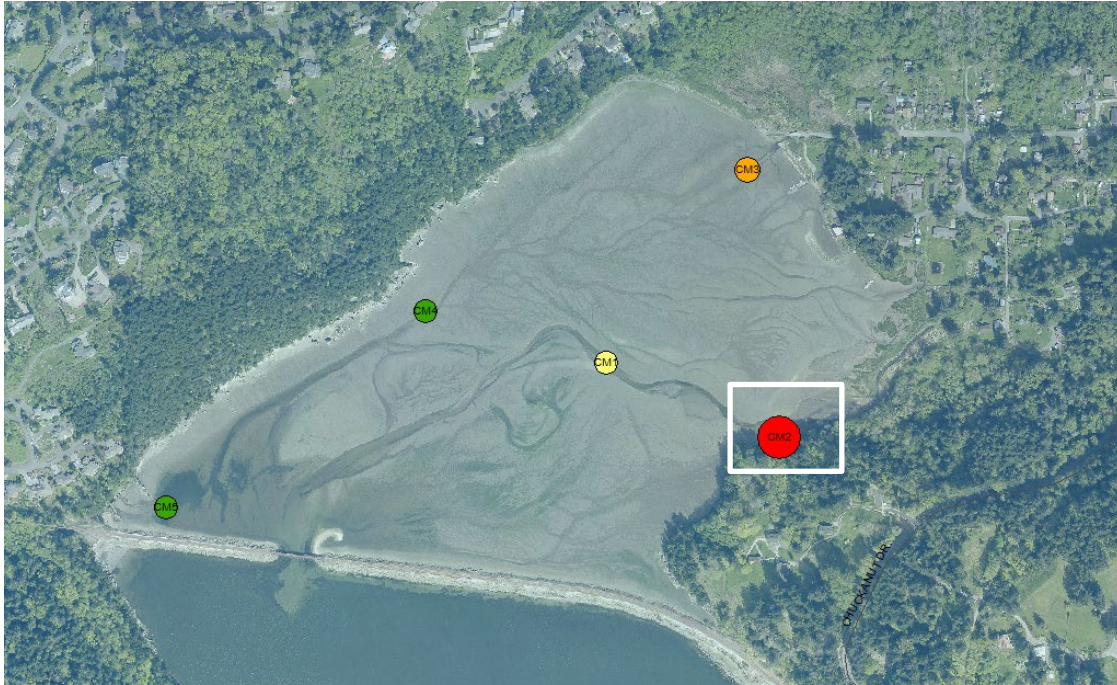
**Figure 5: Status of fecal coliform bacteria at marine stations in Northern Chuckanut Bay watershed.** Dots indicate estimated 90<sup>th</sup> percentile of established marine sites sampled on a bi-monthly basis by the MRC. Green dots indicate sites that are well within standards (< 20 MPN/100mL), yellow dot indicates bacteria results of concern (20-30 MPN/100mL), orange dot indicates bacteria results at a threatened level (30-43 MPN/100mL), and red dot indicates bacteria results above the standard (>43 MPN/100mL). White box indicates the area of the special marine sampling project (Figure 5).

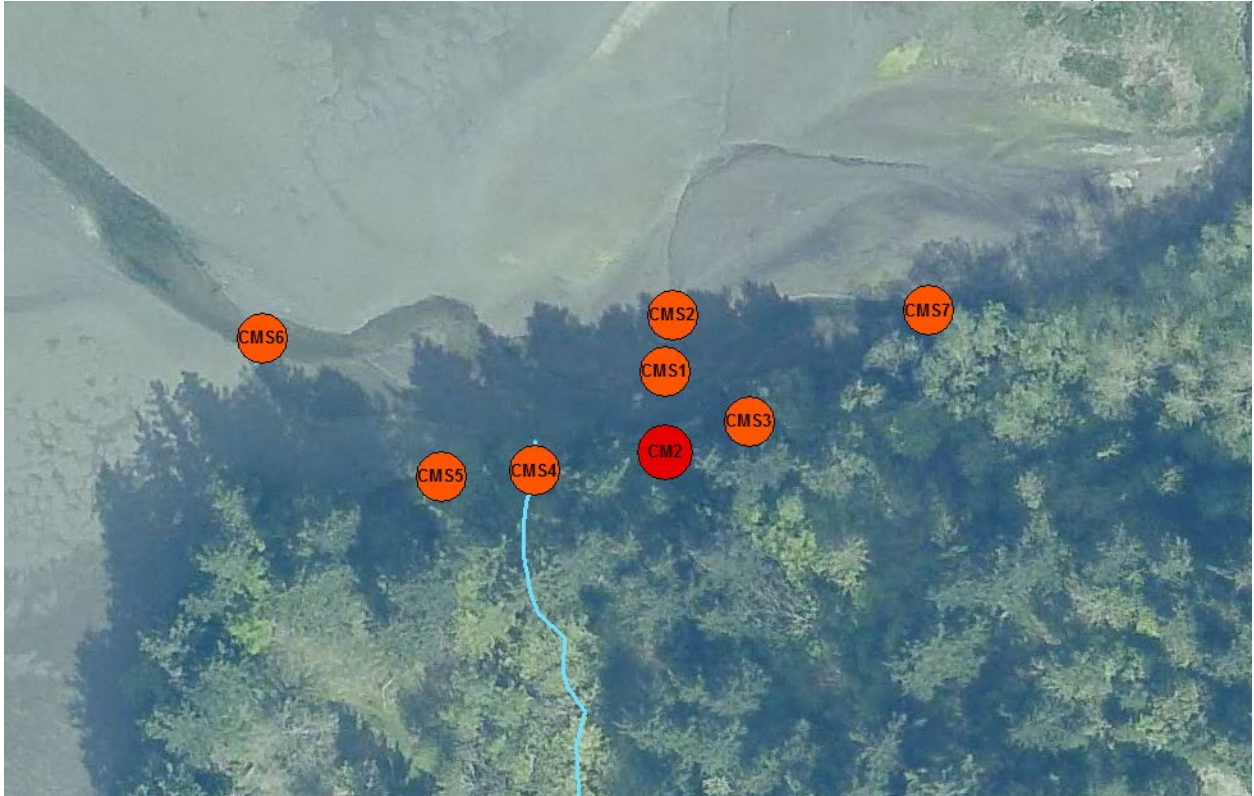
**Figure 6: Northern Chuckanut Bay special marine sampling sites.** Red dot indicates established marine station sampled on a bi-monthly basis by the MRC. Orangedots indicate additional marine stations that will be sampled twice per month through this study.

In coordination with the Marine Resources Committee bi-monthly marine routine sampling run, samples will be collected at a fixed-network of additional 5 marine stations described in Table 1 and Figure 6. These stations represent the main channel of Chuckanut Creek and a 50-200ft zone around CM2.

Sites were identified through review of historical monitoring, field reconnaissance and aerial images of tidal channels. Marine site CM2 is located adjacent to a large rock just below the bank from Woodstock Farm. This site is along a short, side-channel between the main channel of Chuckanut Creek and the shoreline. Special sample sites were located at sites where freshwater is entering the marine system, the main channel of Chuckanut Creek, and over a mudflat with seeps and an abundance of animal tracks. These sites were selected to help determine the extent to which the elevated bacteria levels at CM2 radiate from this site and to assist with evaluation of potential bacteria sources near CM2. Grab samples will be collected and analyzed for fecal coliform bacteria. Salinity and temperature will be measured and compared between sites to characterize freshwater influence.
