# Whatcom County Nearshore Habitat Restoration Prioritization

Prepared for: Whatcom County Marine Resources Committee

Coastal Geologic Services Inc.

June 27, 2007

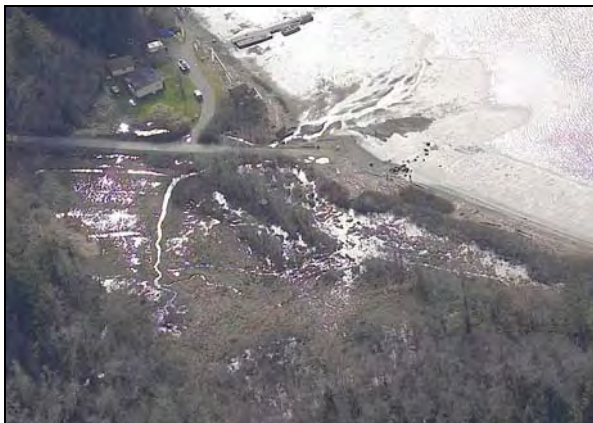
**Figure 9.** Chuckanut Bay backshore wetland looking south (Pictometry International Corp 2004).

This site was tied as the highest scoring restoration opportunity and received a total of 74 out of 117 points (Tables 7 and 8). It scored 30 targeted response points due to the number of ecosystem benefits that could result from the previously outlined restoration actions. Broadening and possibly day-lighting the stream channel flowing from the wetland to the beach would enhance hydrologic

Site 1. Chuckanut Bay – Wetland Reconnection and Backshore Restoration - This project entails multiple restoration actions encompassing wetlands, and portions of the backshore and intertidal at the bayhead in northern Chuckanut Bay. The site is located at the end of Fairhaven Avenue where it reaches the beach. Restoration opportunities are located on both the southeast and northwest sides of the road end and landward of the small parking lot. Restoration actions at the site would ideally be comprised of enhancing the hydrologic connectivity and the tidal prism of the backshore wetland, recovering lost backshore habitat that is currently occupied by a parking lot and associated fill (Figure 7), and removing rock and derelict concrete structures from the upper intertidal/backshore (Figure 8). A 16-inch concrete culvert runs under the gravel road end with flow observed during all site visits. The road is only 12 ft wide in this area, with no shoulder and is in poor condition. Enlarging the tidal channel and installing a much larger culvert that extended lower and would enhance tidal flow in and out of the backshore wetland complex, which extends approximately 500 ft alongshore and 200 ft landward of the backshore berm (Figures 9 and 10). Decommissioning the last reach of road (90 ft long from end of pavement to the parking lot on the beach and backshore) and installing a simple footbridge would enhance the marine riparian and could also provide additional recreation area, in the area currently acting as a parking lot. This would likely require putting in some form of parking in the right-of-way for recreation access.

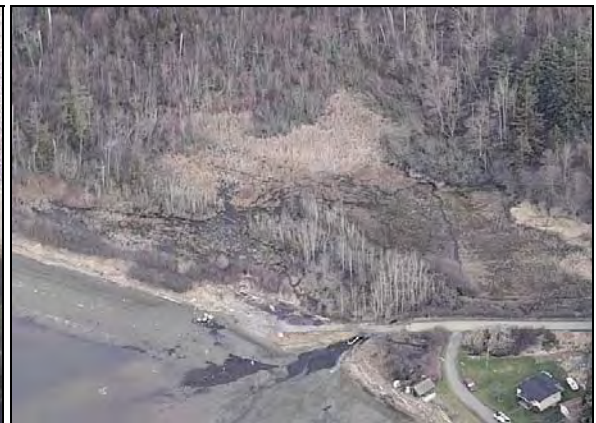
**Figure 10.** Chuckanut Bay backshore wetland looking north (Pictometry International Corp 2004).

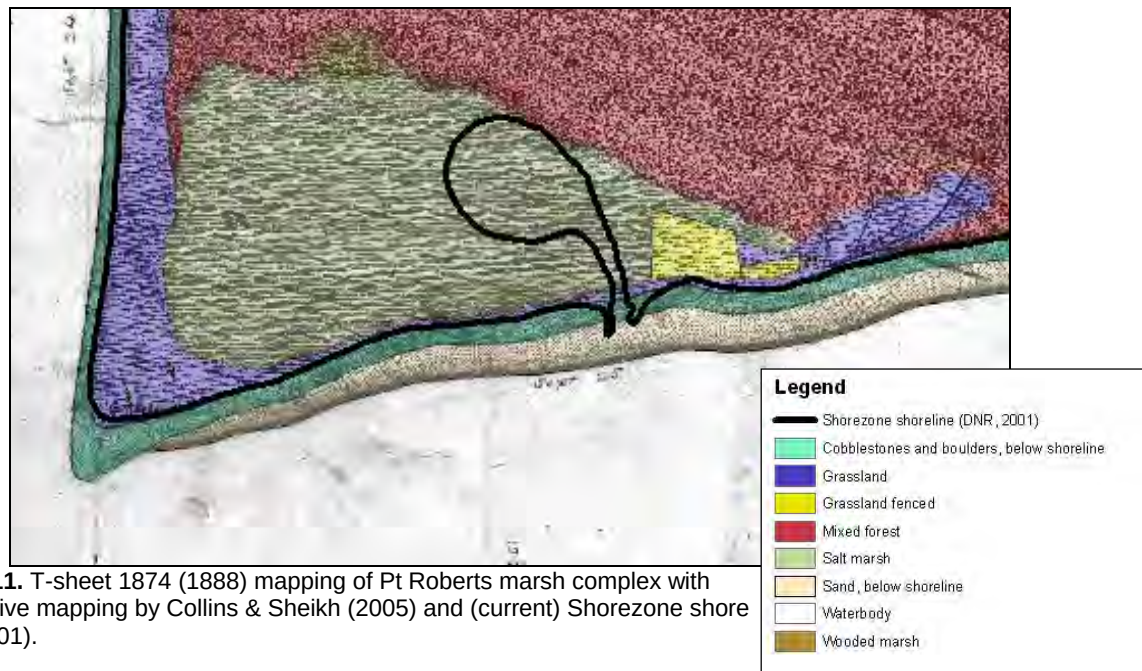
Site 2. Point Roberts - Hydrologically Reconnect Wetland - A culvert system and outfall are located on the beach just east of the Point Roberts Marina jetties that drain a large (historic) wetland complex that used to occupy much of the southwest corner of the Point Roberts peninsula (Figure 11). The outfall is buried under a groin-like structure that crosses much of the intertidal beach width (Figure 12). The rock covering the outfall measured 24 ft across on average and extended approximately 135 ft across the shore. The concrete culvert measured 48-inches in diameter (Figure 13). The culvert discharges at approximately - 0.5 ft MLLW, and delivers considerable freshwater flow to the marine environment. The culvert extends approximately 700 ft from the lower intertidal, up the beach and beneath the backshore, under a cleared lot owned by Point Roberts Marina and Point Roberts Marina Resort (Whatcom County Assessor's Database 2007).

**Figure 11.** T-sheet 1874 (1888) mapping of Pt Roberts marsh complex with Interpretive mapping by Collins & Sheikh (2005) and (current) Shorezone shore-line (2001).

Similar to Site 1, day-lighting the channel and restoring the connectivity between the fresh water and marine environment could enable this site to provide several pocket estuary functions such as rearing, foraging and osmoregulation for migrating juvenile salmonids from both the Fraser River Delta and other nearby salmonid bearing streams within Boundary Bay. Additional ecosystem services such as water pollution abatement and flood mitigation may also be an indirect result of this restoration action. Wetland ecosystems provide several ecosystem services including; water pollution abatement and flood mitigation, which would likely be additional indirect benefits of these restoration actions.

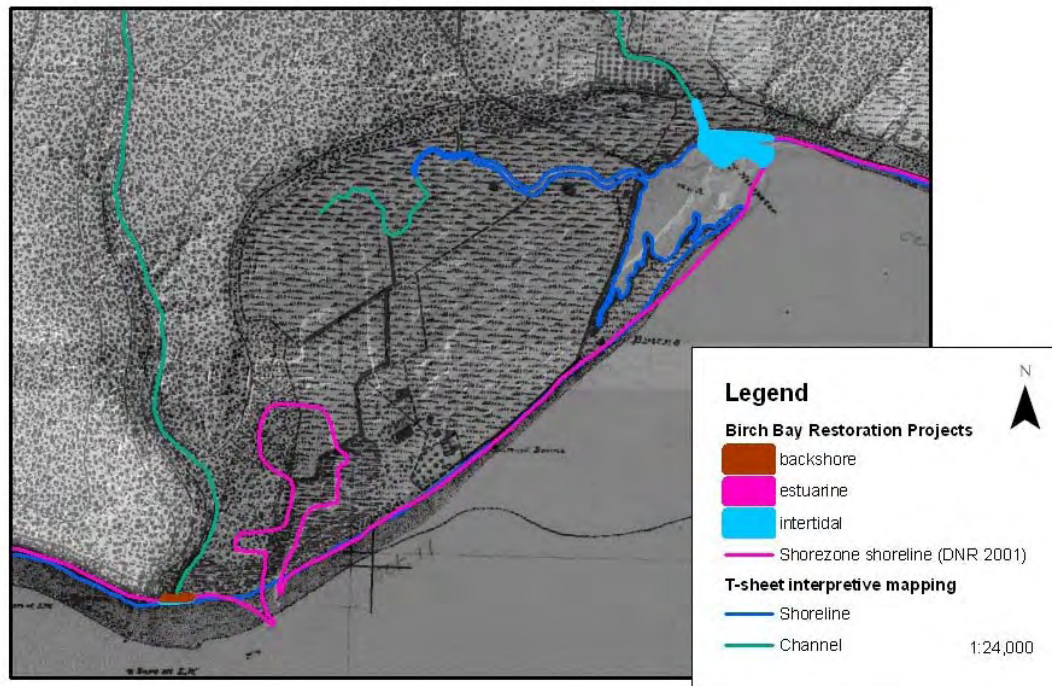
**Figure 18.** Historic T-sheet with interpretive mapping (Collins and Sheikh 2005) with Lidar imagery (USGS 2007), current shoreline (DNR 2001) and proposed restoration sites.
