# East Marrowstone Island Eelgrass Survey

July 1-2, 2006

James G. Norris

CH2M Hill, Inc.  
1100 112<sup>th</sup> Avenue NE, Suite 400  
PO Box 91500  
Bellevue, WA 98004-4504

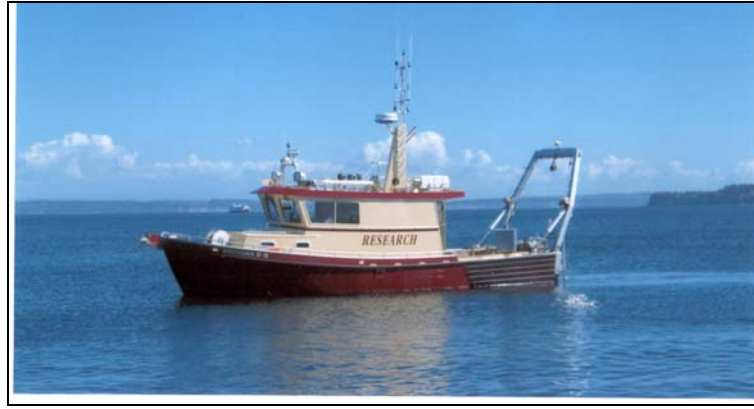
Figure 2. The R/V *Brendan D II*.

We conducted sampling aboard the 36-ft *R/V Brendan D II* (Fig. 3). We acquired position data using a sub-meter differential global positioning system (DGPS) with the antenna located at the tip of the A-frame used to deploy the camera towfish. Differential corrections were received from the United States Coast Guard public DGPS network using the NAD 83 datum. A laptop computer running Hypack Max hydrographic survey software stored position data, depth data from one echosounder (Garmin), and user-supplied transect information onto its hard drive. Position data were stored in both latitude/longitude and State Plane coordinates (Washington North, US Survey Feet). All data were updated at 1 s intervals. Table 3 lists all the equipment used during this survey.
