PROJECT TITLE: **SWAT Installation Report**

STORMWATER ANTIMICROBIAL TREATMENT UNIT INSTALLATION AND MONITORING PROJECT REPORT

Task 12: Installation and Monitoring of a Storm water Antimicrobial Unit at Bay View, Washington

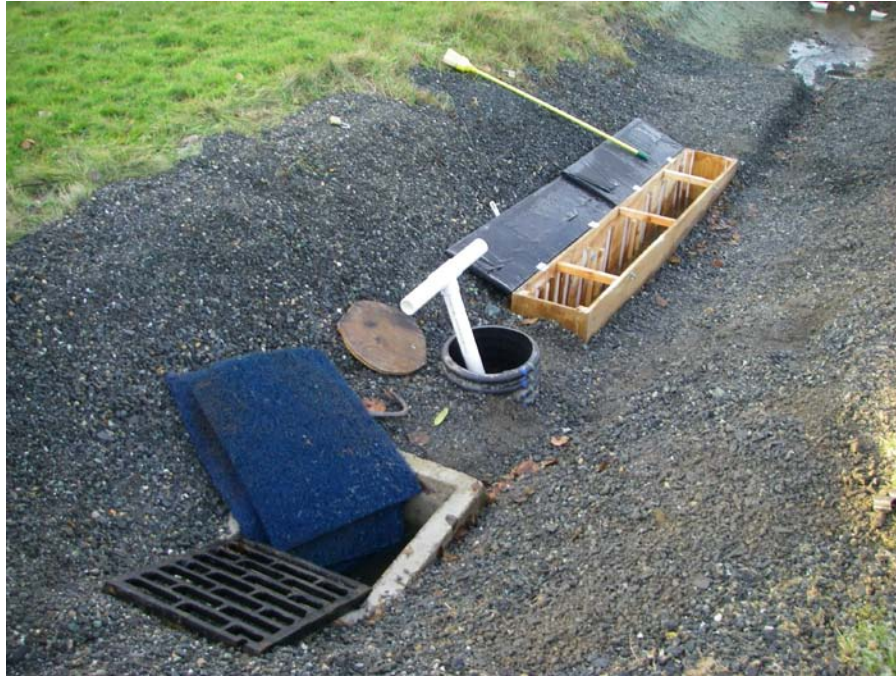
Figure 2. Detail of the SWAT experimental unit installed at Bay View. The sediment retention sump (with filter material) is in the foreground. In the middle is the well holding the 2" PVC flow control valve and the SWAT experimental trough is in the background.

The new uphill site was especially interesting because it was in a roadside ditch that had been converted to a bioswale structure to "treat" a small portion of the overall storm water flow being carried inside an underground pipe. A plan evolved to install a much smaller experimental unit to test the smaller amount of diverted storm water at this location. The plan was initiated by providing Skagit County Public Works (SCPW) personnel with conceptual drawings of the proposed experimental unit. SCPW then constructed the unit and installed it at the specified location. The unit consists of a plywood flow through trough measuring 8' long x 14" wide x 18" deep with a sediment settling sump (30" length x 24" wide x 32" deep) installed inline prior to the experimental trough (Figures 1-3). The inflow line to the trough is 2" PVC and the outflow is 4" PVC. A 2" PVC valve was installed between the sediment sump and the experimental trough to control the flows. "Horse hair" air conditioning filter material

was inserted into the sediment sump to assist with removal of sediments that might clog the Smart Sponge[®] media.

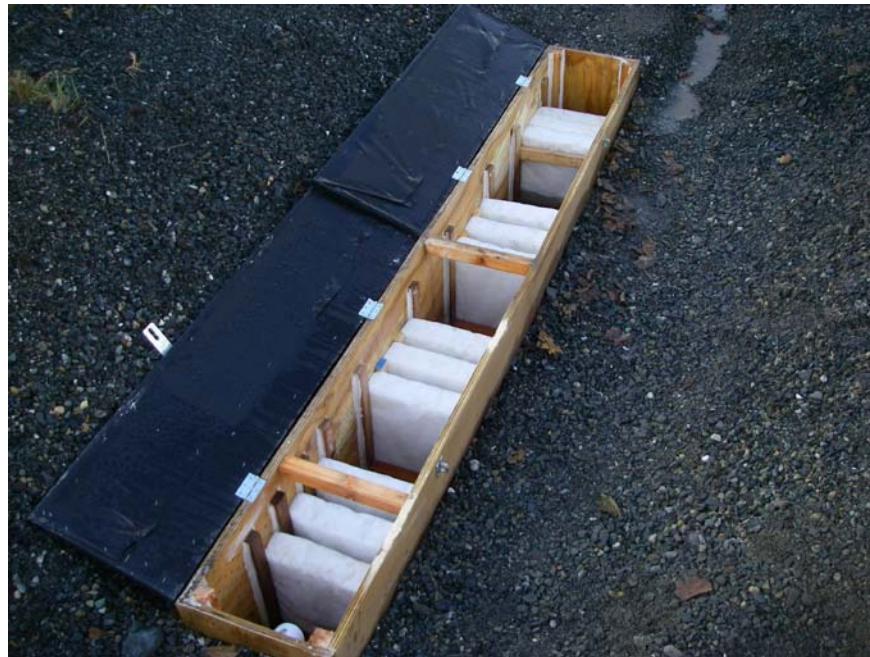
Figure 3. The SWAT experiment trough with the Smart Sponge[®] Paks installed. The design allows the water to flow through up to 12 Paks. If the leading Paks clog due to sedimentation, then the storm water will flow over the clogged Paks to the next sets.

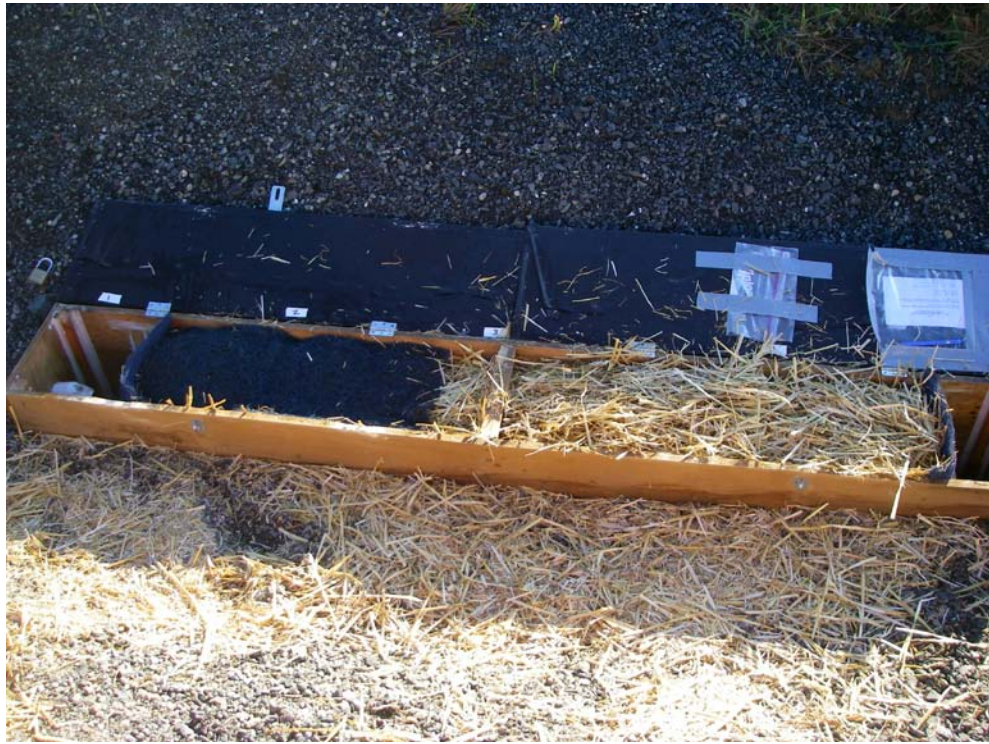
Figure 4. Following clogging of the Smart Sponge[®] Paks with sediment during a heavy rainfall, a second experiment was set up to test the ability of straw to act as a pre-filter for the Smart Sponge[®] media.

Progress as of January 2011 includes: 1) several conversations with Terry Stevens and staff of the Padilla Bay Research Reserve regarding funding and timing of the Reserve boat ramp/outfall project with which the SWAT unit construction will be synchronized (but, as noted above, will not happen), 2) conversations with Skagit County Public Health and the Padilla Bay Reserve staff about processing samples collected for bacterial counts, 3) conversations with Skagit Beach Watchers and the Padilla Bay Reserve about use of volunteers to collect routine water samples before and after SWAT treatment, 4) purchase of the Smart Sponge matrix to be tested, 5) construction and installation of the SWAT unit by Skagit County Public Works, 6) training of Storm Team volunteers in collection of samples from the SWAT unit and processing of samples for bacterial counts and turbidity at the Padilla Bay Reserve, 7) completion of experiment number 1 using Smart Sponge[®] Paks and 8) initiation of experiment number 2 using straw to help reduce sedimentation of the Smart Sponge[®] media (Figure 4).
